LANDSLIDES CAUSED BY THE MW7.8 KAIKŌURA EARTHQUAKE AND THE IMMEDIATE RESPONSE

ABSTRACT

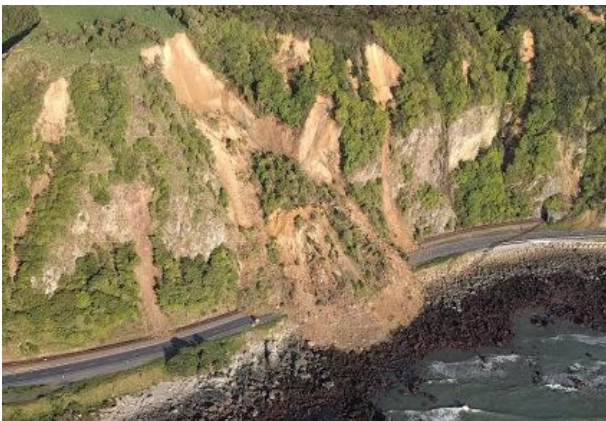
Between Waipapa Bay and Mangmaunu at the Mouth of the Clarence River in the north, to the mouth of the Hapuku River in the south, State Highway 1 and the main trunk railway line was completely inundated by debris from large landslides in several places (Figure 2). After stopping briefly in Kaikōura the reconnaissance continued, travelling south and observing State Highway 1 and the main trunk railway line again being blocked in several places by large landslides between Peketa and Oaro. Continuing south along the coast, landslides were prominent on the coastal cliffs as far south as Goose Bay (Figure 3).

Figure 2: Landslide blocking the railway line and State Highway 1 north of Kaikōura. The landslide has broken the railway line and dragged the tracks across the road on the right hand side of the photo. The coastal uplift at this site is also visible in the exposed shoreline covered with sub-tidal seaweed. (Photo: S. Dellow 14/11/2016).

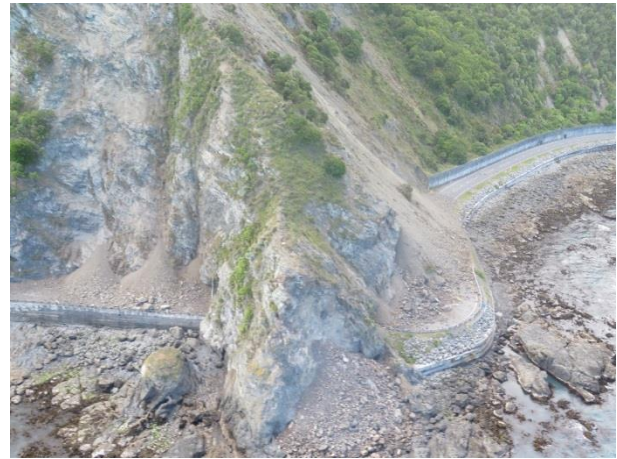
Figure 3: Landslides on either side of the Paratatahi Tunnels, State Highway 1, south of Kaikōura. The railway line at this location is enclosed in a rock shelter, and so was not directly affected. (Photo: S. Cox, 20/11/2016).

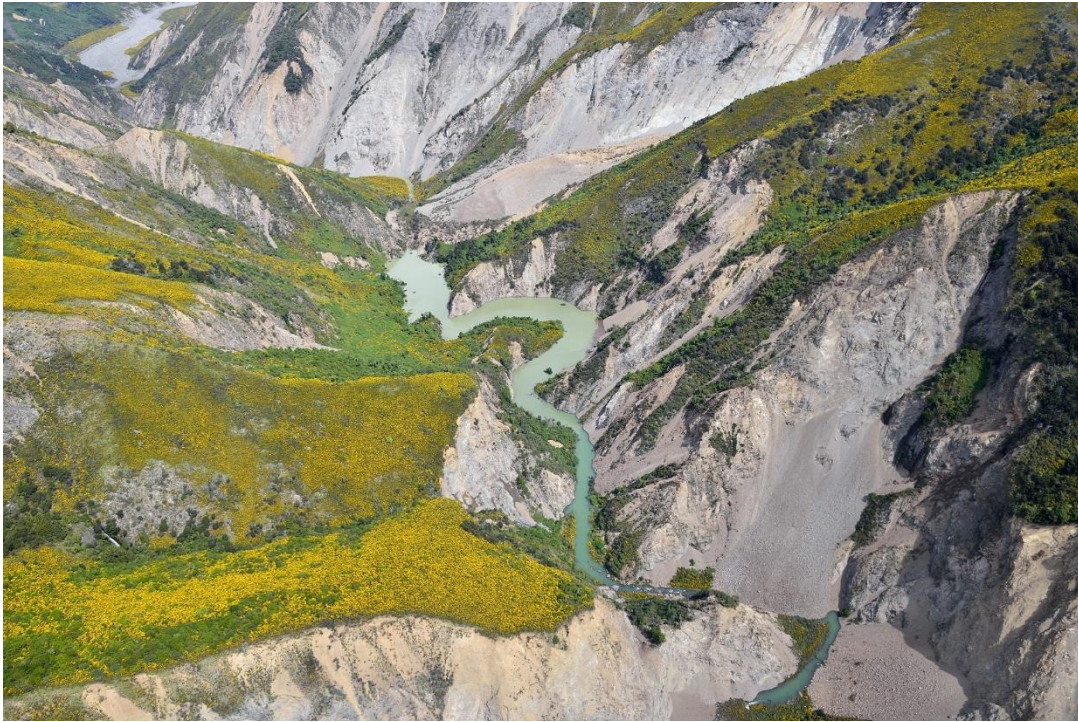
apparent in the days and weeks that followed. From Hanmer Springs the Hope Fault was picked up and flown along back to the coast, north of Kaikōura. While flying along the Hope Fault, which is at the southeast foot of the Seaward Kaikōura Range, several of the rivers crossing the range front were flown upstream, particularly if river flows were absent or the water was discoloured. This revealed landslide damming in several river valleys with water slowly impounding behind the landslide dams (Figure 4).

Figure 4: Landslide dams in the upper reaches of the Conway River in the Seaward Kaikōura Ranges. Two landslide dams are visible in the photo with water still impounding behind both. The source material for the landslides is Torlesse Greywacke which typically forms disrupted rock slides because of the closely jointed and fractured nature of the source rock mass. The resulting debris can be described as an angular gravel and is highly permeable. As a result, none of the large greywacke derived landslides overtopped under non-flood conditions, but developed flows through the permeable material forming the dam. (Photo: D. Townsend, 16/11/2016).

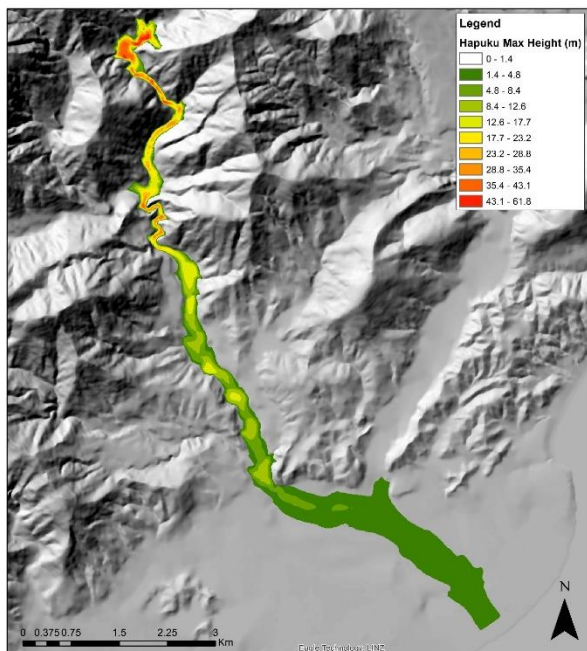
Figure 5: RAMMS modelling of the flow heights from rapid failure of the Hapuku landslide dam. Model parameters include a dam height of 80 m, dam width of 230 m; total volume of flow of $3 \times 10^6 \text{ m}^3$; and a maximum discharge of $13,000 \text{ m}^3/\text{s}$. Even with good data a range of scenarios is possible. This model run depicted the maximum credible flow height from rapid dam failure.

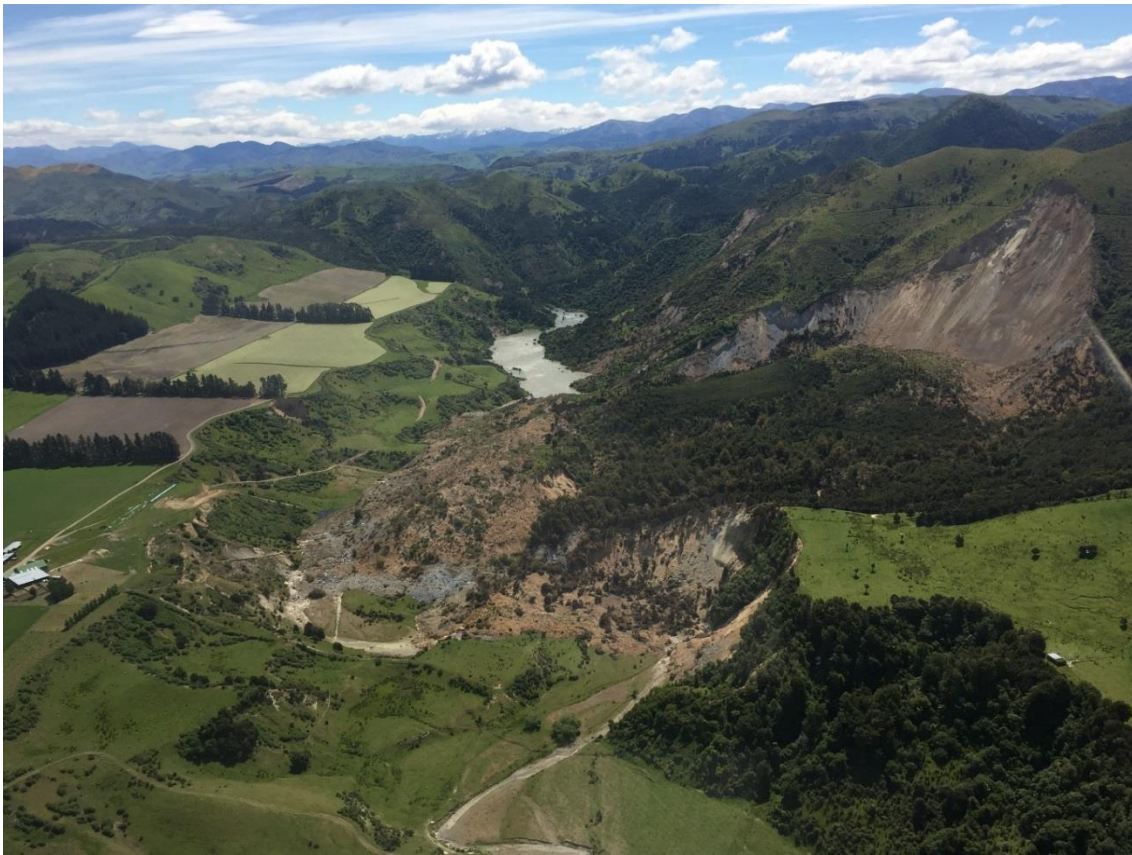
Two types of landslide dams are recognised based on the source material, namely: weak (5-20 MPa) Neogene sedimentary rocks (sandstones and siltstones), and moderately strong to very strong (20-100 MPa) Carboniferous to Cretaceous Torlesse ‘basemen’ rocks (greywacke (sandstone) and argillite (mudstone), but also includes some Neogene limestones). The most frequently occurring landslide types, adopting the scheme of [4], correlate to these materials, where reactivated rock planar and rotational slides tend to be the dominant landslide type in the Neogene sedimentary rocks

(Figure 6). First time rock and debris avalanches with strong structural geological controls, were the dominant landslide type in the basement materials (Figure 7). This led to two quite distinct types of landslide dam. The weak rocks failed as large block slides and slumps and, compared to the strong rock dams, were relatively impervious. In contrast, the landslide dams formed from strong source rocks were effectively piles of porous angular gravels where piping of water flows through the dam is readily apparent. How these two very different styles of landslide dam perform over the coming months and years is of interest because of the ability this has to inform landslide dam assessment after future earthquakes. As of the 12th May 2017 only one of the large, strong source rock dams remain (on the Hapuku), the others having breached during annual flood flows generated by heavy rainfall in early April 2017. Both of the large weak rock dams on the Stanton and Leader rivers are still intact (Stanton River) or partially intact (Leader River).

Figure 6: Landslide dam on the Leader River shortly after the earthquake. The landslide is a slump/block slide in a siltstone unit and is characteristic of the large landslides in weak Neogene rocks. The landslide dam overtopped and partially breached on the 13-14 February 2017 (Environment Canterbury).

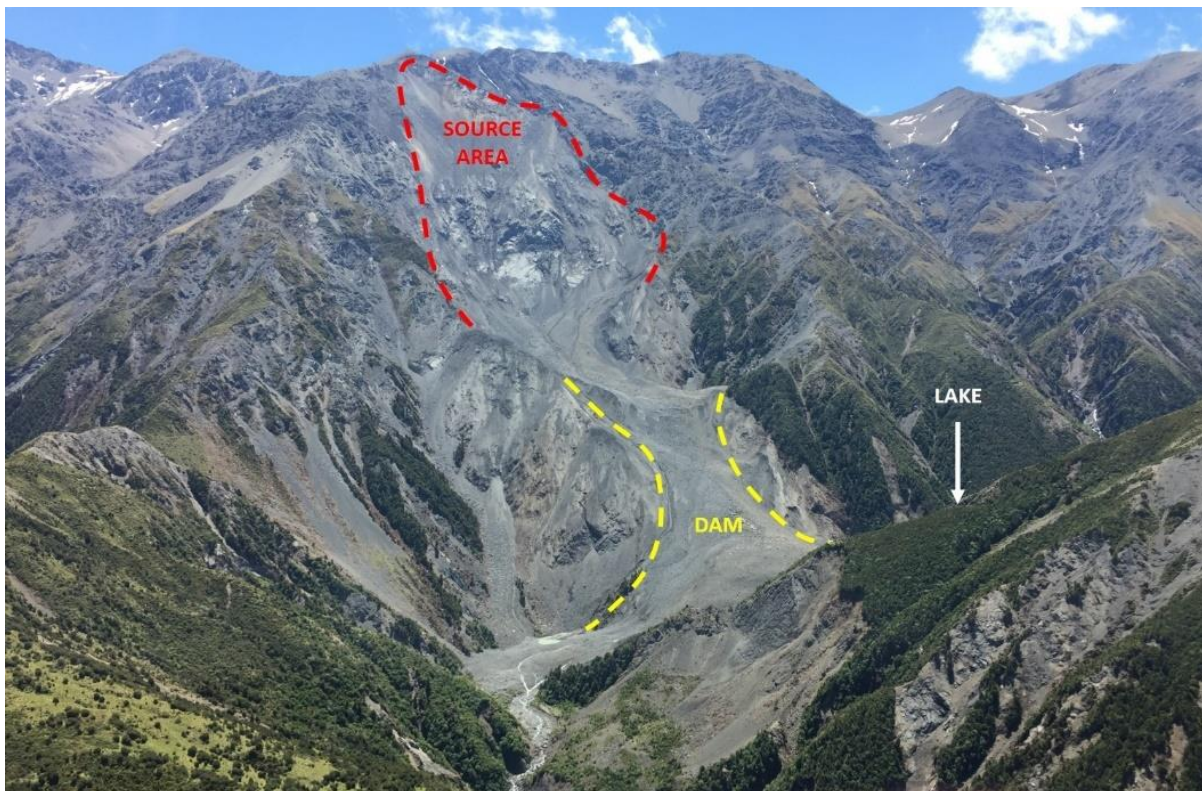
In one case, the largest landslide dam in the upper reaches of the Hapuku River (Figure 7), the terrestrial laser scanning process has been repeated three times. This showed that the landslide dam itself was slowly deforming (lowering at the crest by a nearly one metre over a period of nearly four months and bulging at the toe, again by a nearly one metre).

Figure 7: Hapuku River Landslide dam showing source area, landslide dam and valley downstream of dam. The landslide is a rock avalanche with a horizontal distance between top of the source area and the toe of the debris of 2.7 km. The volume of material in the landslide dam is estimated at $12 (\pm 2) \times 10^6 \text{ m}^3$. This is an example of a greywacke dam with internal flows readily apparent as seepage discharges near the toe of the dam on the downstream face

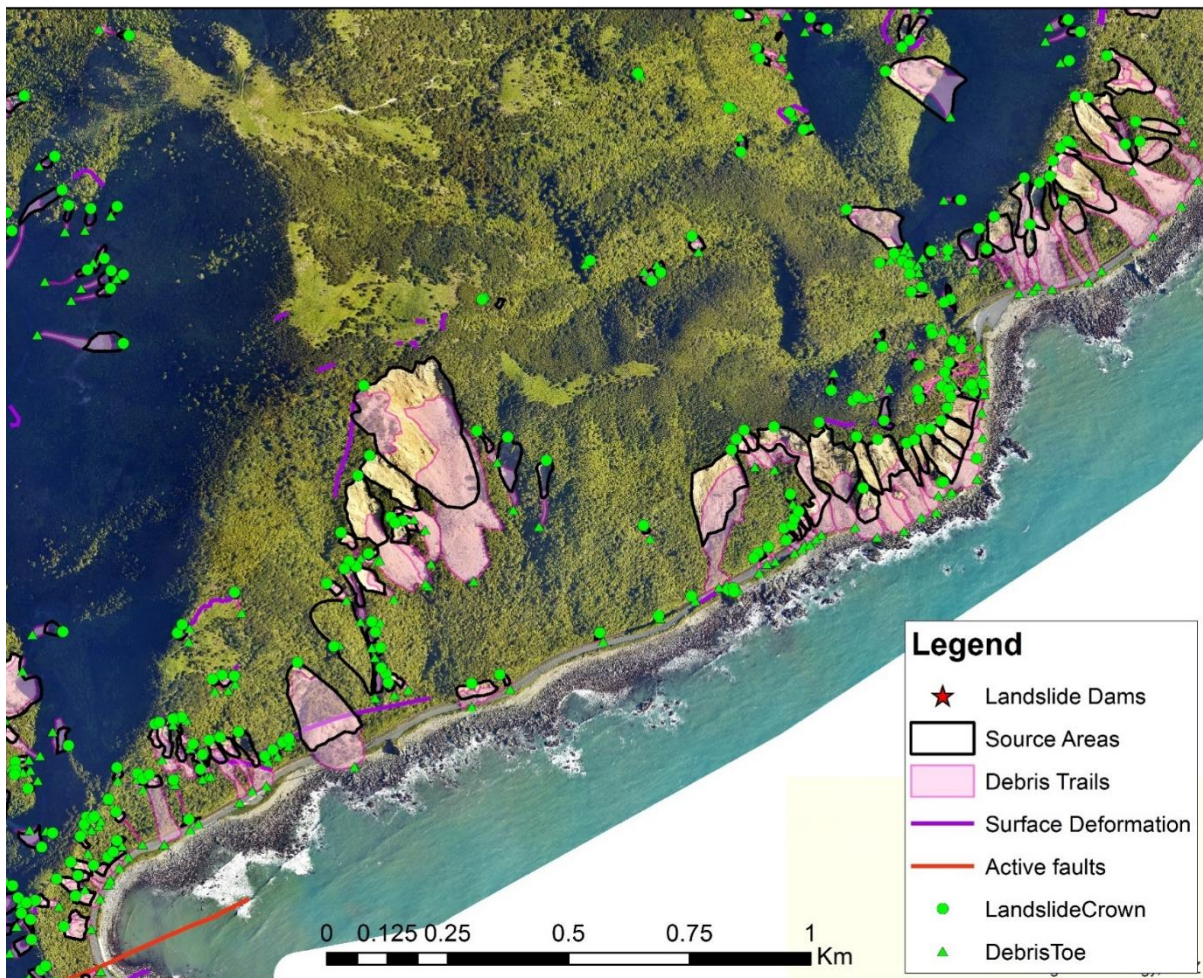
The data will be useful for recognizing immediate hazards (potential for failures/reactivations; Figure 8), outburst floods (dam breaches), short- to longer-term potential for debris flow and valley floor aggradation impacts, sediment budgets for catchments, and for assessing landslide causes (i.e. relationships with topography, geology, fault structures, shaking; Figure 9). One of the main uses of this data will be to assess how slopes performed in particular rock and soil (material) types during the earthquake. This data will be especially useful for those similar-sized slopes in Wellington, where much of the city is formed in similar materials (greywacke sandstones and argillites) to those forming the slopes in the, albeit more mountainous, Kaikōura region. Such data will allow us to better constrain the response of the Wellington slopes to strong shaking e.g. a Wellington Fault earthquake.

Figure 8: An example of landslide inventory mapping on the coast north of Kaikōura. The large landslides in the centre left of the photo did not reach the foot of the slope and the debris is a hazard that could remobilize in an aftershock or rainstorm and will present an ongoing risk to road and rail users if mitigation measures are not determined and implemented
