Master's Thesis

Evaluation of repairing techniques for
damaged natural fiber reinforced
composites

Juan Cardenas Velasco

August 2023

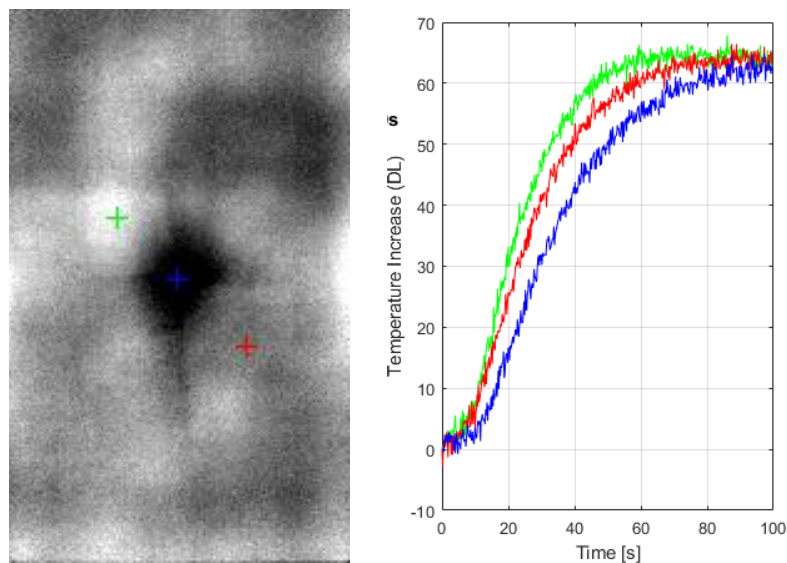
Figure 20: Thermography of impacted epoxy-specimen 20 J– Temperature profile difference

Thermography images are captured at a frequency of 5 Hz over a 100-second duration. The choice of this 100-second interval stems from the fact that it is the average time the composite plate takes to reach and sustain a stable temperature for a period of time before the temperature drops. Figure 20 provides an example using the 20 J epoxy-based damaged specimens as the subject of examination.

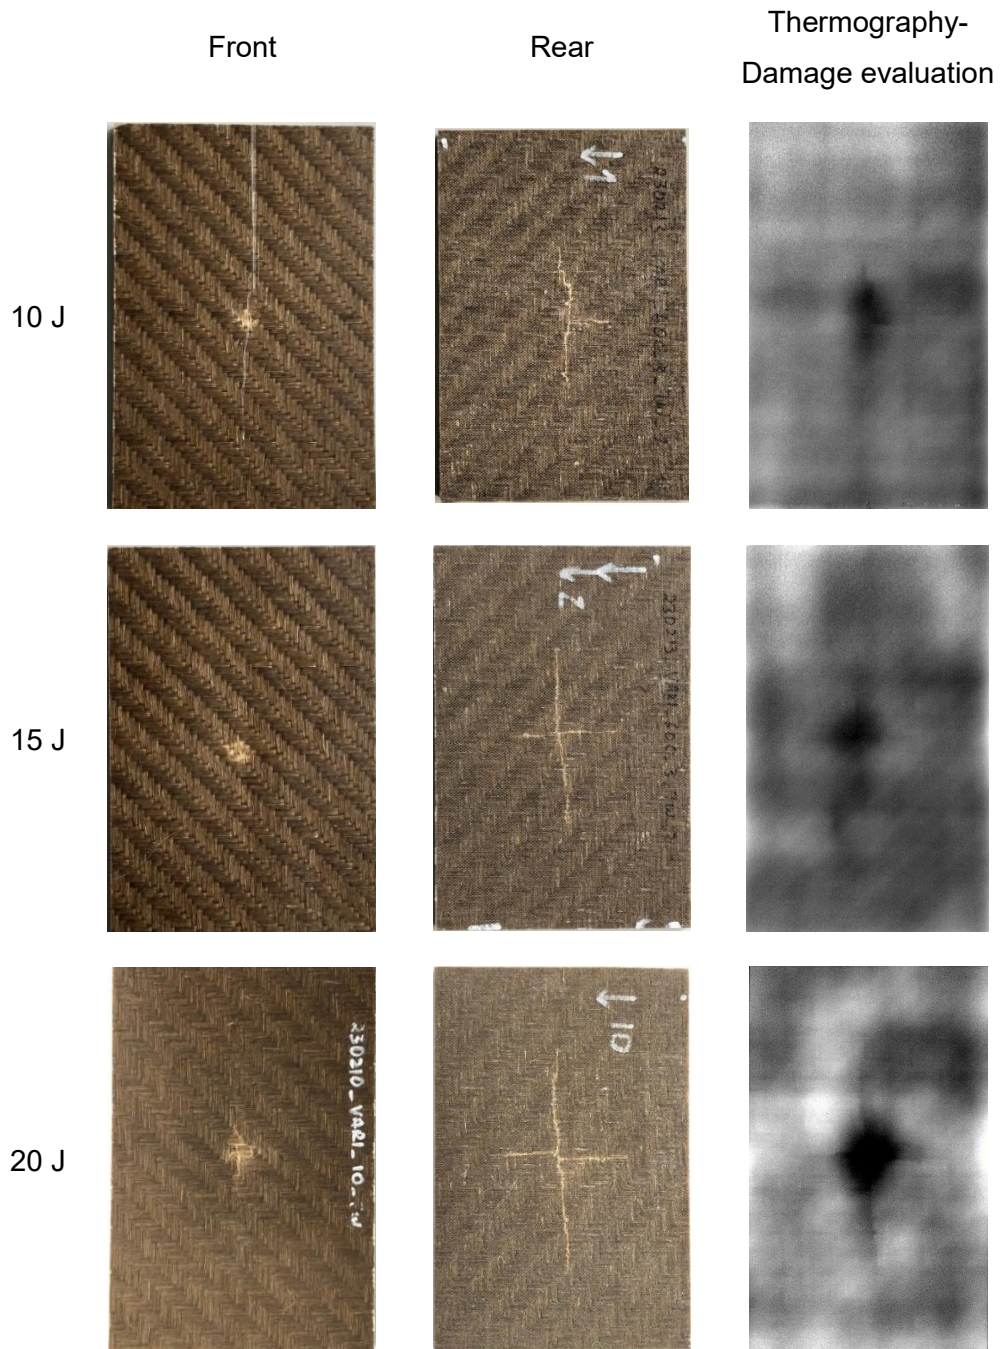
Figure 21: Front, rear and thermography image of impacted epoxy-based specimens

This conclusion is supported by the rear side view of the specimen, confirming such damage.

shaped crack caused by fiber breakage on the rear side, indicating internal damage. These findings underline the significance of employing both visual inspection and thermography techniques to comprehensively understand the damage evolution in composite materials.

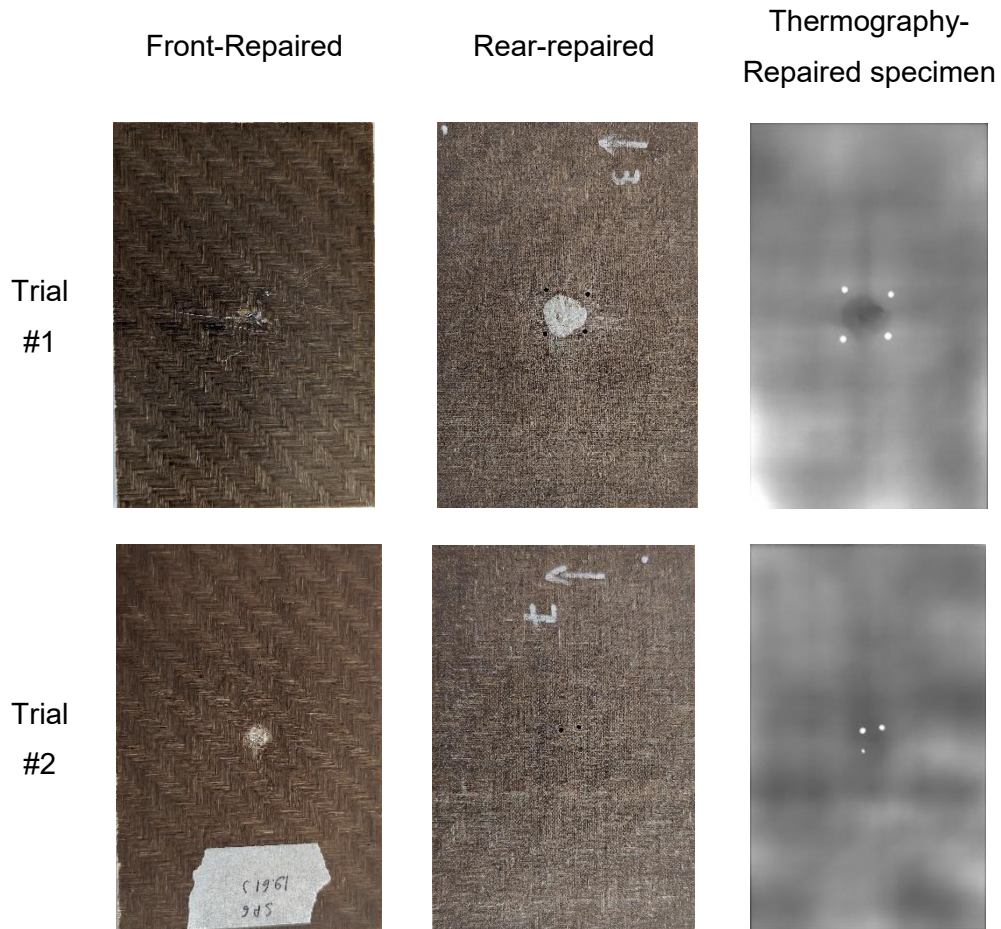
Figure 25: Front, rear and thermography image of NF-EP specimen repair trials

The initial testing of the repair methods outlined section 4.8 involved the vent hole approach [8]. For this assessment, a 15 J impacted specimen was utilized. In Trial #1, five through holes were drilled, with one serving as the injection hole positioned at the center of the impact mark, and the other four as vent holes situated 10 mm away from the injection hole, as shown in Figure 25.

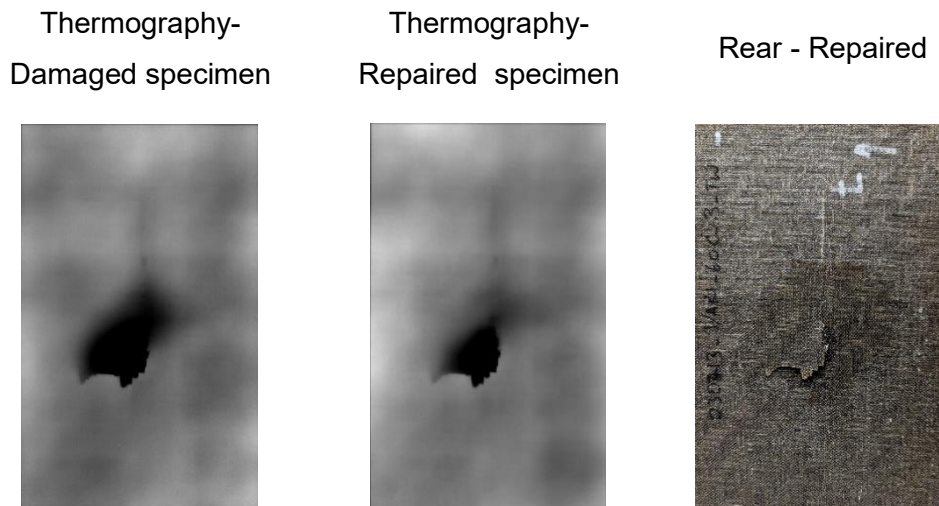
Figure 26: Thermography of third trial NF-EP specimen repair – Excessive delamination

a distinct type of damage characterized by delamination on its rear side, differing from the typical cross-shaped mark, as depicted in Figure 26.

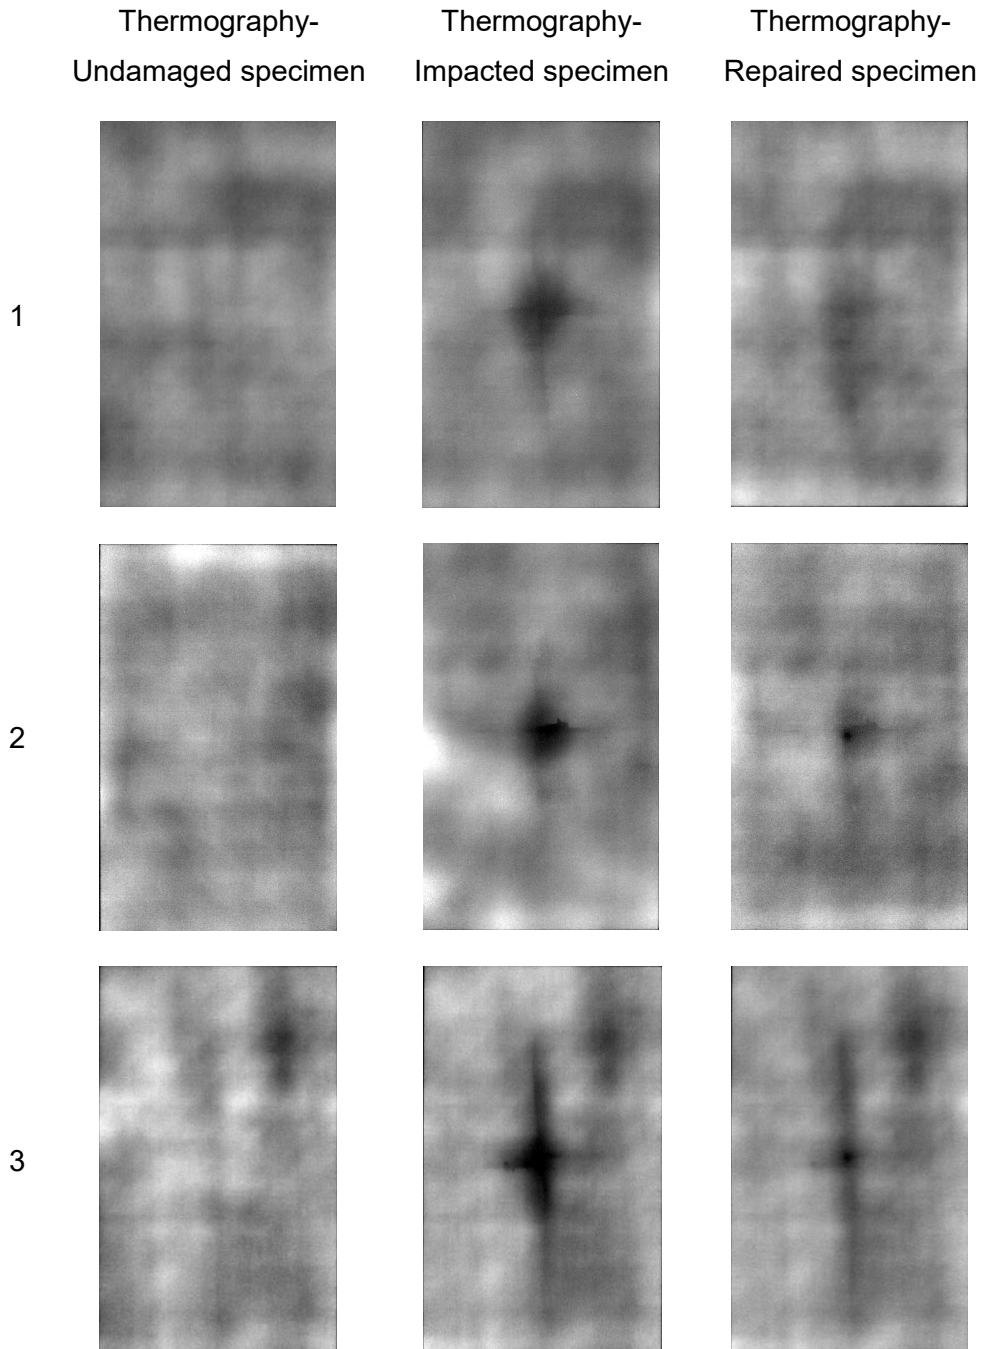
Figure 28 Thermographs of epoxy-based selected specimens

The images obtained from the NF-EP specimens exhibit a high level of clarity, as depicted in Figure 28. It's important to acknowledge that the presence of bright white spots near the specimen's edges can be attributed to an imperfect fit between the specimen holder and the specimen during the thermography procedure. This occurrence arises from the potential for light from the flash lamp to leak around if the holder doesn't securely conform to the specimen's shape. Furthermore, in the case of selected specimens 2 and 3, it's noticeable that the damage existing prior to repair involved a minor delamination of the outermost layer. This delamination, although not extensive, was sufficiently managed by the subsequent injection repair process, leading to a satisfactory outcome.

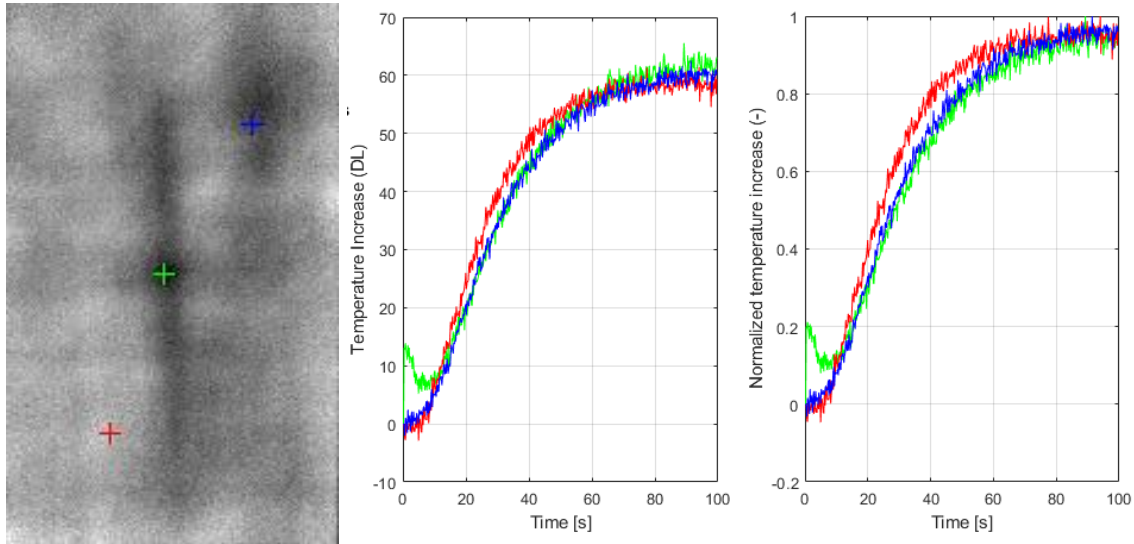
Figure 29 Thermography of repaired Epoxy-specimen #3– Temperature profile difference

the light and energy passed through this fiber-less region at the center of the specimen. This phenomenon resulted in a seemingly elevated initial temperature in this particular spot, as evident in both graphs. However, the temperature profile around the rest of the specimen conforms to the anticipated outcomes.

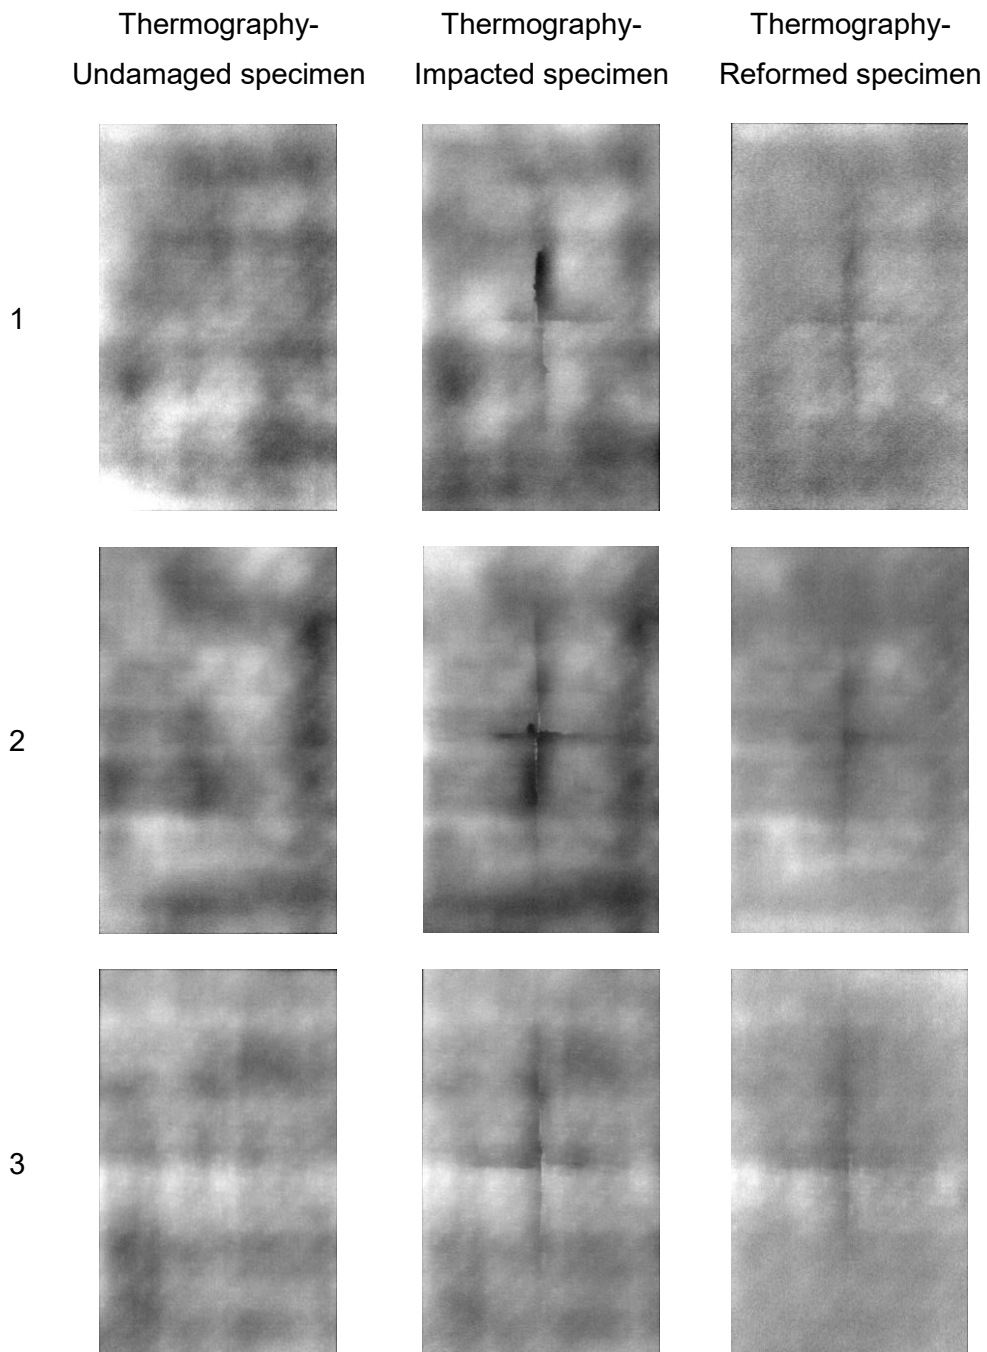
Figure 30: Thermographs of vitrimer-based selected specimens

The thermographic outcomes of the selected three NF-Vi specimens are displayed in Figure 30. Similar to the epoxy-based specimens, the reformed vitrimer-based specimens exhibit a more uniform appearance compared to the damaged specimens. An interesting observation is that despite the slight alteration in average specimen thickness due to the reforming process, the thickness demonstrated reduced variation, as indicated in Table 6. This enhanced uniformity in thickness can be attributed to the reforming process, contributing to the overall more consistent thermographic results, evident in Figure 30.

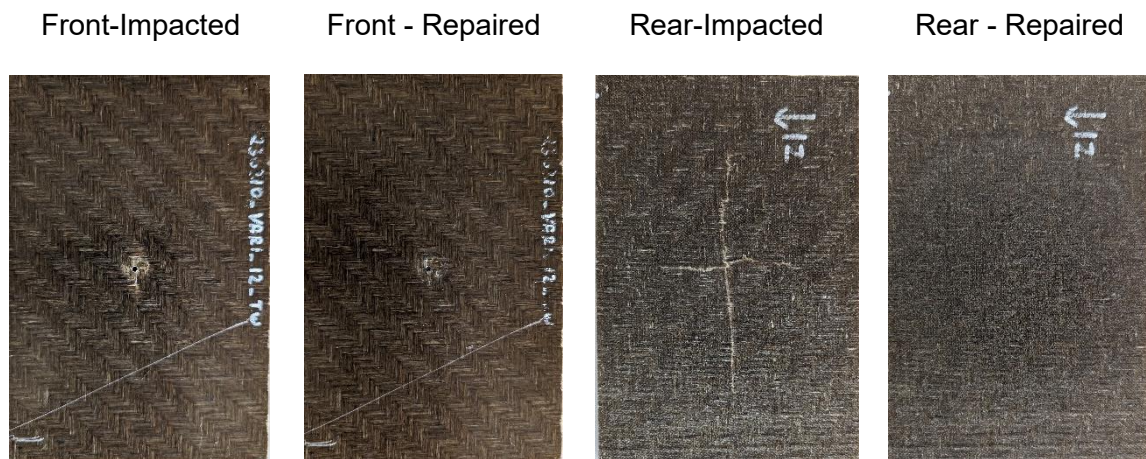
Figure 37: Comparison between same epoxy-based specimen (#2) appearance before and after repair approach

Upon closer examination, it becomes apparent that the injected resin has established pathways through the impacted zone, extending from the center of the specimen towards the outer regions in a radial manner. This radial resin flow, by the conclusion of the injection process, had enveloped a radius of approximately 45 mm. This resulting resin distribution effectively masked the cross-shaped crack that had formed a layer of the composite, along with the adjacent matrix, following the impact event. This visual representation is indeed striking, as the repair process not only reinstated a portion of the composite's original strength but also effectively concealed the aesthetic defect.

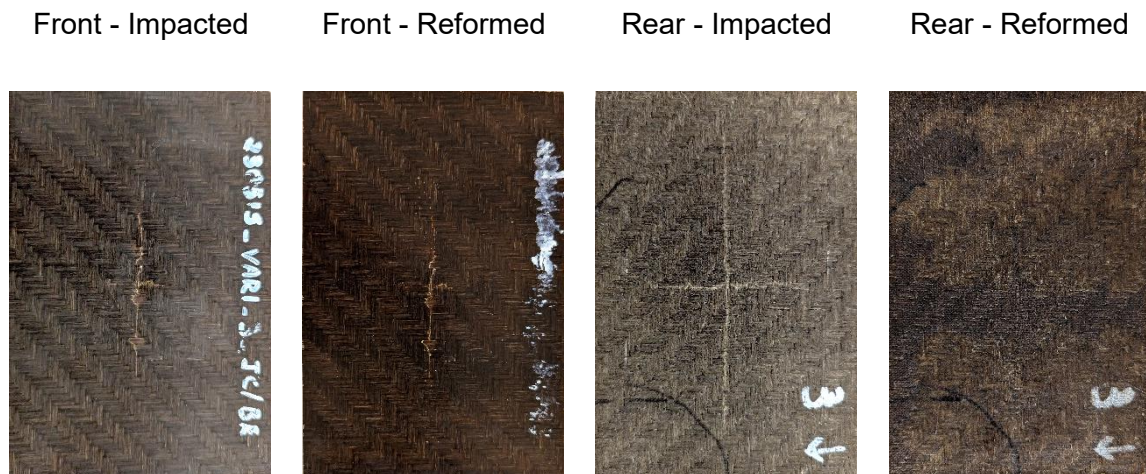
Figure 38: Comparison between same vitrimer-based specimen (#3) color before and after repair approach

The visual aspect of the repairing method, as discussed in section 5.6.2, have exhibited distinct changes in the process. As depicted in Figure 38, a direct comparison of image taken of vitrimer-based repaired specimen #3 reveals both front and rear views of the specimen. Evidently, a noticeable shift in coloration is evident between the impacted specimen and the repaired one.
