High temperature abrasion in sinter plants and their cost efficient wear protection

A dissertation submitted to the
Department of Product Engineering
Montanuniversität Leoben
January 2016

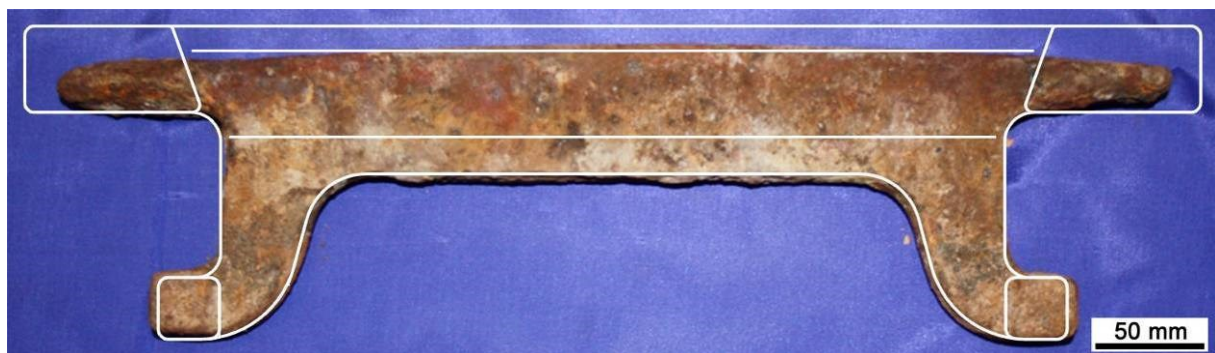
Fig. 6: Comparison of worn grate bar with the technical drawing (white lines)

One grate bar at the end of his lifetime is compared in Fig. 6 with the original geometry. With prolonged use, additionally to the wear of the drop-off edge, the whole surface gets abraded and the grate bar loses height. The wear gradually increases from the centre to the head. The symmetric wear loss to both heads is caused by the maintenance changes of the grate bars: when one side is worn too much, the grate bar is turned around. Corrosion products are visible at the entire surface of the grate bar, also white areas of salt depositions. The feet of the grate bar almost maintain their geometry during use. Flank zones in the vicinity of the contact with the sinter have to endure much higher temperatures and more pronounced material loss due to

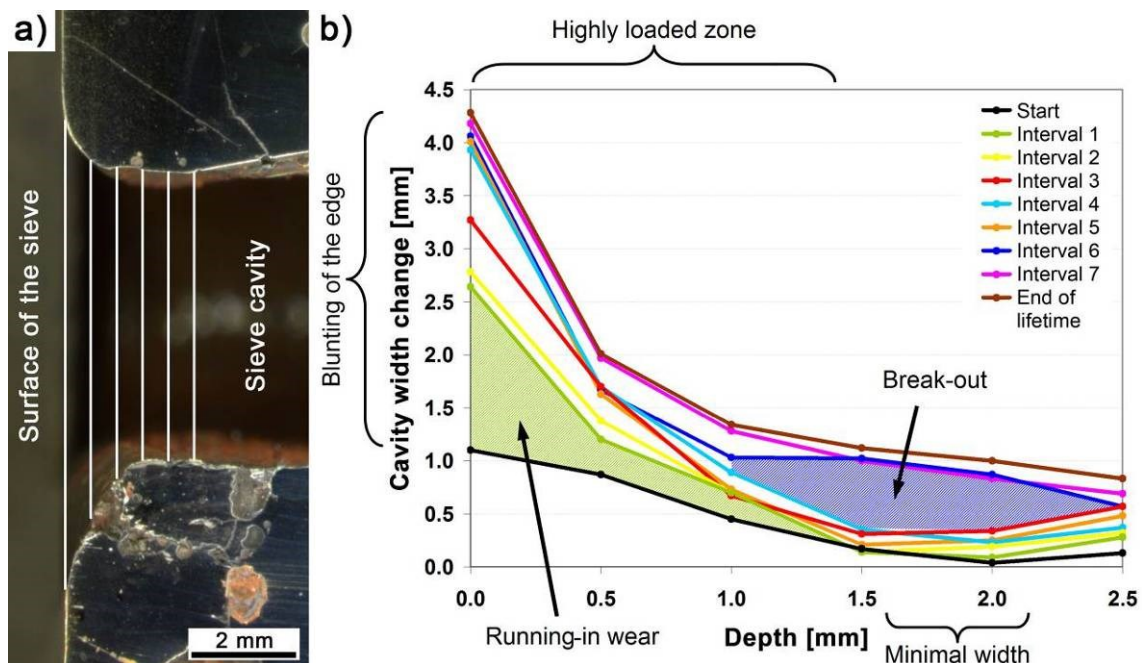
Fig. 13: Quantitative cavity width change over the lifetime of the HT sieve: a) measurement positions from the surface to the depth (stereo microscopy); b) width change evolution [VAR15-2]

Abrasive wear on the sieve's surface was of minor importance. The lifetime of the HT sieve is limited by the widening of the cavities. In the work of the author et al. [VAR15-2] a detailed wear history over the lifetime of the HT sieve is given. Blunting of the cavities' edges is the major wear loss. Fig. 13 gives quantitative results of the measurements of the sieve cavity geometry. Measurement was done at 0.5 mm intervals from the top of the sieve as shown in Fig. 13a. Seven intervals within the lifetime of the sieve of ~1 year were investigated and changes of the minimal width are given in Fig. 13b. Rapid blunting on the very edge was found at the first interval, the sharp edges lose their geometry significantly. Ongoing wear of the edges widens the cavity by ~4 mm within the lifetime of the sieve. Due to the brittle hardfacing larger break-outs were found at several occasions. The minimal cavity width, limiting the size of the screened sinter, was usually found in a depth <2.5 mm. Here a widening of ~1 mm was observed.

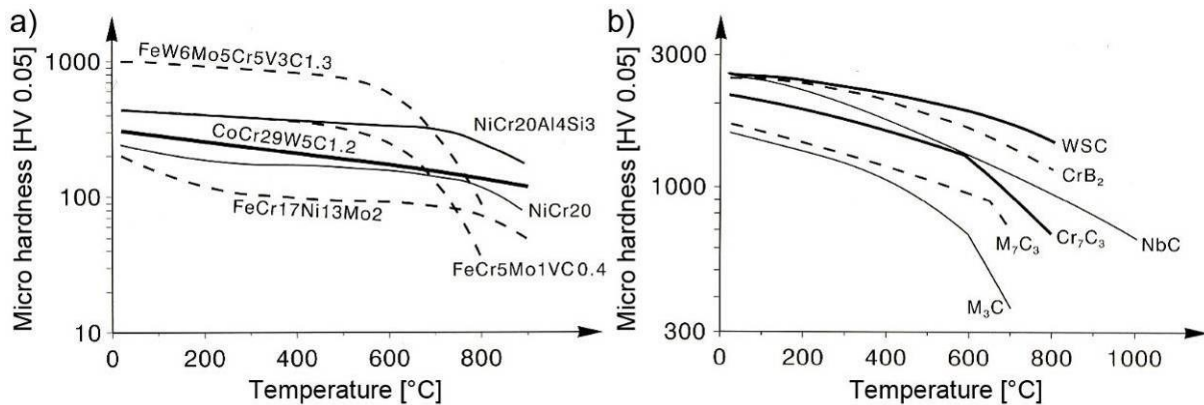
Fig. 25: Temperature dependence of micro hardness: a) metal matrices, b) hardphases [cf. BER98]

The order of the hardphases does not change within the investigated temperature range. Softer carbides (M_3C , M_7C_3 and Cr_7C_3) soften $>600^\circ C$ distinctly. [BER98]

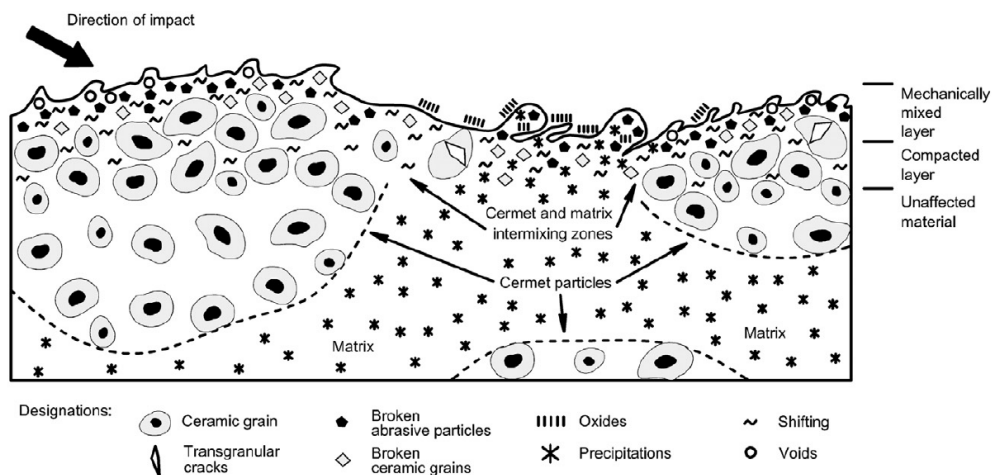
Fig. 27: Surface degradation and MML formation of MMC during HT erosive wear [ZIK13]

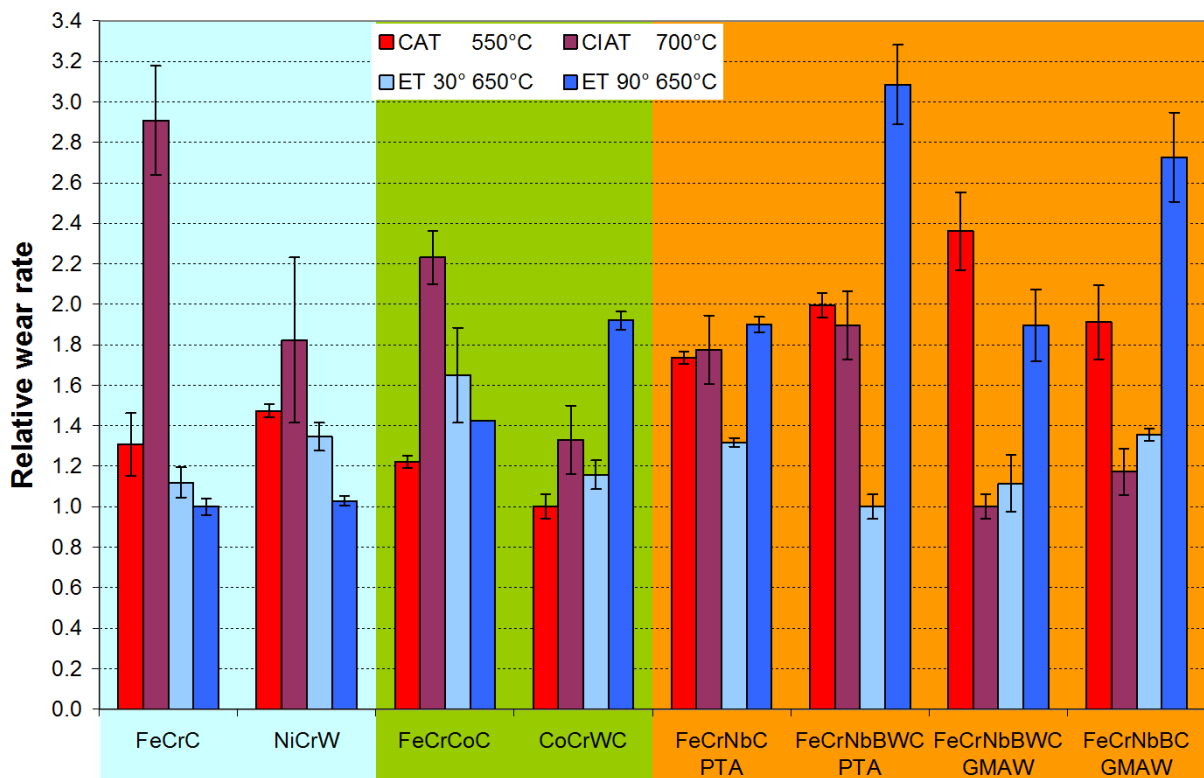
Fig. 70: Relative wear rates at HT for high-stress abrasion (550°C), impact-abrasion (700°C) and erosion (650°C)

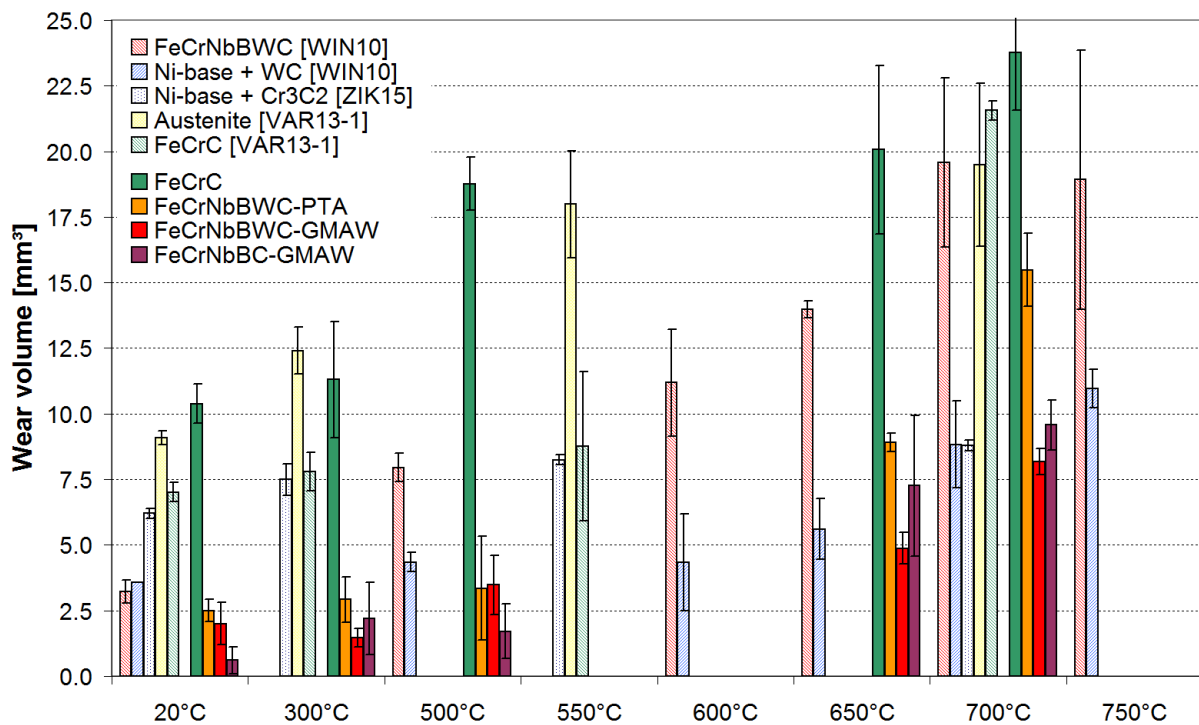
Fig. 74: Direct comparison of HT-CIAT wear of best materials in [WIN09-1, ZIK15, VAR13-1] with alloys tested within this work

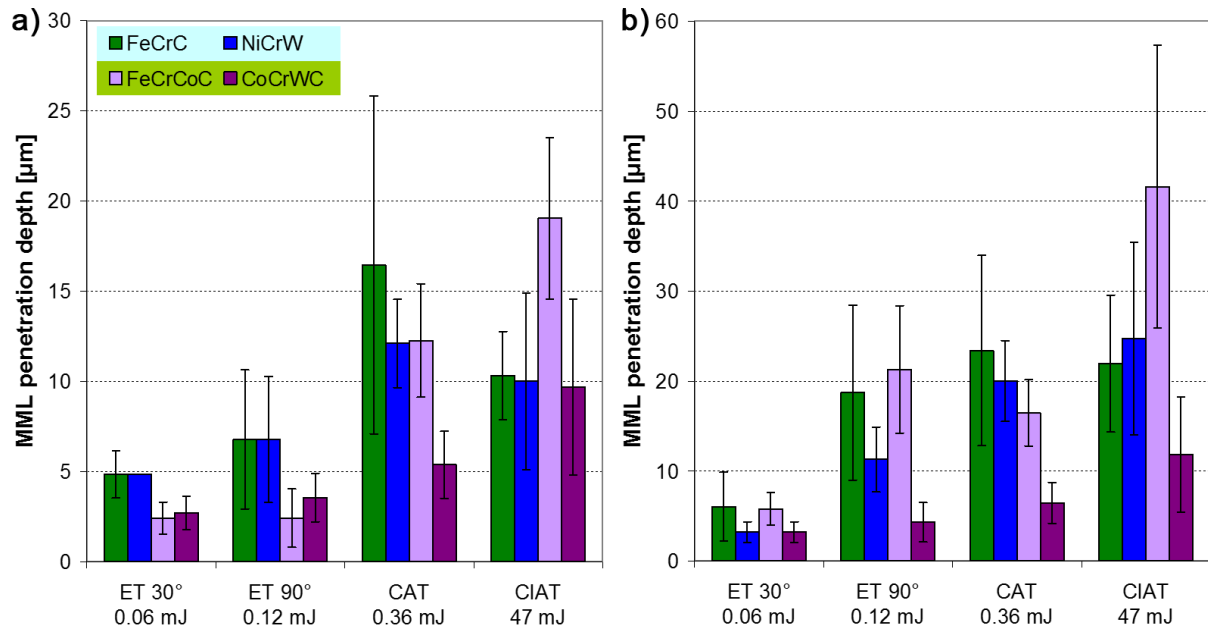
Fig. 85: Abrasive particle energy influence on the MML penetration depth for the MML forming alloys: a) RT testing; b) HT testing: ET at 650°C, CAT at 550°C and CIAT at 700°C

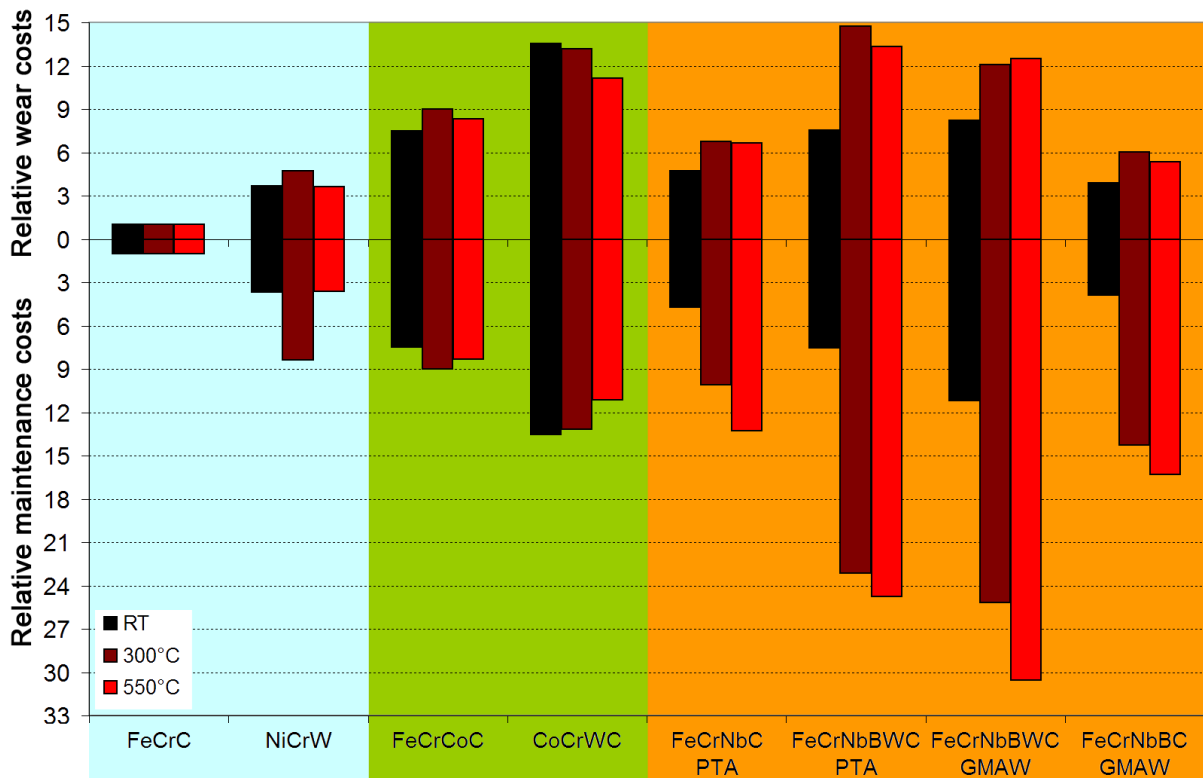
Fig. 94: Relative costs for wear protection in high-stress abrasive environment
