Master Thesis

Investigation of Velocity and Sensor Position Dependencies of Signals in Pipeline Inspection Tools using MFL Technique

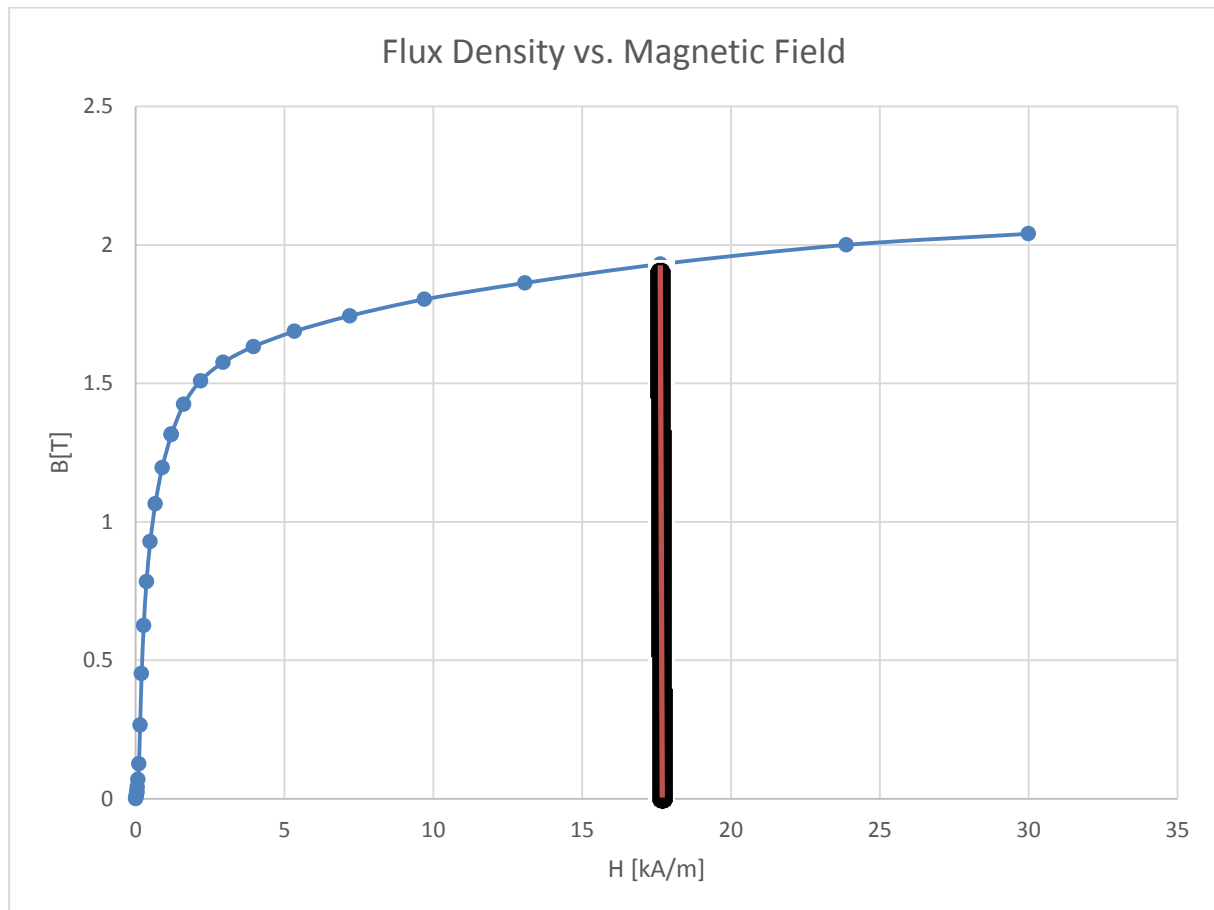
Figure 4: Flux Density vs. Magnetic Field.[3]

because magnetic disturbance factors occur in such areas. The relationship between the applied magnetic field and the flux density in a pipe is nonlinear. For low applied magnetic fields, a large change in in flux can be observed for small changes in the applied field and vice versa for higher magnetic field levels. That is why a reduction in material alone may not always lead to flux leakage.[4]

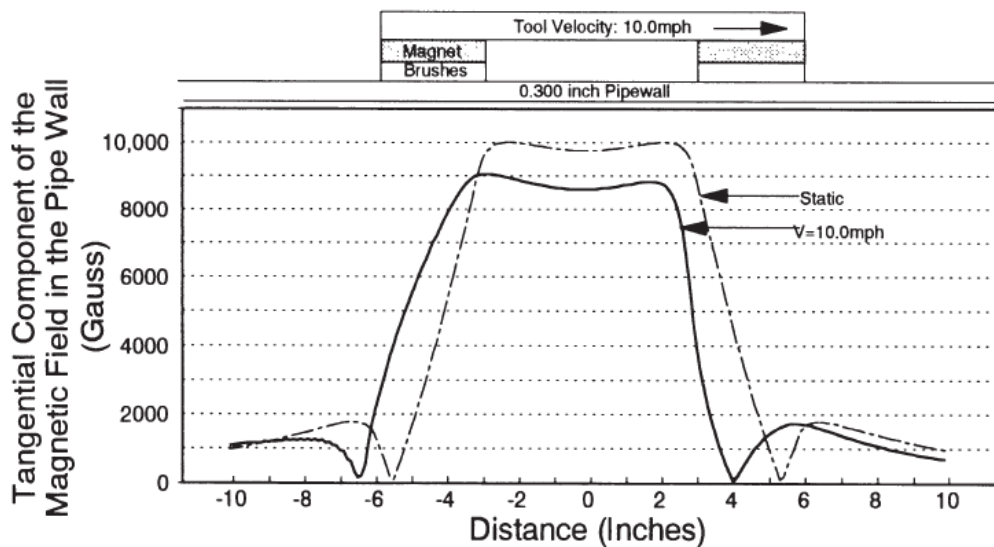
Figure 5: Velocity Effect on the magnetic field.[1]

Figure 5 shows the expected field levels due to velocity effects on a pipe with no defects. For the static case, the magnetic field stays more or less uniform, note that 1 Gauss = 10^{-4} Tesla. With the increase in speed it can be clearly seen that the strength of the magnetic field dropped significantly and its symmetry is lost, which would affect the detection and the characterization process.

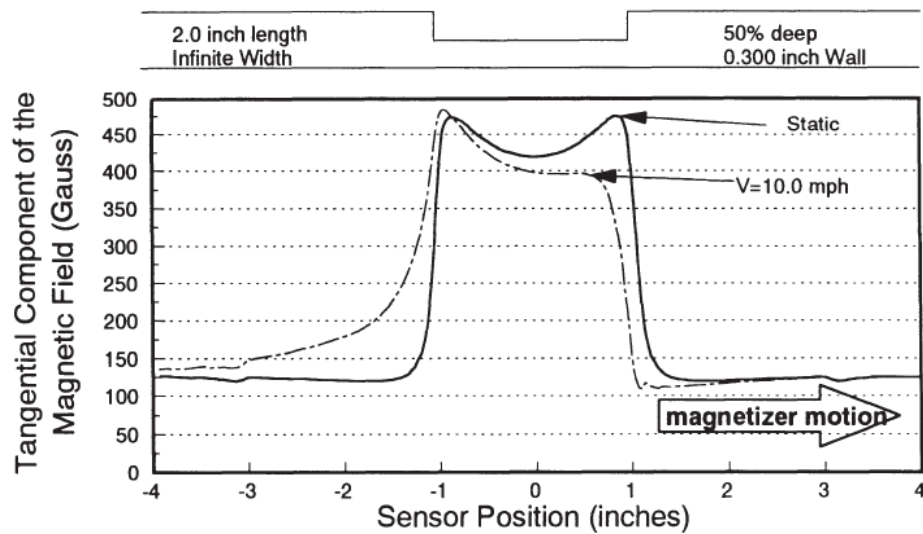
Figure 6: Velocity Effect at the Presence of a Defect.[1]

Figure 6 shows the expected behaviour of the leakage fields around a defected region when velocity is increased. Figure 7 shows the tangential field components at 2.5 and 8.0 miles per hour. From these two figures it can be concluded that:

- An increase in velocity causes a decrease in the flux leakage field, reducing the defect detection and characterization accuracy.
- Symmetry of the flux leakage field is lost as the signal tends to shift towards the trailing pole, making it difficult to interpret defect length as it is highly dependent on the length of the measured leakage field.

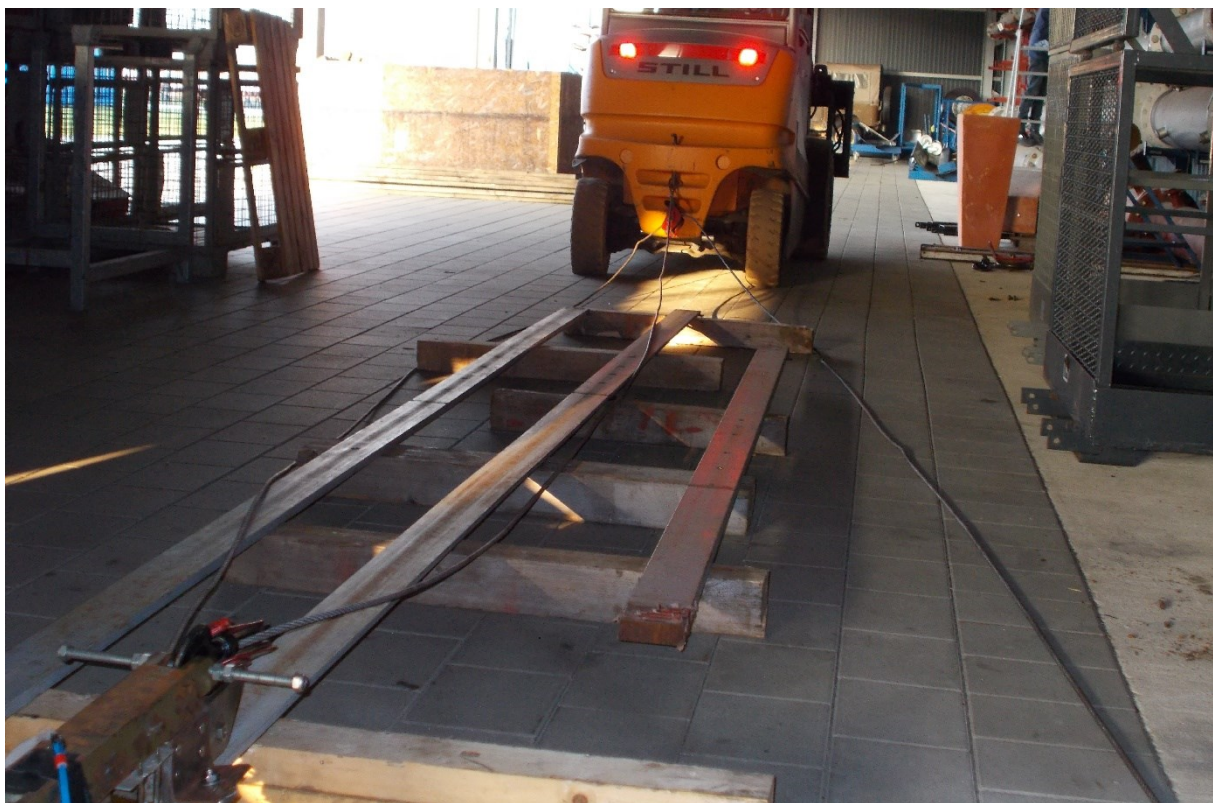
Figure 12: 3m/s pull test.

Figure 12 shows how the 3 m/s velocity was reached by using a wire rope where one end is fixed (the right part of the wire on the picture), then going through one sheave hooked to the fork lift and another one to the tool, the loose end of the wire is then attached to the fork lift. For the 2,5 m/s same principle was applied with only one sheave hooked to the fork lift and the loose end of the wire attached to the tool.

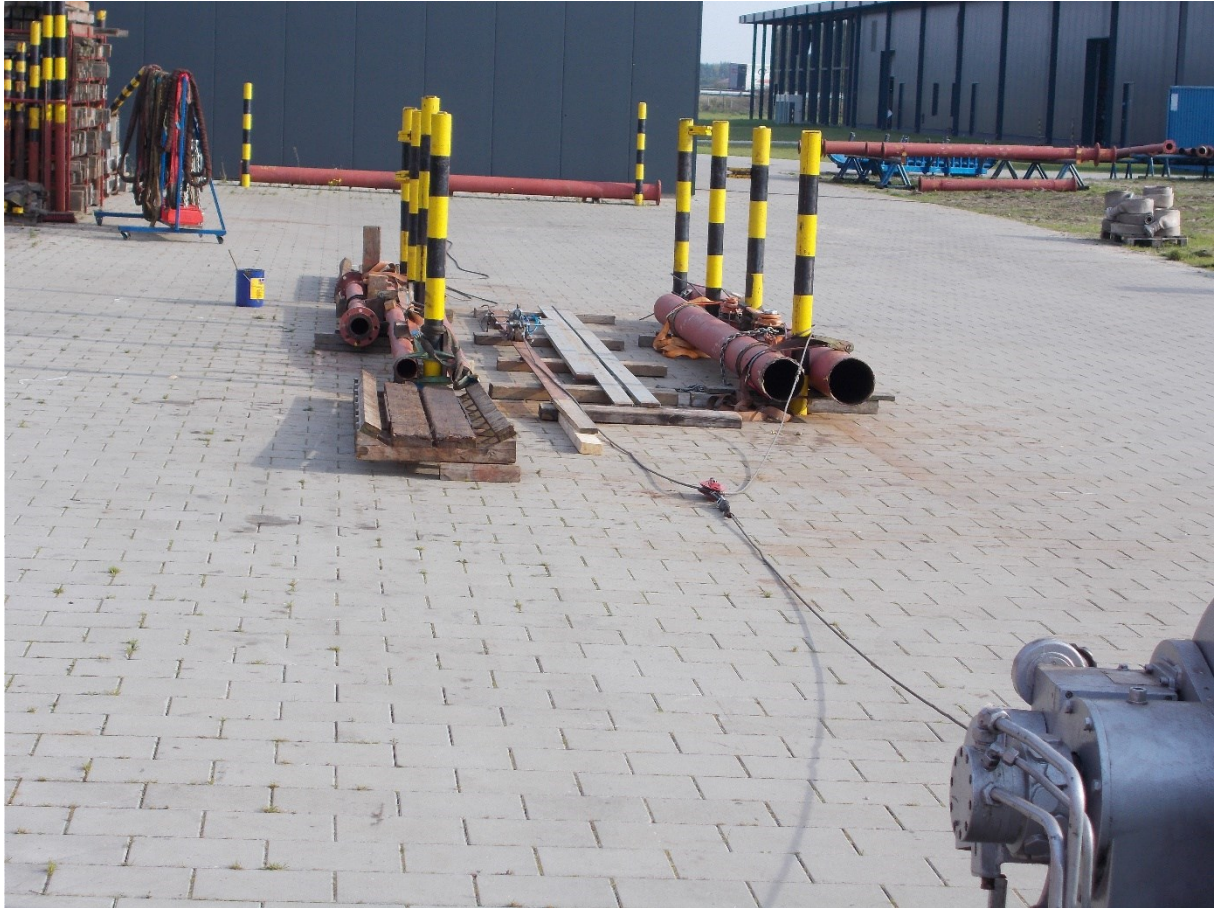
Figure 13: 4,5 m/s pull test.

In order to come up to the 4,5 m/s velocity a wire winch had to be utilized in addition to a sheave as seen in Figure 13 above. The first three velocities were simply performed by pulling the tool over the defect by hand and the 2 m/s were reached by pulling the tool directly with a wire rope by the fork lift.

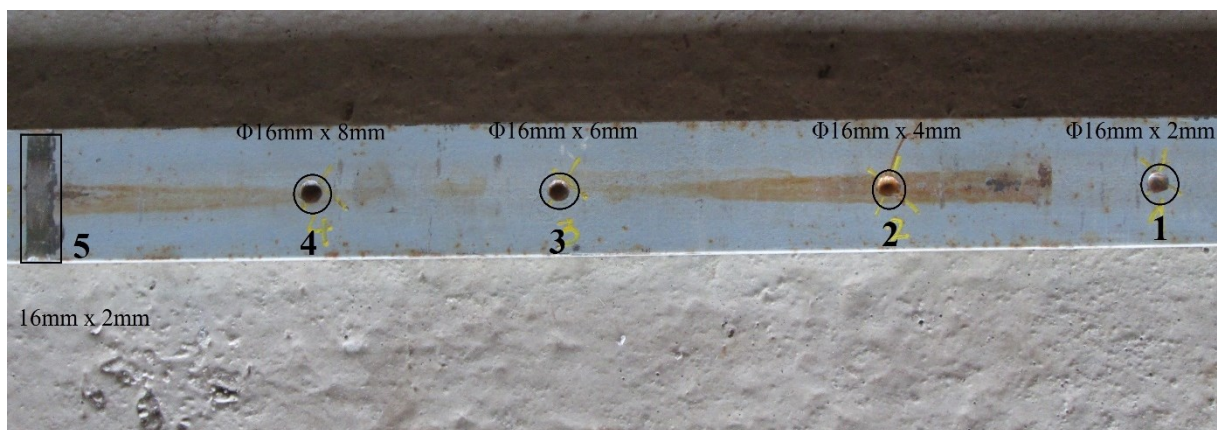
Figure 14: The 100mm x 30 mm Bar.

In Figure 14, it can be seen how the defects were drilled into the bar as well as their dimensions. The defects 1 to 4 are normal circular defects, whereas defect 5 is a groove, which is a rectangular slot drilled across the complete width of the bar. The groove is then filled with a strong glue material to facilitate the movement of the yoke over it. The tool will then be run from the right hand side, starting with defect 1 all the way to defect 5. After the run is done the electronic piece, where the data has been stored, is then disconnected from the tool and taken for the data to be read and visualized via the software "PipeAnalysis". Figure 15 below shows how the data looks like when imported to the software.

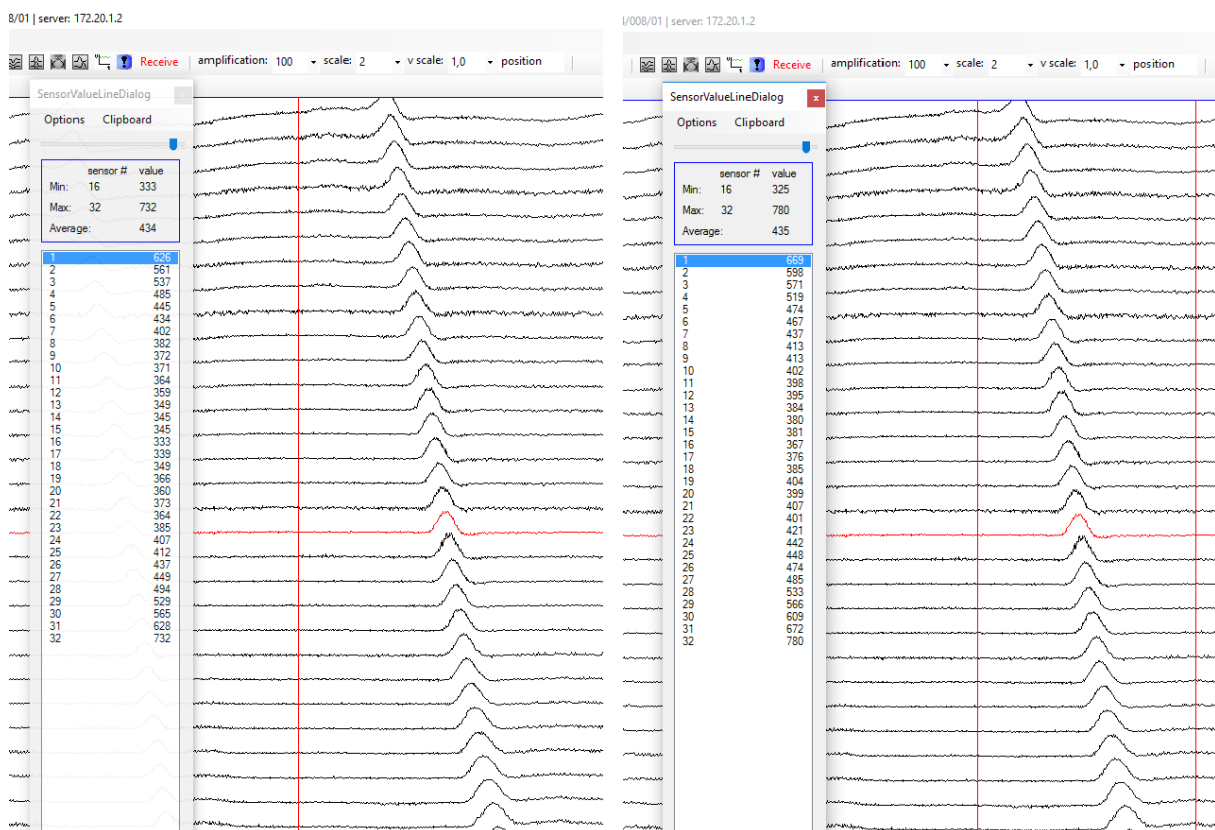
Figure 16: Obtaining the Amplitude.

With the help of the software the offset values for each effect can be determined, as seen on the left hand side of Figure 16. The offset represents the magnetic field at non-defected intervals, meaning areas where no flux leakage is present, and it is the basis for measuring the signal's amplitude for a present defect. Then the maximum values for a highlighted interval can also be obtained for each sensor, which can be seen on the right of Figure 16.

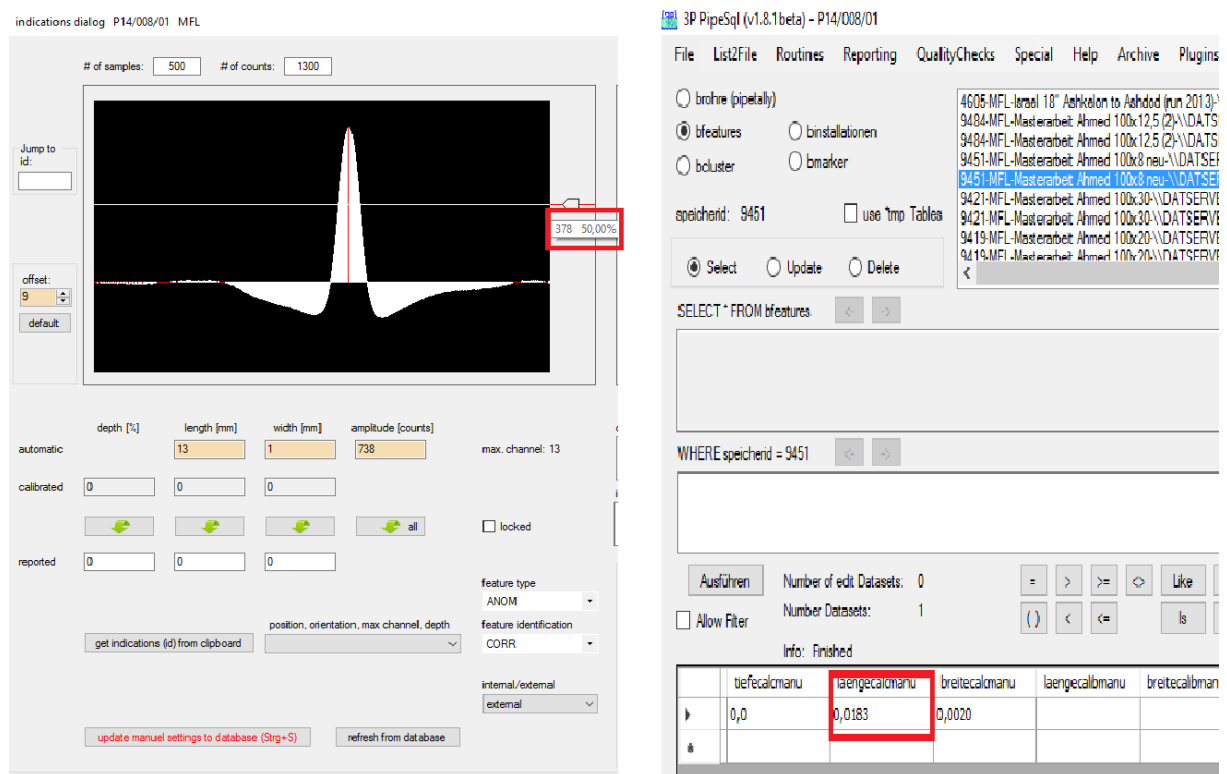
Figure 18: Obtaining the FWHM.

By accessing each defect via the software, any assigned length can be obtained as seen in Figure 18, in this case it is assigned at the middle of the amplitude in order to get the FWHM. All the assigned lengths are then stored in the company’s data base and can be recovered from there.

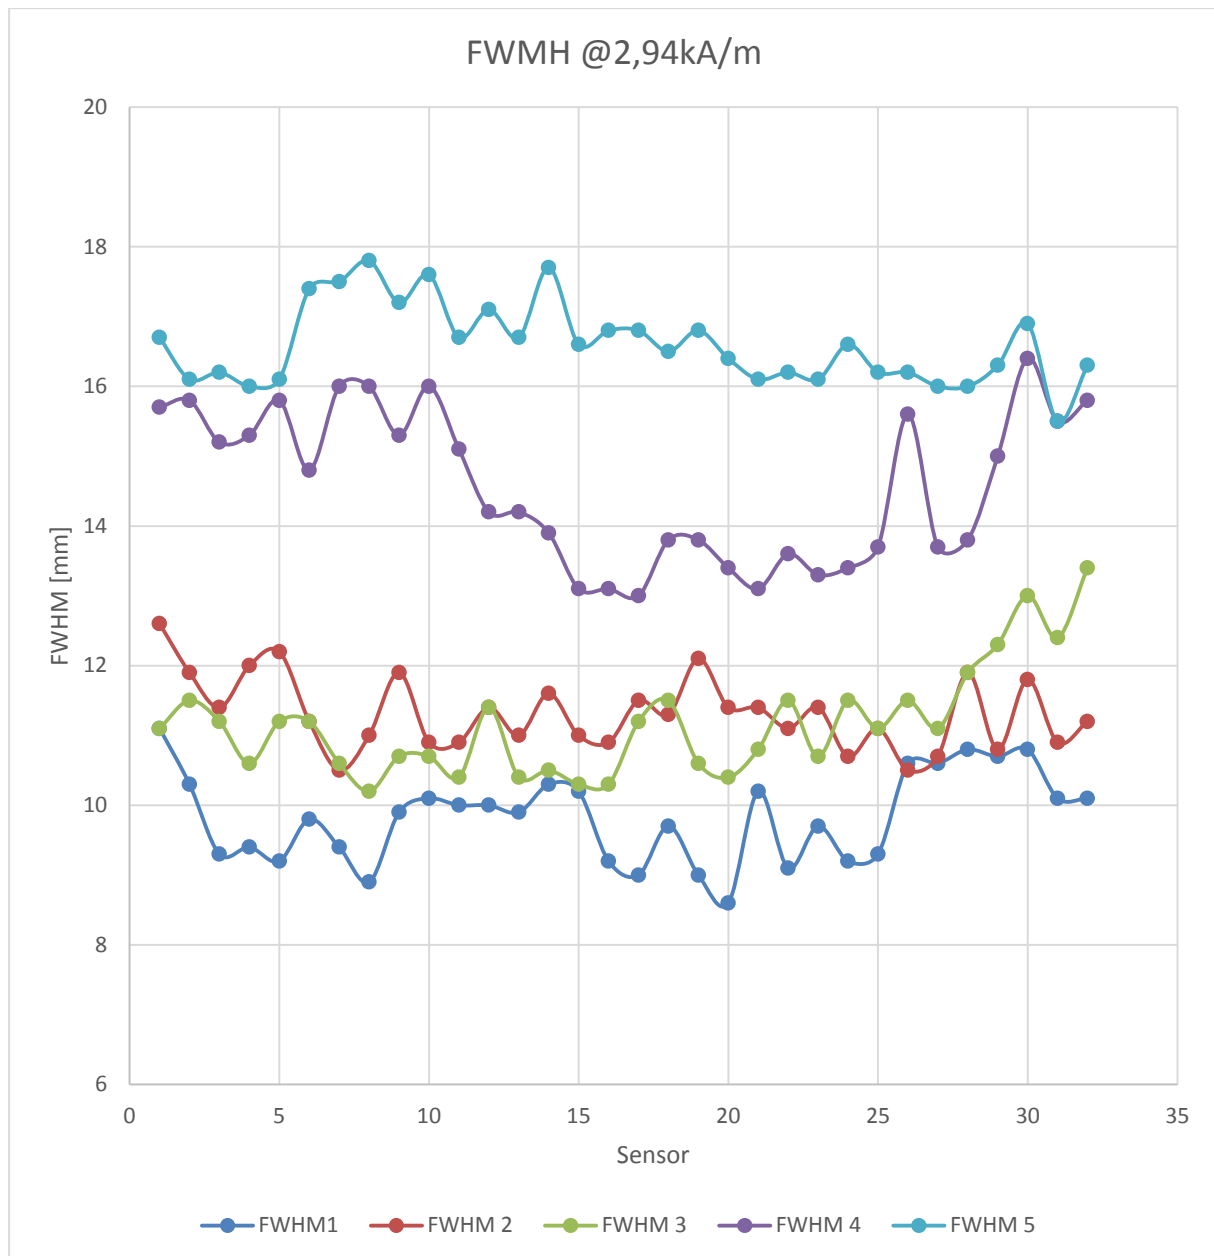
Figure 19: FWHM for the first Bar.

Like the amplitude, the same graph is generated again, but this time for the width.

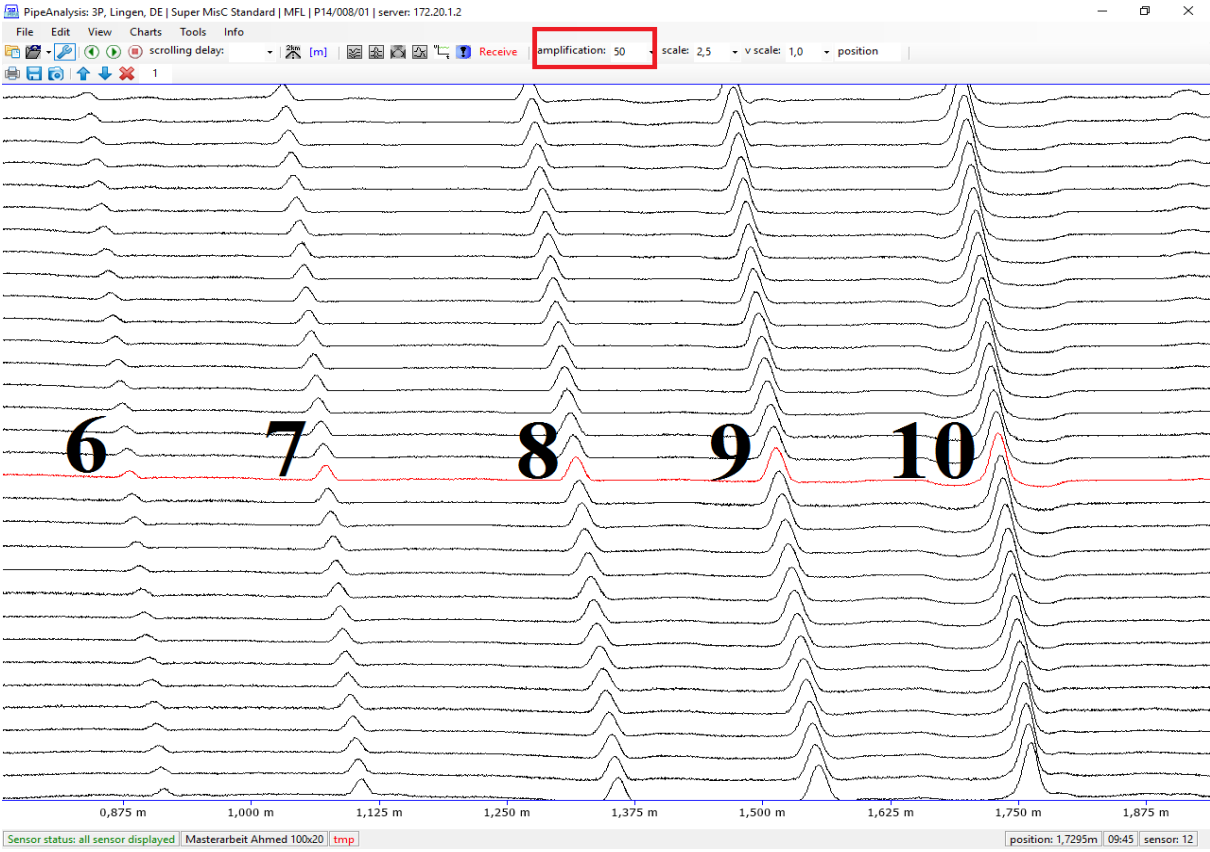
Figure 21: Corresponding signal for the second Bar.

Same as before the tool was run and the data was imported to the software.

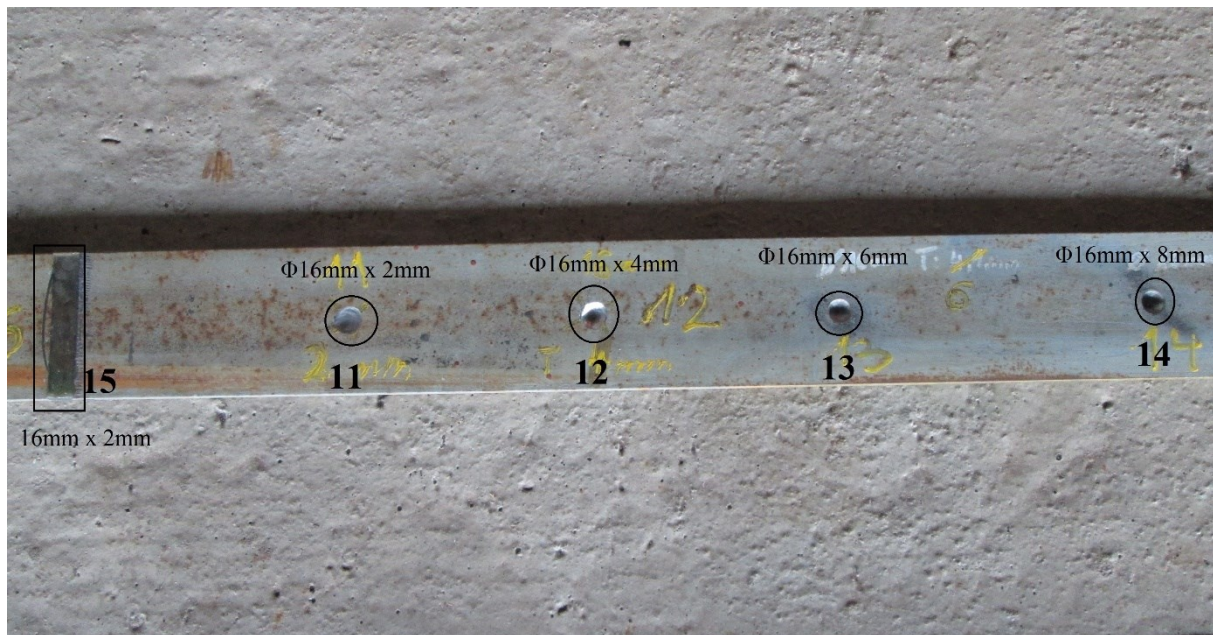
Figure 24: The 100mm x 12,5mm Bar.

Figure 24 below shows the defect present along the bar. Note that the order in which the first 4 defects were drilled is different than it was in the two previous cases, with the deepest defect at the beginning, but maintaining the same numbering order, starting with the shallowest defect as number 11 and ending with deepest defect then the groove as number 14 and 15 respectively.

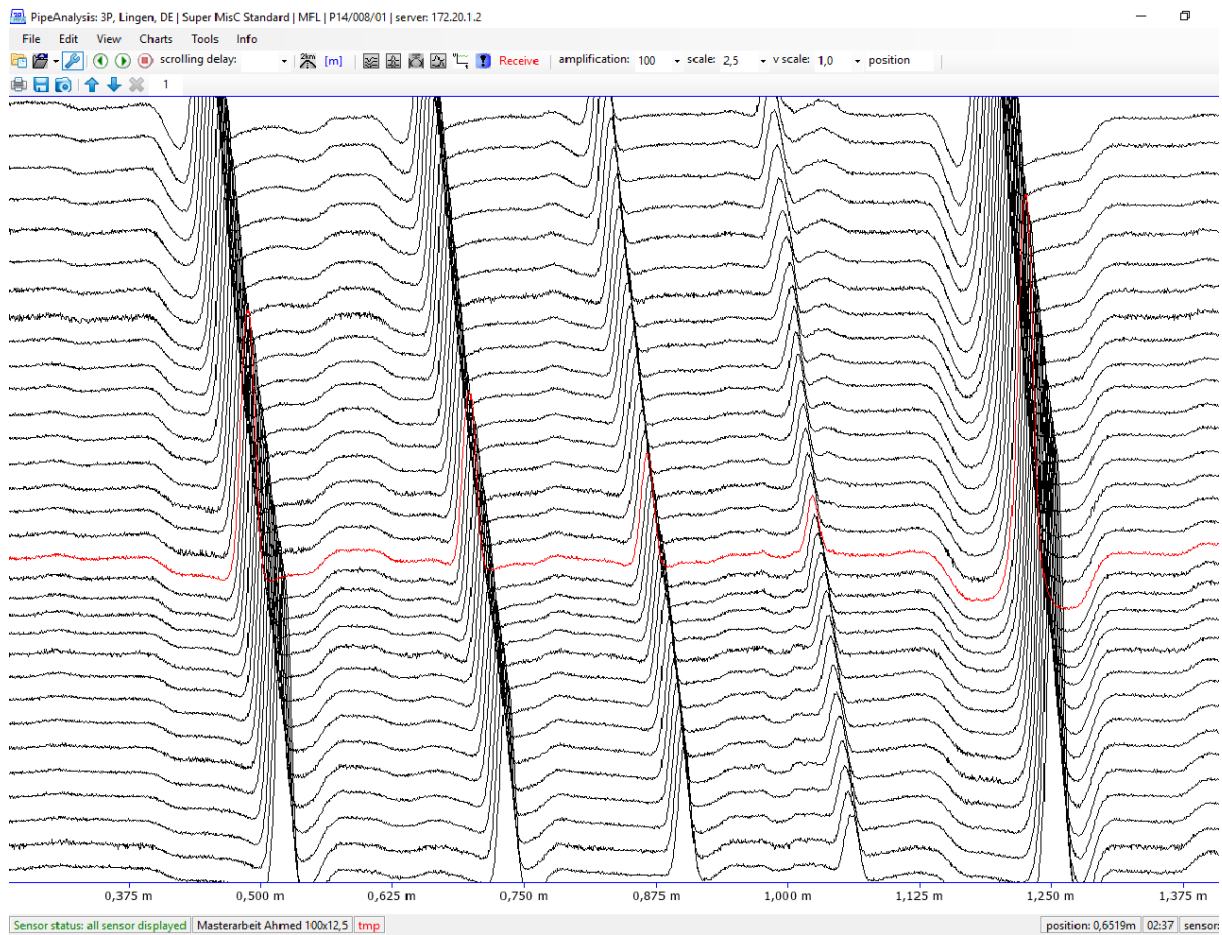
Figure 26: Amplified Signal.

To illustrate the difference a bit more Figure 26 below shows how the same signal would look like if it was amplified to 100 like the very first bar.

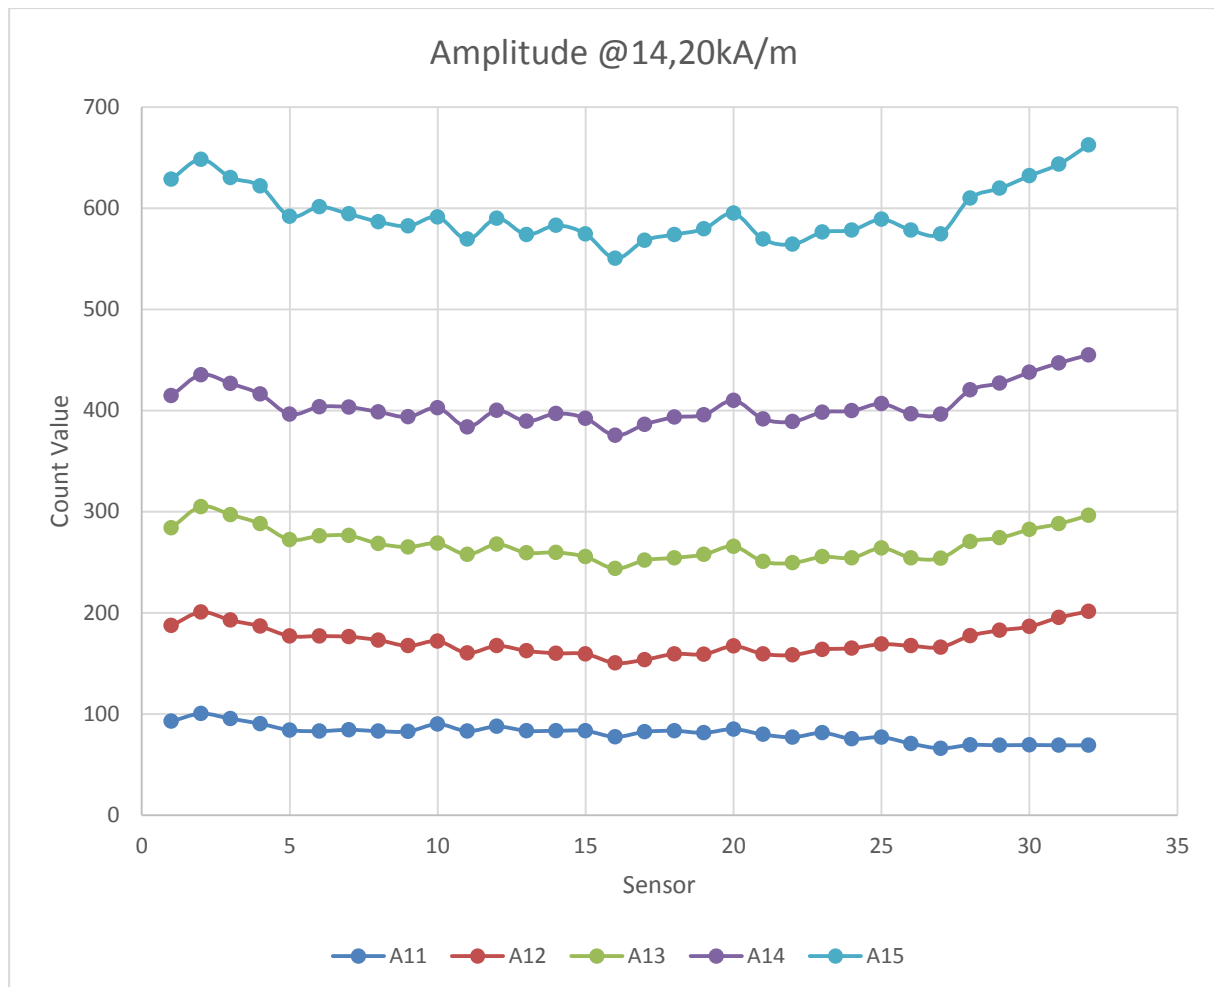
Figure 27: Amplitude @14,20kA/m.

Important to notice is also the fact that, the smaller defects, especially 12 and 13, now show the same behaviour as well, which was not the case at low magnetization levels. Defect 1, however, did not behave accordingly and stayed rather constant for all the sensors.

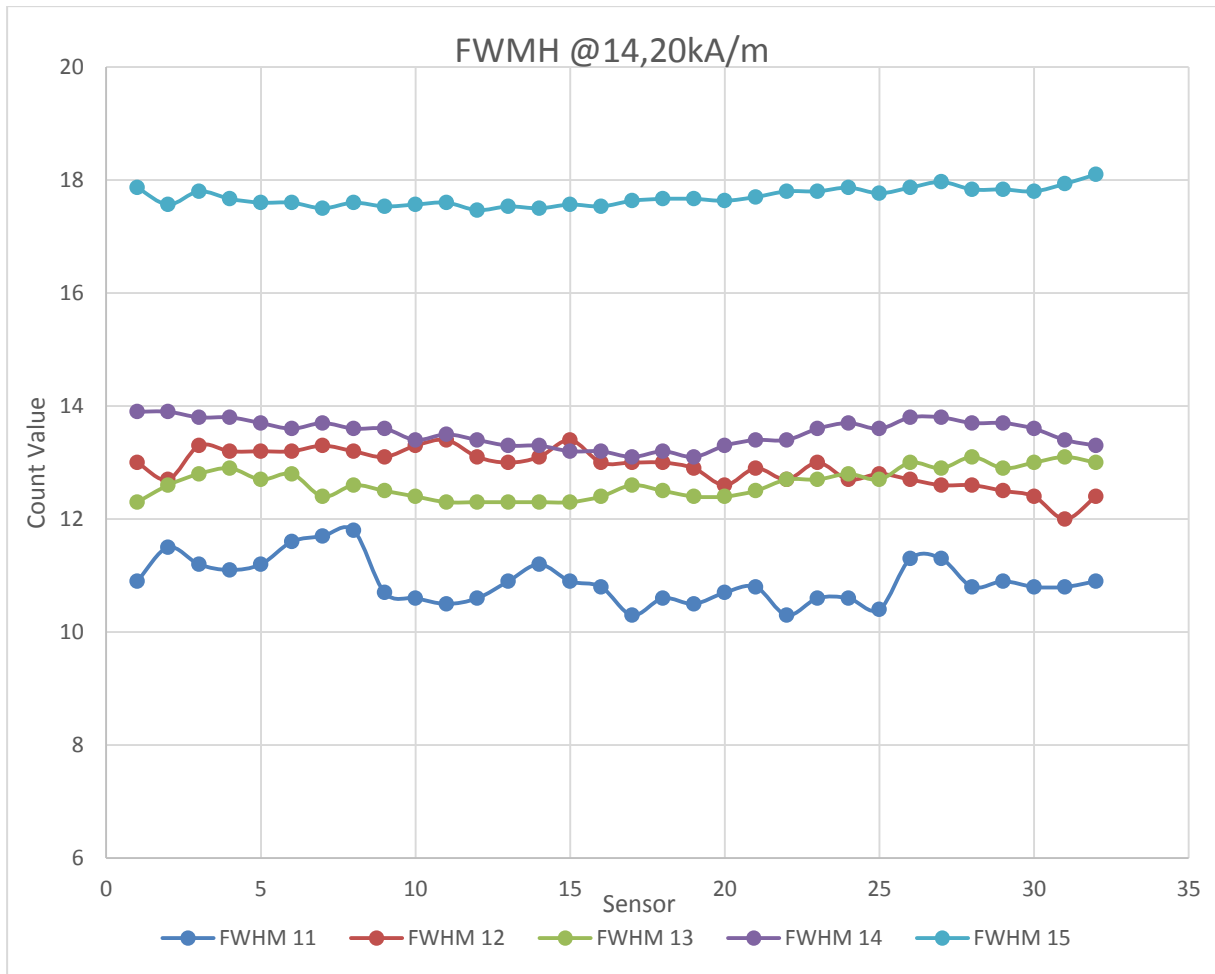
Figure 28: FWHM @14,20kA/m.

To analyse the data furthermore, the FWHM curve was generated again, and can be seen in Figure 28 below.

Once again a big difference between the data collected from this run and the previous ones can be easily identified. Except for defect 11 all the other defects show an almost constant FWHM for all the sensors. The best consistency can be seen at defect 15, where the strongest flux leakage is expected. The reason why the FWHM values for the groove are close to 18 despite the actual length being only 16, is because the stronger the magnetization level the sooner the field would start leaking even before reaching the defect. Meaning the signal will deliver a slightly bigger. Figure 29 below shows the length of the groove provided by sensor 23. At the bottom left it can be seen that the signal reads an anomaly with a length of approximately 34mm, which explains the FWHM of about 18mm.

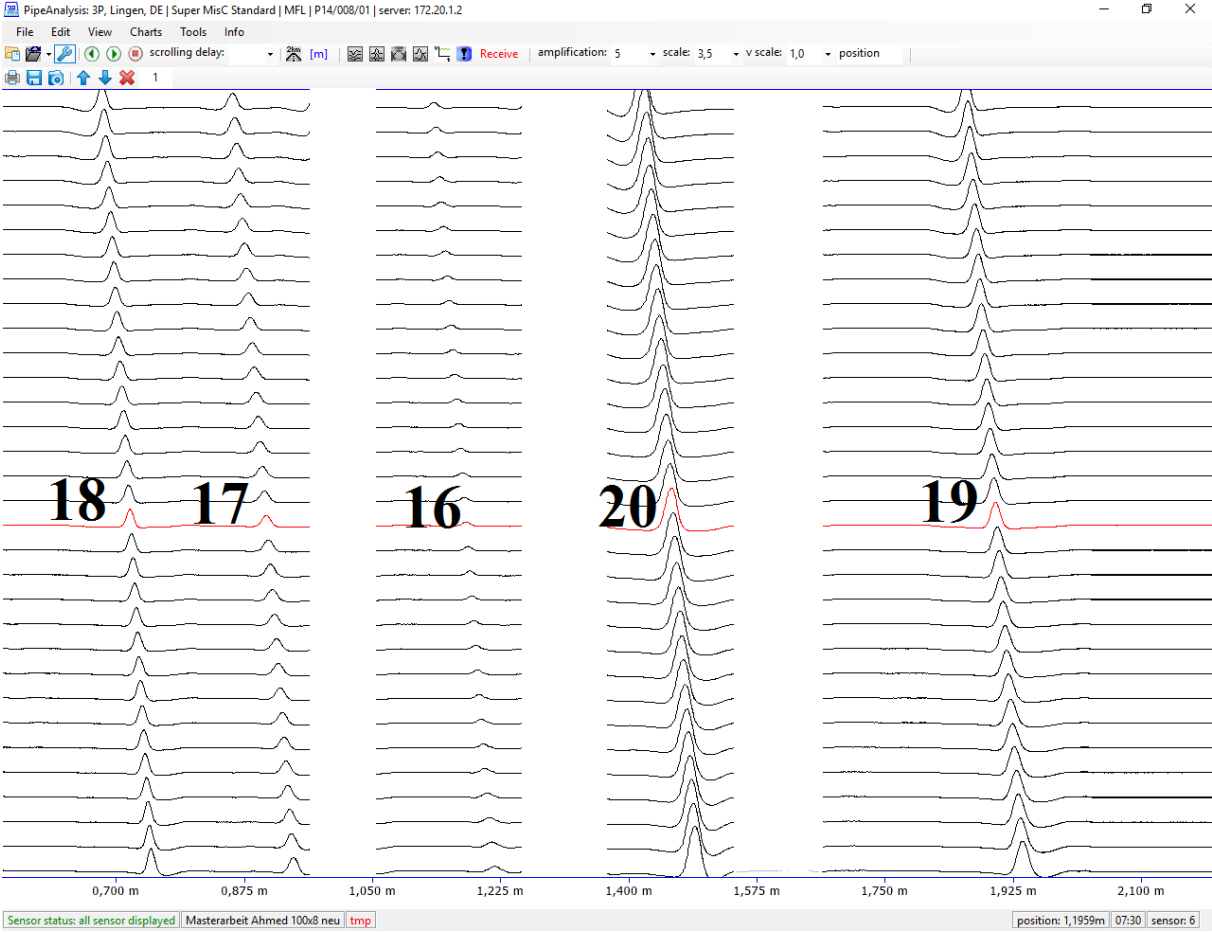
Figure 31: Corresponding signal for the fourth Bar.

Same as before it can be seen how the signal peaks were affected by the geometries of the defects, with deeper defects resulting in stronger signals. In addition, the groove still delivers the highest peak despite having the smallest depth, for the reasons explained earlier in this chapter.

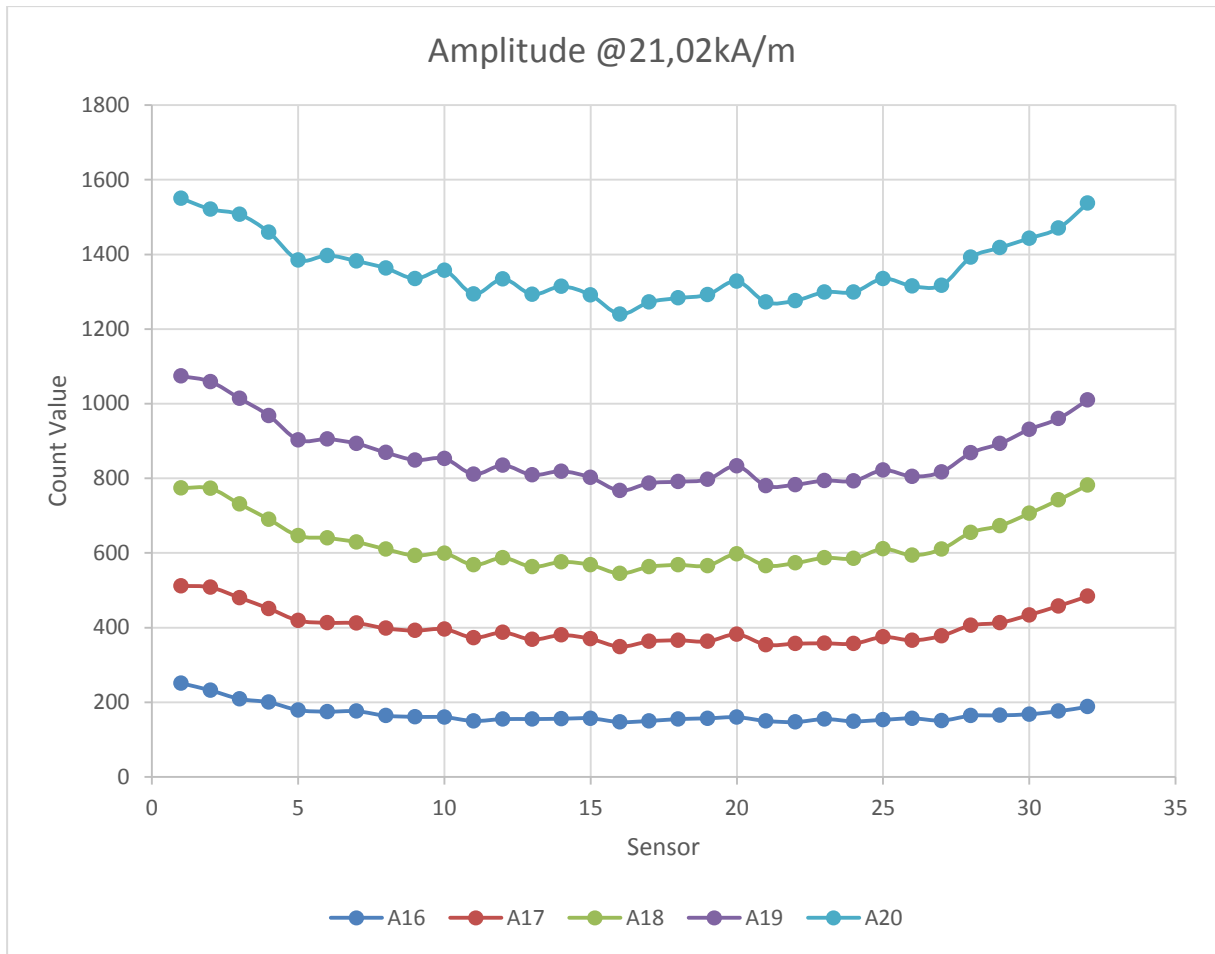
Again both the amplitude and the FWHM curves were generated for this bar as well in order to investigate the acquired signal furthermore, the results can be seen in Figure 32 and Figure 33.

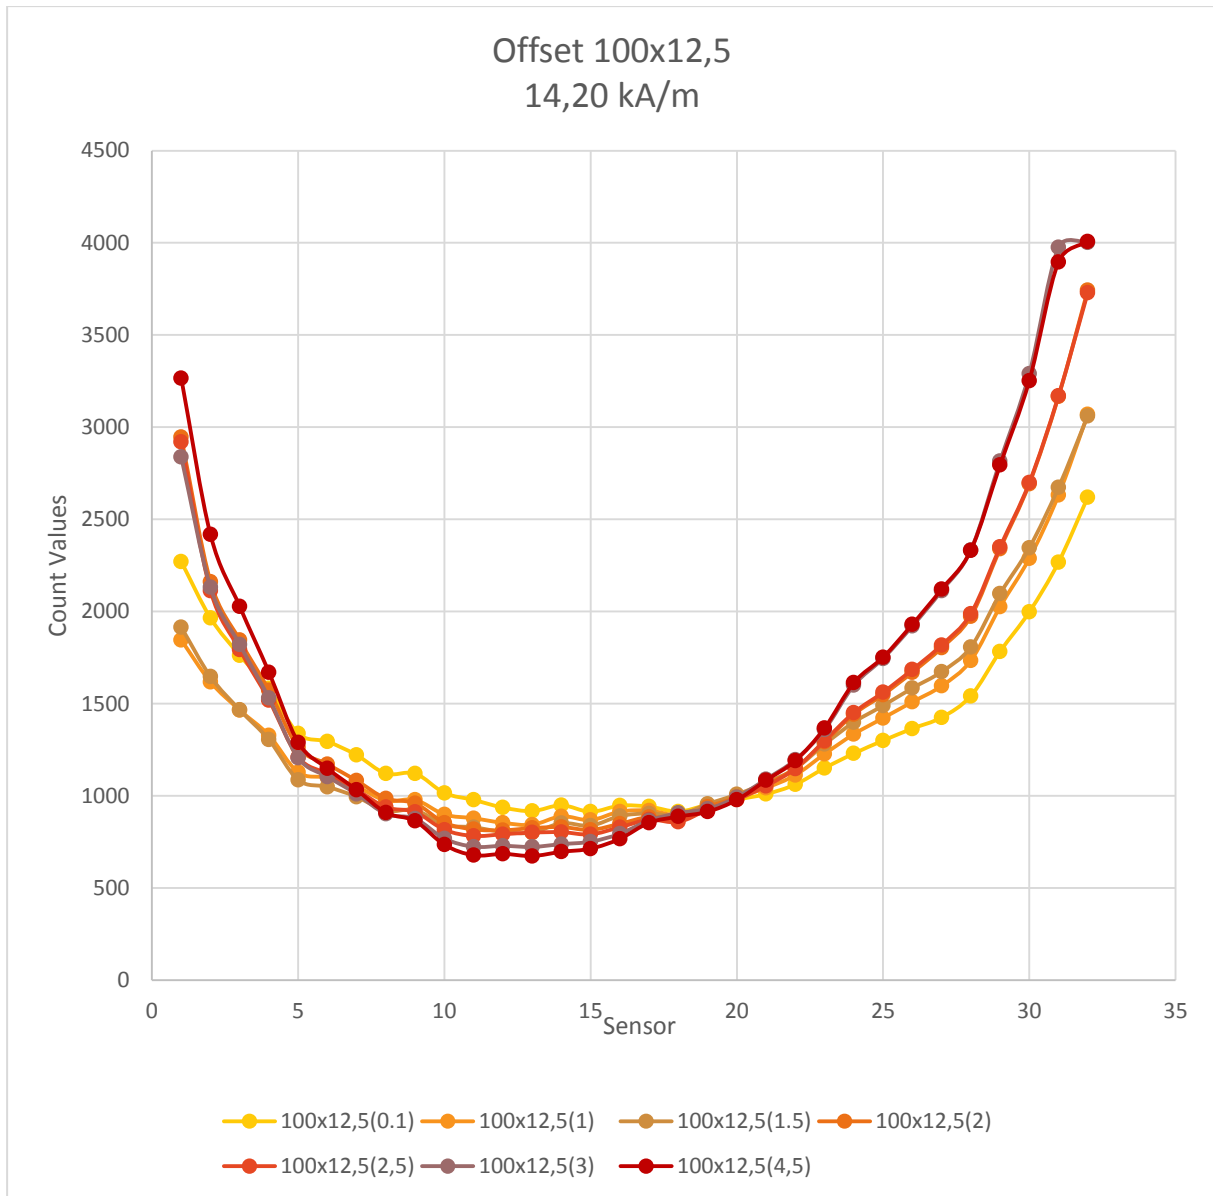
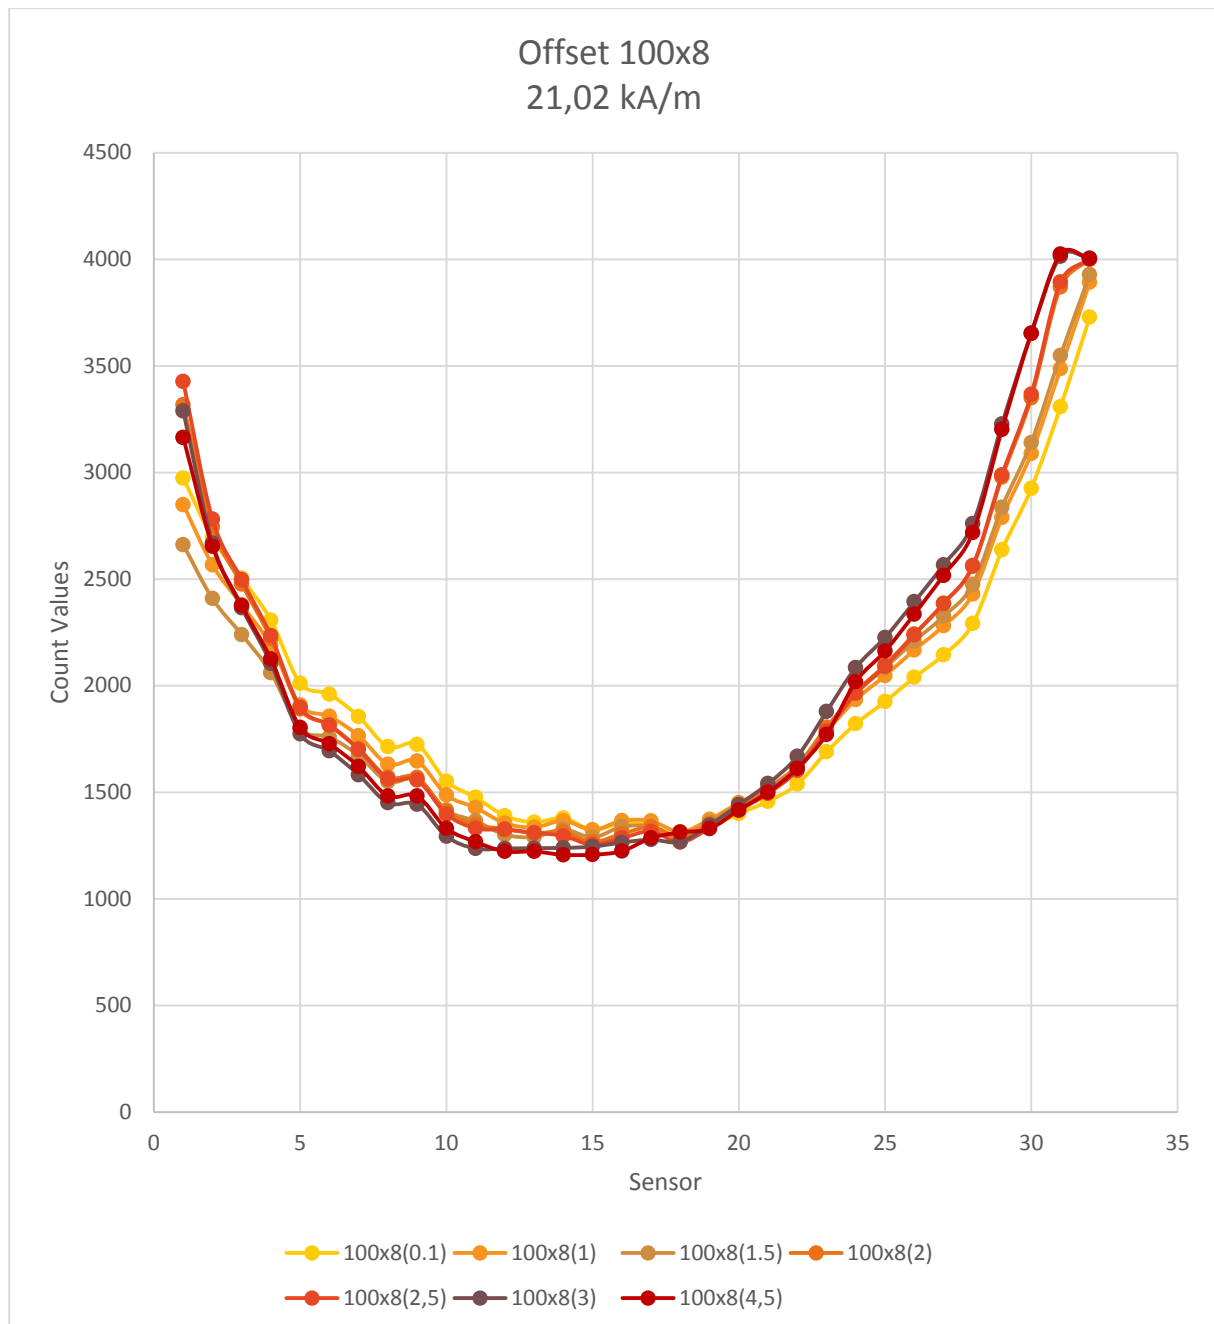
The first thing to be looked at in order to identify the influence of velocity is the offset values from each sensor at each velocity. The offset represents the magnetic field at the non-defected intervals, meaning areas where no flux leakage is present, and it is the basis for measuring the signal's amplitude for a present defect. Offset values for each bar at different velocities were collected, as explained earlier in Figure 16, and put in comparison with one another. The velocities were colour scaled from yellow for the lowest velocity to dark red for the highest velocity. Figure 35-Figure 37 below show the behaviour of the offset for the three metal bars for the seven different velocities.

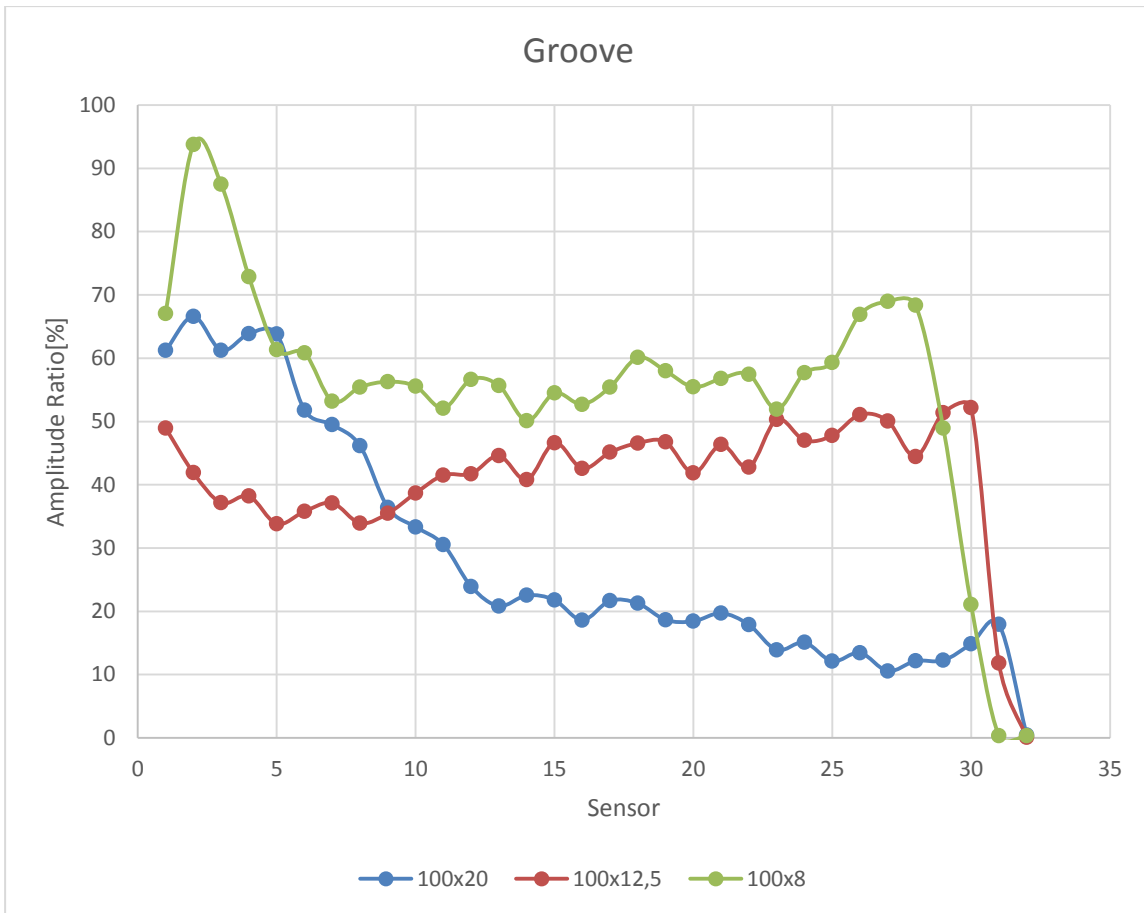
Furthermore, in order to illustrate the dependency of the amplitude on the sensor positioning as well as the velocity, the amplitude from the 4,5 m/s run was plotted as a percentage of the amplitude at the 0,1 m/s velocity, which represents an "ideal" amplitude, this should help identify where the most amplitude losses occur as a result of velocity effects. Each plot represents one defect and its amplitude ratio for each bar.
