Master Thesis

Investigation of Velocity and Sensor Position Dependencies of Signals in Pipeline Inspection Tools using MFL Technique

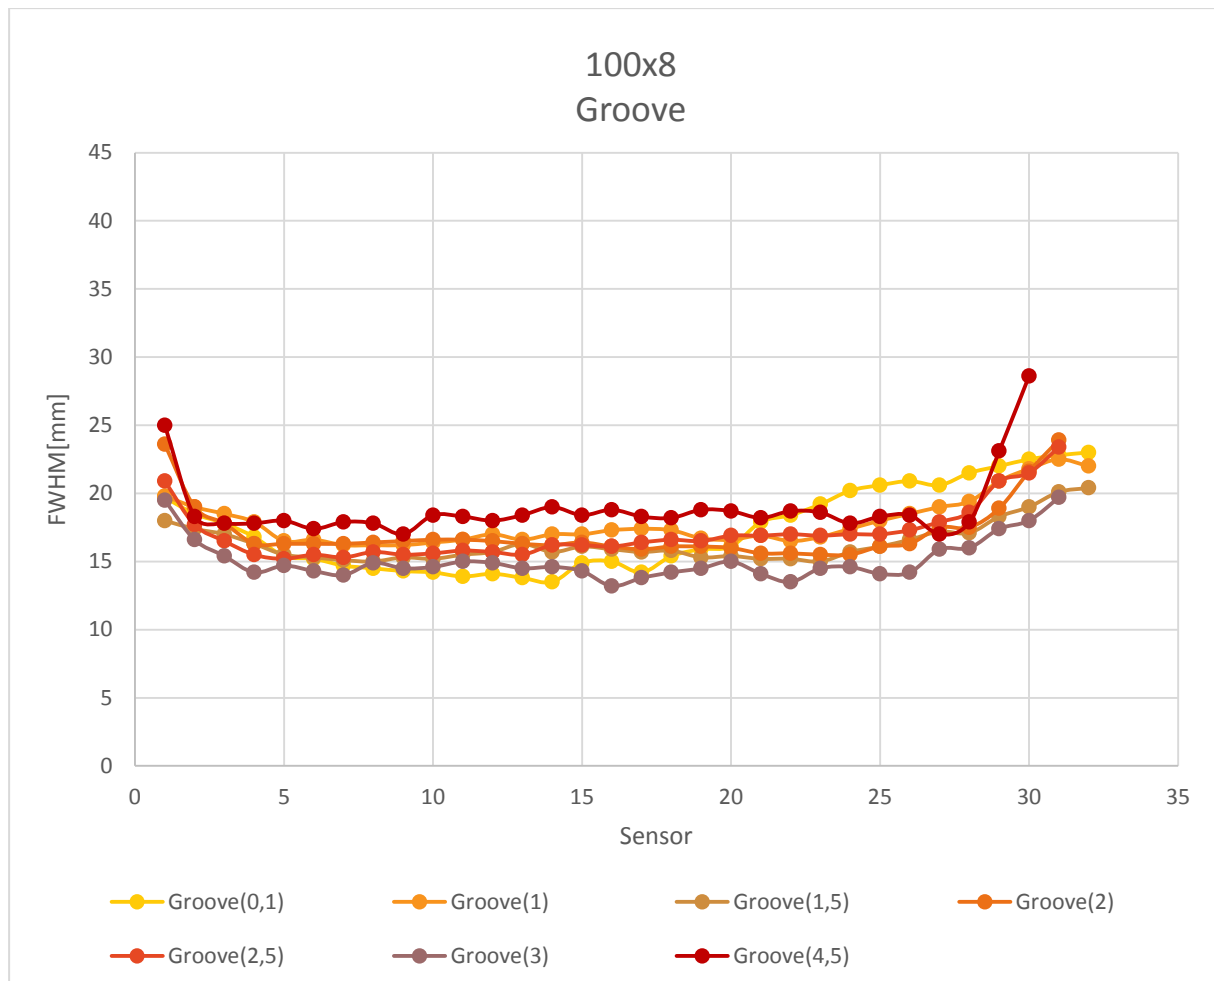
Like in chapter 4 the FWHM of the defects was to be investigated, as was the case for the amplitude, defects 1, 4 and the groove are of concern. The FWHM will be compared for each defect at each of the tested velocities, starting with the groove.
