Optimization of Bit Selection and BHA Design for the Oberkling Gas Storage Drilling Campaign

Department Mineral Resources and Petroleum Engineering

Chair of Drilling Engineering

Montanuniversität Leoben, Austria

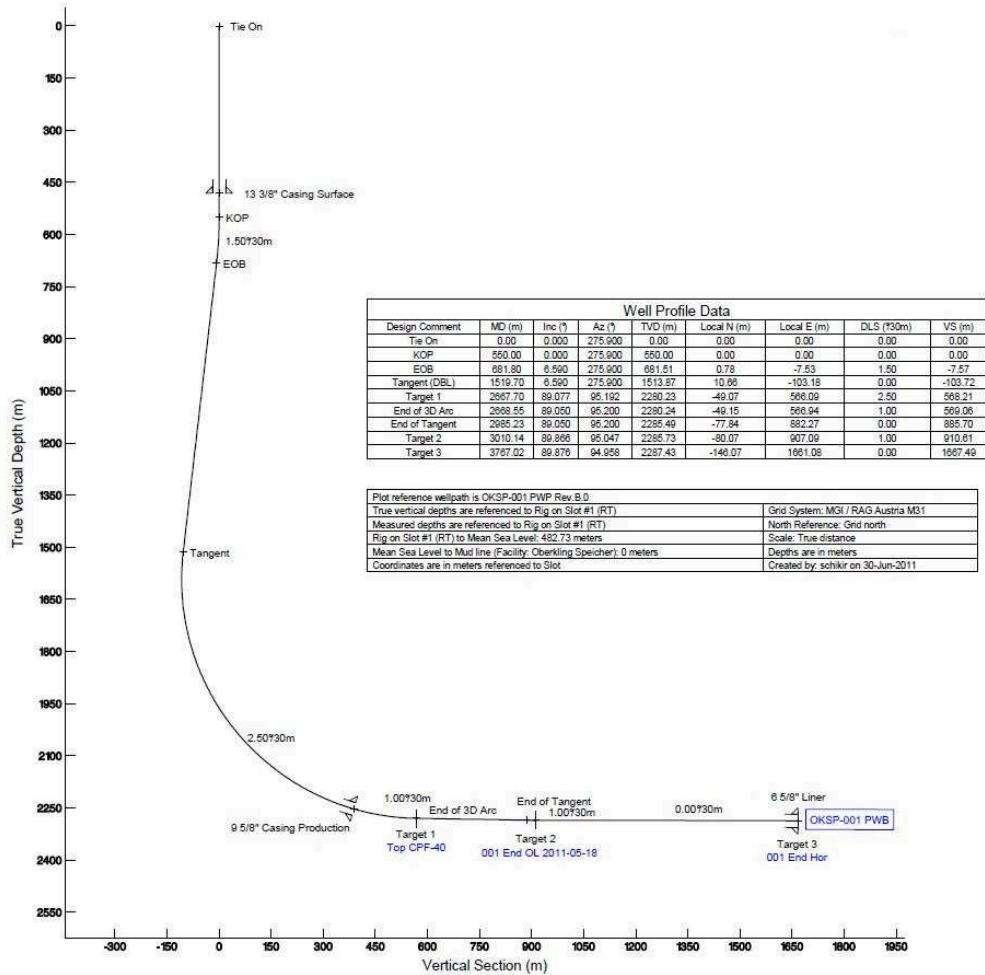
Figure 3.1 - Trajectory of OKSP-001

The targets are defined as driller's targets as a sphere with a radius of 25 m without the consideration of ellipse of uncertainty.

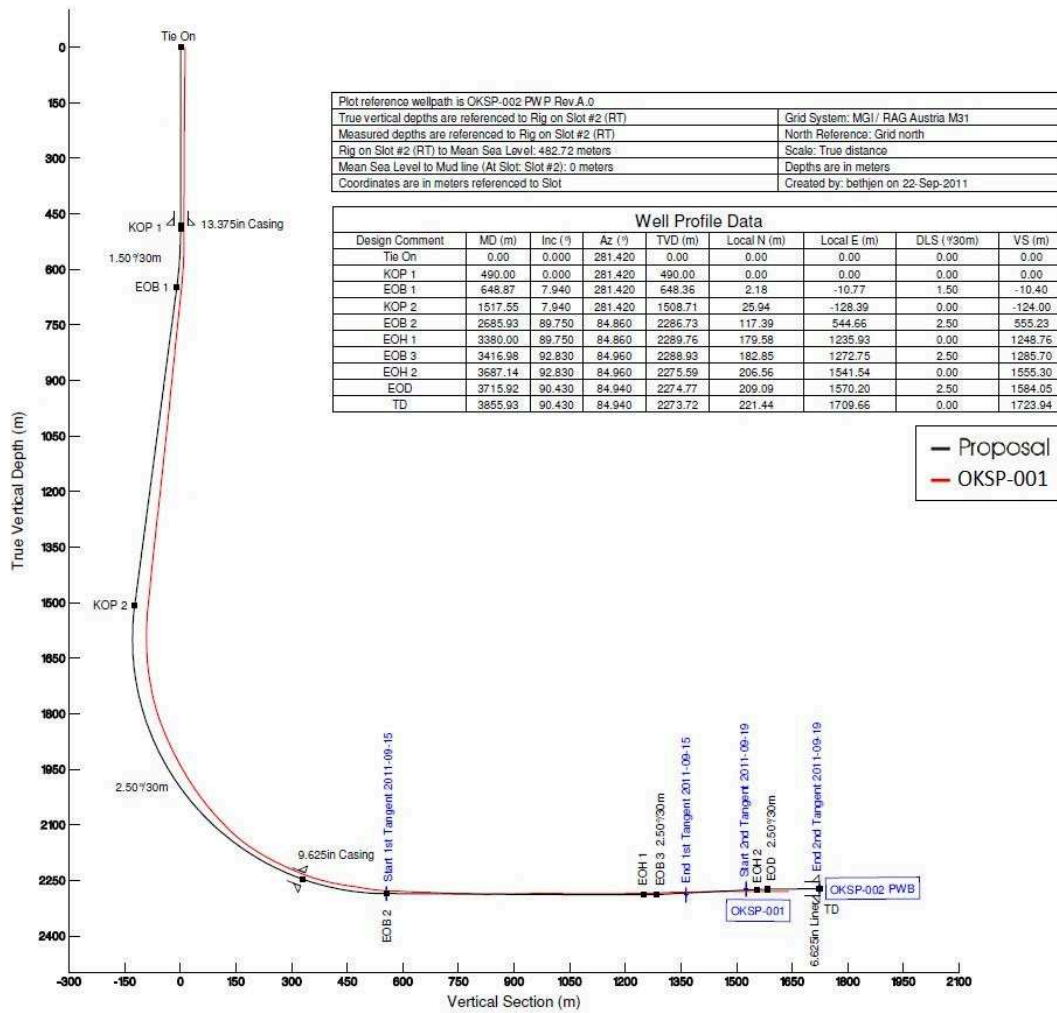
Figure 3.2 – Trajectory of OKSP-002

For OKSP–002, the targets are defined as driller’s targets as a sphere with a radius of 20 m without the consideration of an ellipse of uncertainty.

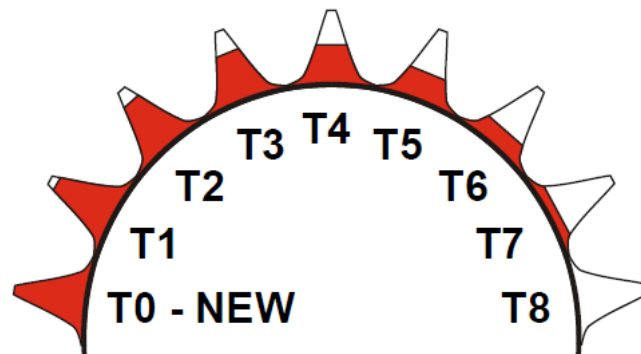
Figure 4.2 – Tooth height measurement³

Column 1 (I) describes the cutting elements not touching the wall and their wear. After IADC standardization this counts for the inner 2/3 of the bit. To report the wear of the cutters touching the wall (outer third of the bit), line 2 (O) is used, but a Smith guideline states clear not to include heel elements. So, both criteria are put into a linear scale from 0 to 8 measuring the structure reduction (Figure 4.2).

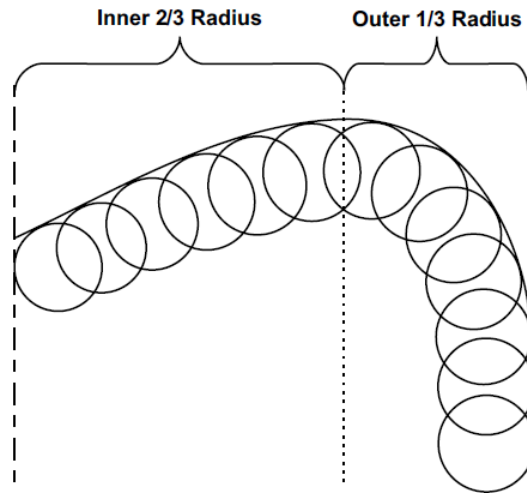
Figure 4.4 – Inner / outer body designation of fixed cutter bits³

The distinction between inner (I) and outer row (O) follows the 2/3 rule of IADC, leaving the first column for the inner 2/3 radius. The second space then is intended for the outer 1/3 of cutters (Figure 4.4).

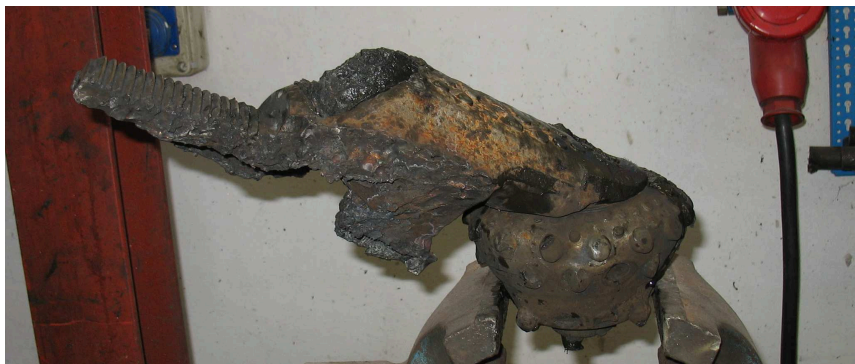
Figure 5.1 – Disassembled leg after arc welding

After breaking all old weld seams, the original parts were able to be investigated one by one.

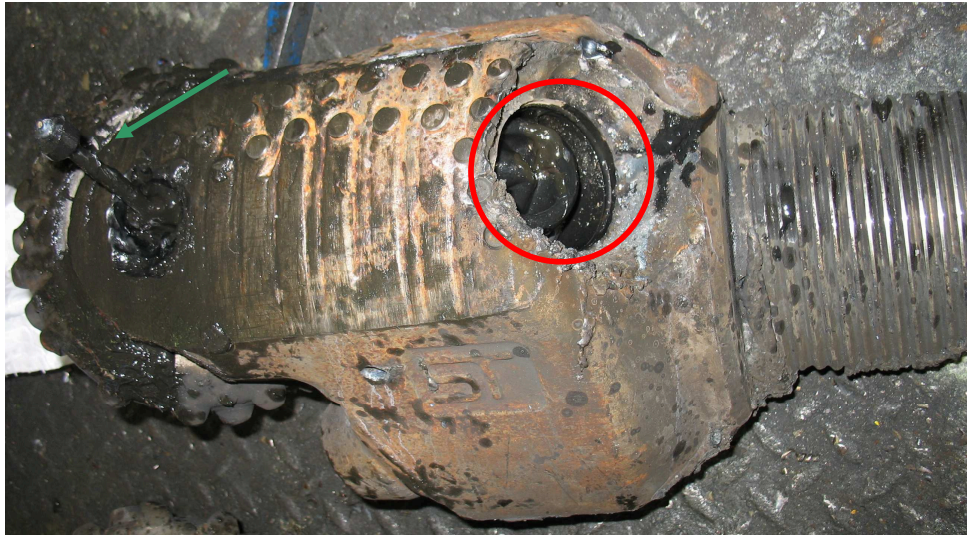
Figure 5.2 – Dismantled pin (green) and reservoir section (red)

Without removing the pin, the cone cannot be dismantled and a detailed analysis would not be possible.

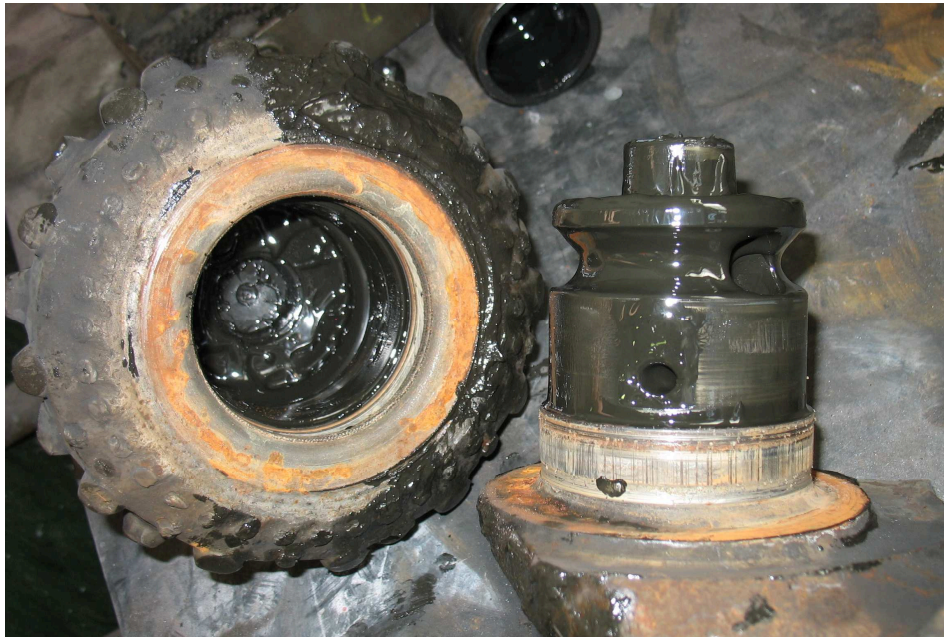
Figure 5.3 – Dismounted cone – bearing and leg with remaining lubricant

Via a magnet, the balls are removed from their position. Only after removing every ball of the 13 in the bearing, the cone can be removed from the leg (Figure 5.3). All parts can be dismantled and are being investigated visually.

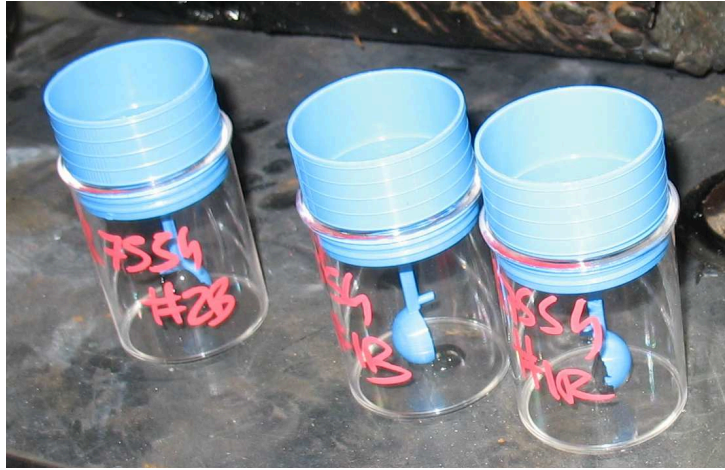
Figure 5.4 – Collected grease samples, ready for grease – water analysis

If the reservoir shows a higher water contamination than the bearing, a failure of the boot seal is more likely. Analogical, an increased water percentage in the bearing, combined with a lower water cut in the reservoir, it is very likely that a bearing seal is broken.

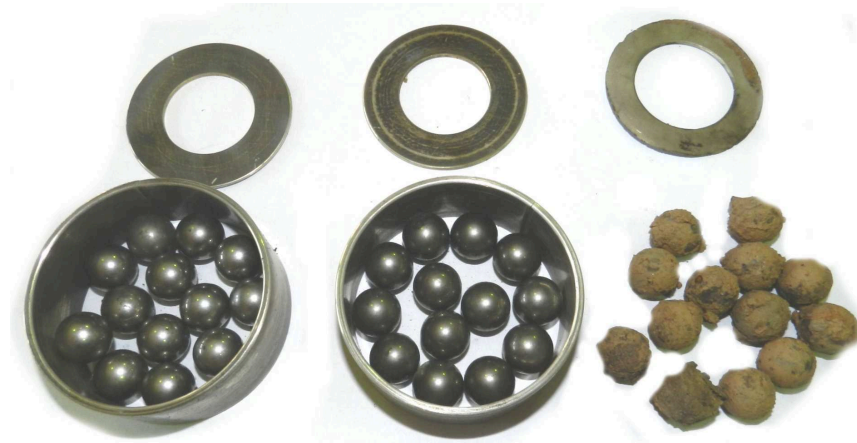
Figure 5.5 – Internal bearing components (#3 components show strong mud intrusion)

During the grease - water analysis, all components of the bearing are being washed and the grease is removed. Then, the components as mentioned in Chapter 5.2 are being investigated and damage can be observed since all dirt and grease is gone.

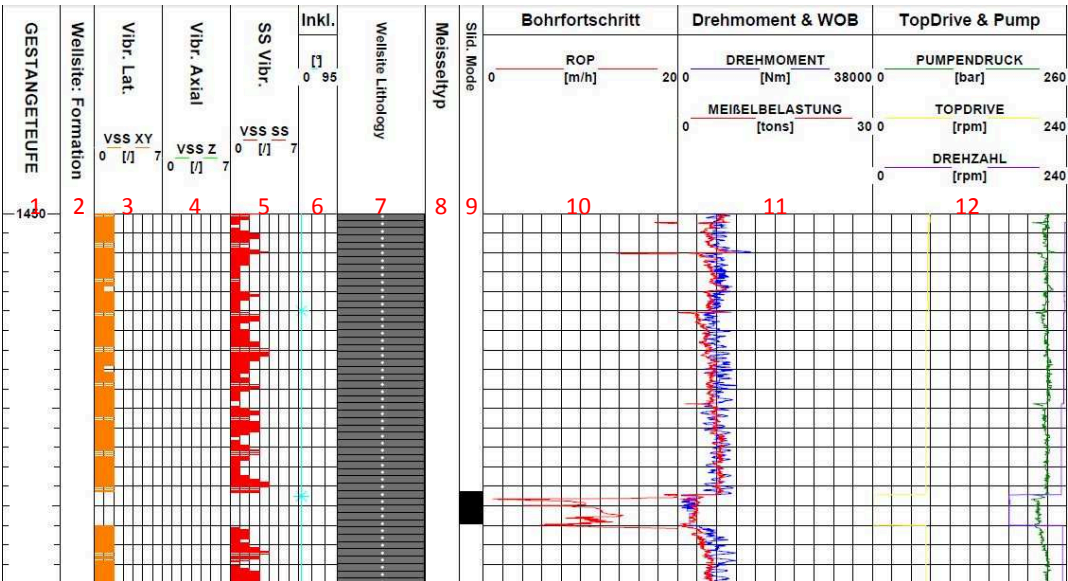
Figure 7.1 – Log with combined channels for first interpretation

RPM of the top drive was used for generating an auxiliary channel describing the drilling mode. Black bars were integrated into a minor channel, where top drive revolutions were 0 (Figure 7.1 – point 9). This had to be done manually, since no automated program was at hand. The last channel included a bit and BHA description (Figure 7.1 – point 8).

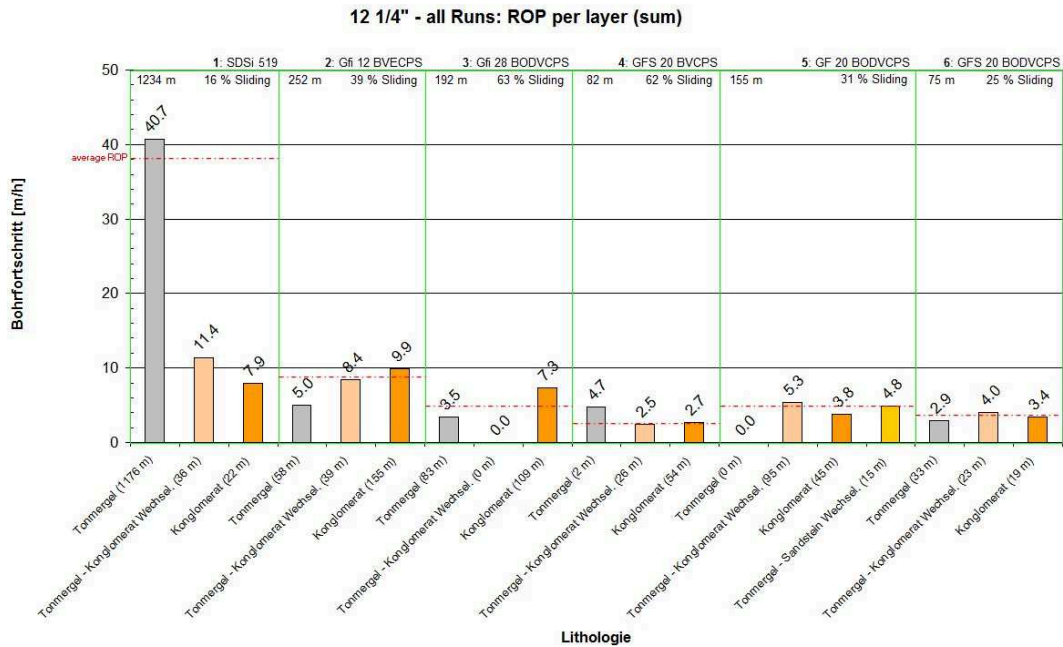
Figure 7.4 – Summary sheet for the 12 ¼ inch section of OKSP-001

- Grey – clay marl,
- light orange – clay marl – conglomerate interbedding,
- orange – conglomerate,
- dark yellow – clay marl – sandstone interbedding and

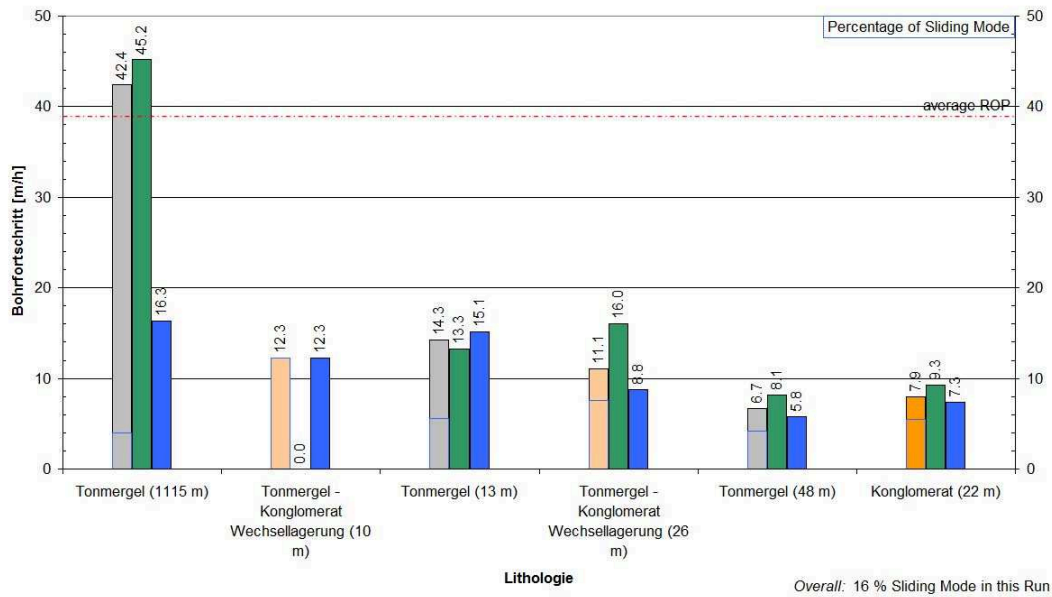
Figure 7.5 – Detailed sheet for run #1 of OKSP-001

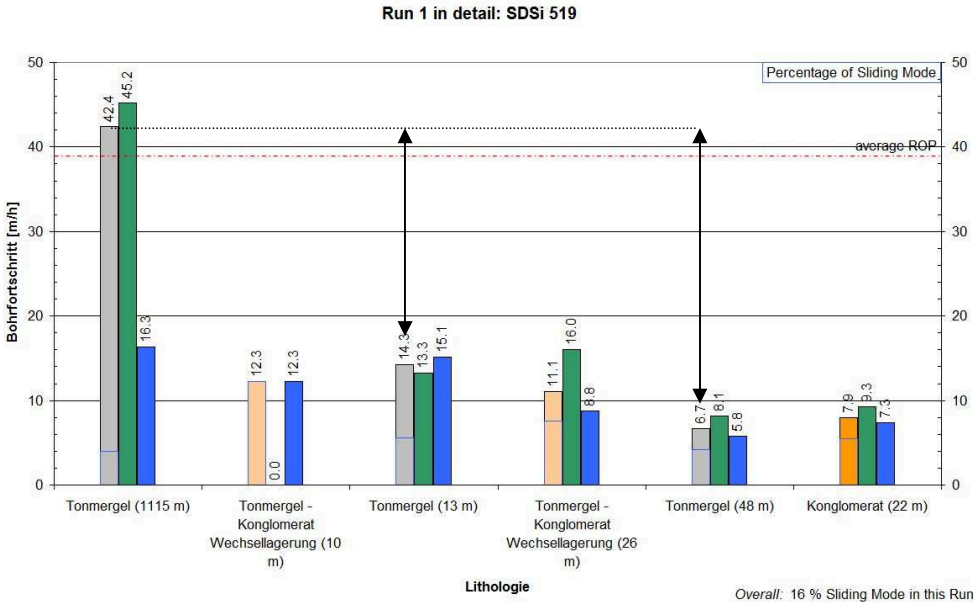
Figure 8.2 – OKSP-001 run #1: loss of cutting capacity after encountering conglomerate layers

As previously brought up, the PDC showed a significant drop of ROP, allowing the assumption that cutting elements have been destroyed after encountering the first conglomerate layer. This can be observed, because the penetration rate did not increase in the following clay marls again (Figure 8.2). A reduced penetration depth of the cutters and a chamfered structure ruined the PDC’s capability to drill.

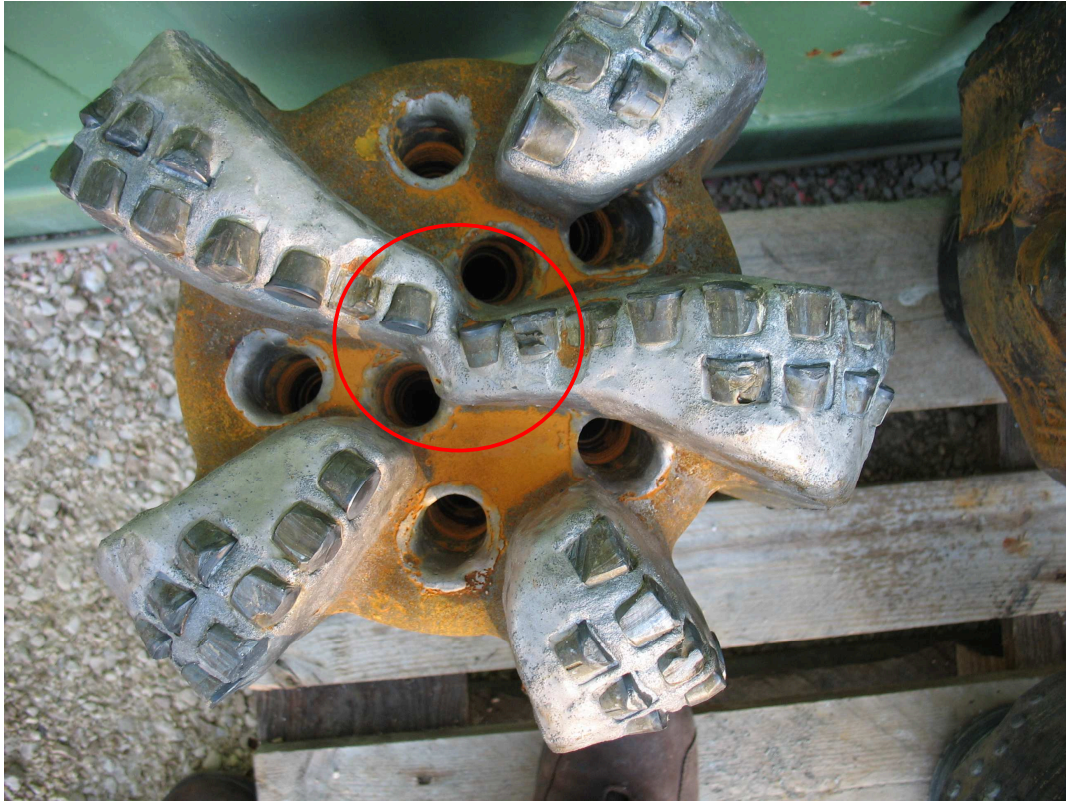
Figure 8.3 – OKSP-001 run #1: PDC with a ring out and worn teeth

In a conglomerate layer at 1234 m MD and with a rate of penetration below 3 m/h the PDC was pulled and on surface, it showed the already assumed forms of dullness. Worn teeth at all areas and a ring out (see Chapter 4.3) could be observed leaving a clear damage pattern and the reason for the significant performance drop.

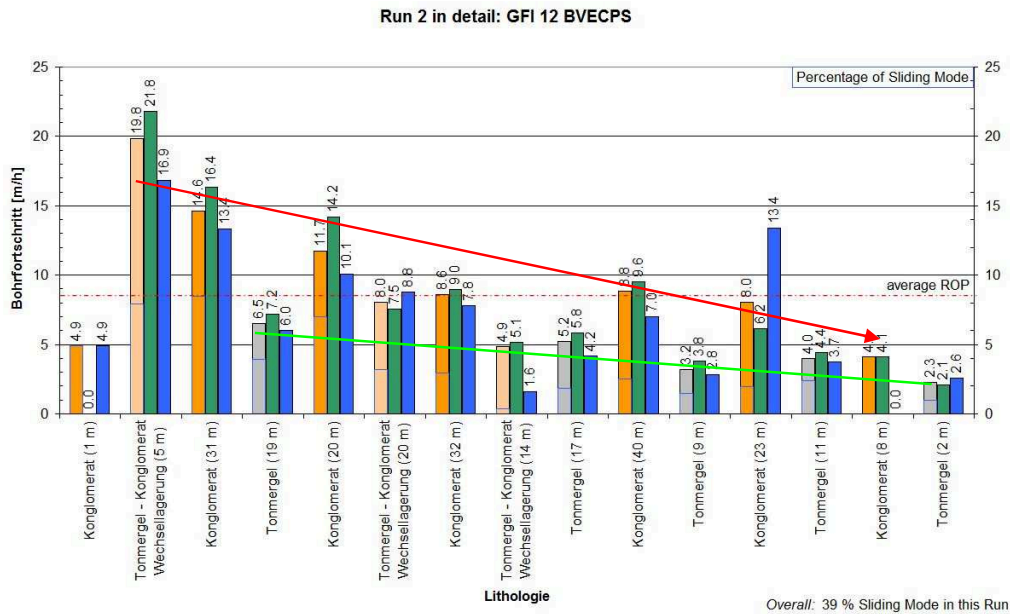
Figure 8.4 – OKSP-001 run #2: constant decrease of ROP indicating bit dulling

As to be found out later, the increased axial impacts wore off the TCI cutters, explaining the ongoing decrease of ROP (Figure 8.4 – red arrow).

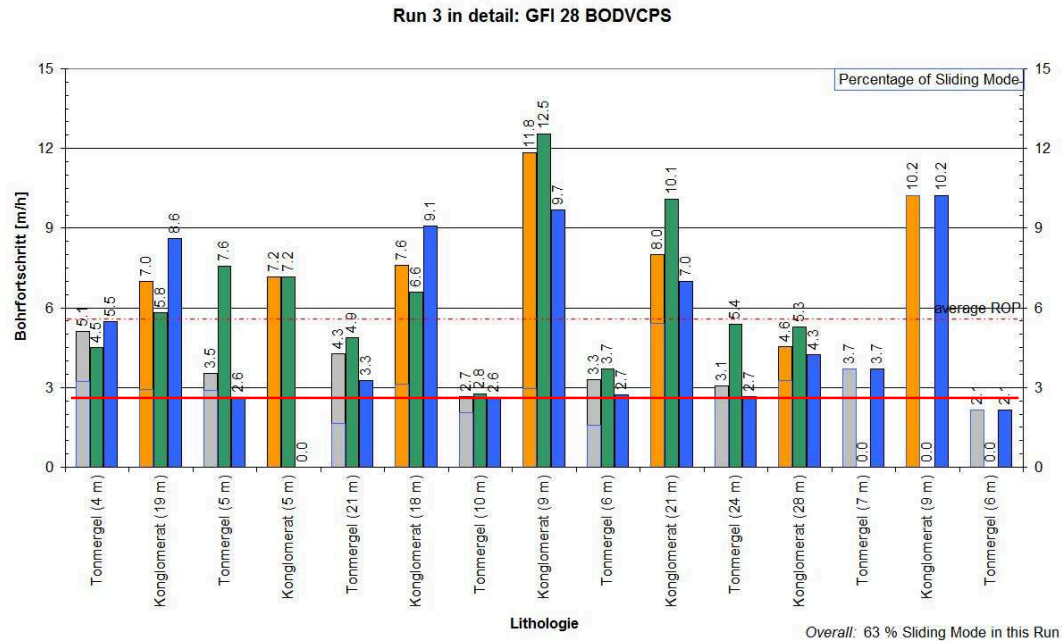
Figure 8.6 – OKSP-001 run #3: increasing sliding time and constant low ROP in clay marl

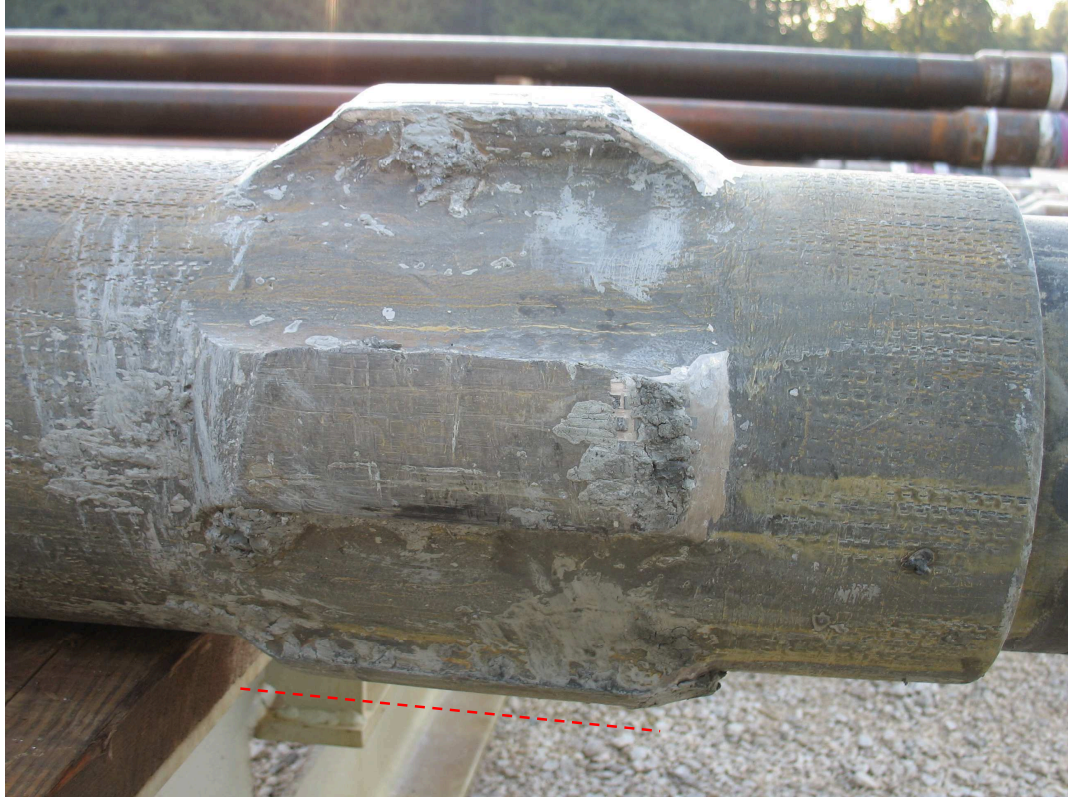
Figure 8.7 – OKSP-001 run #3: bearing sub with extensive wear on low side

the given geometry was by far the most damaged one. The point, where the momentum to the bit is transferred, is consequentially the one with the most contact to the formation causing the biggest damage (Figure 8.7).

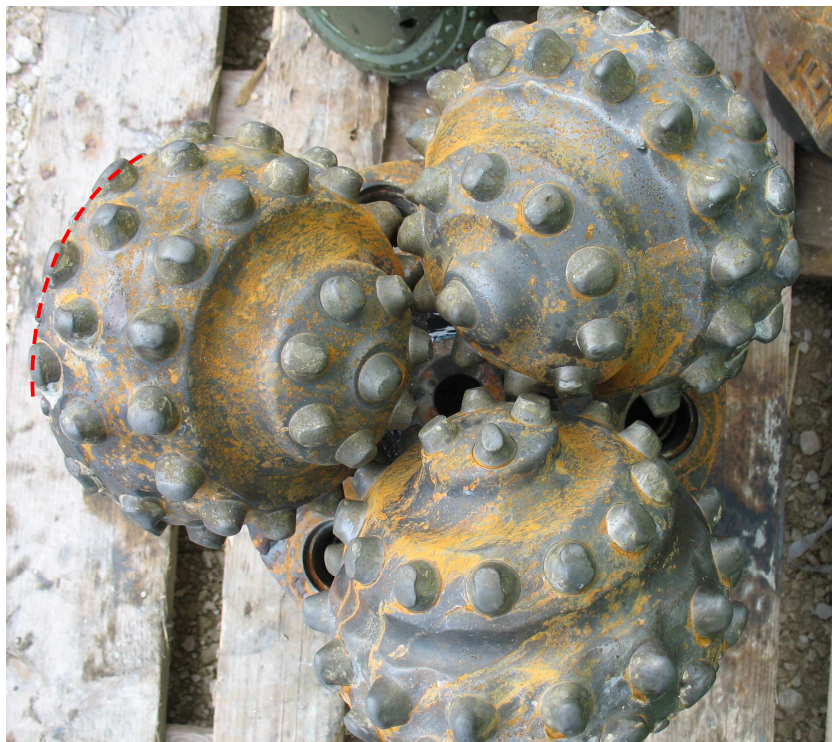
Figure 8.8 – OKSP-001 run #3: roller cone bit with minor signs of wear

The high IADC grading of the bit allowed coming out of the well without severe damage. Therefore, the company man's visual inspection and dull grading of 8 for the outer rows (Chapter 4.2) do not apply. As shown in Figure 8.8, the outer rows show regular signs of wear, most likely gauge-rounding, but no broken teeth as reported, allowing the assumption, that a more aggressive bit might have improved ROP.

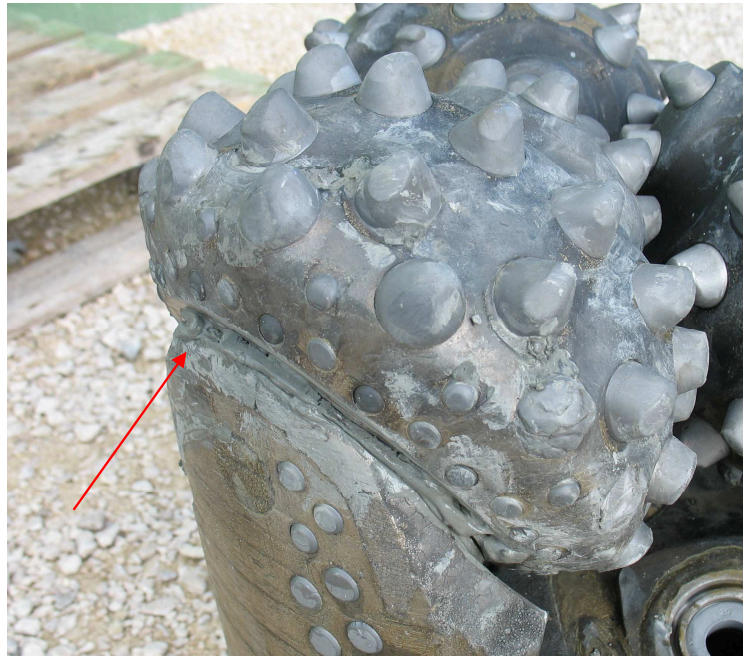
Figure 8.9 – OKSP-001 run #4: roller cone bit with seal breakage and mud intrusion

With broken teeth in the outer rows and flat crested cutters at all rows, the GFS 20 showed the expected wear. One thing, which does not appear in the company man's dull grading, is the loss of lubrication at two cones. Mud intrusion (Figure 8.9) already happened and the cones were easy to rotate without any springback on their legs.

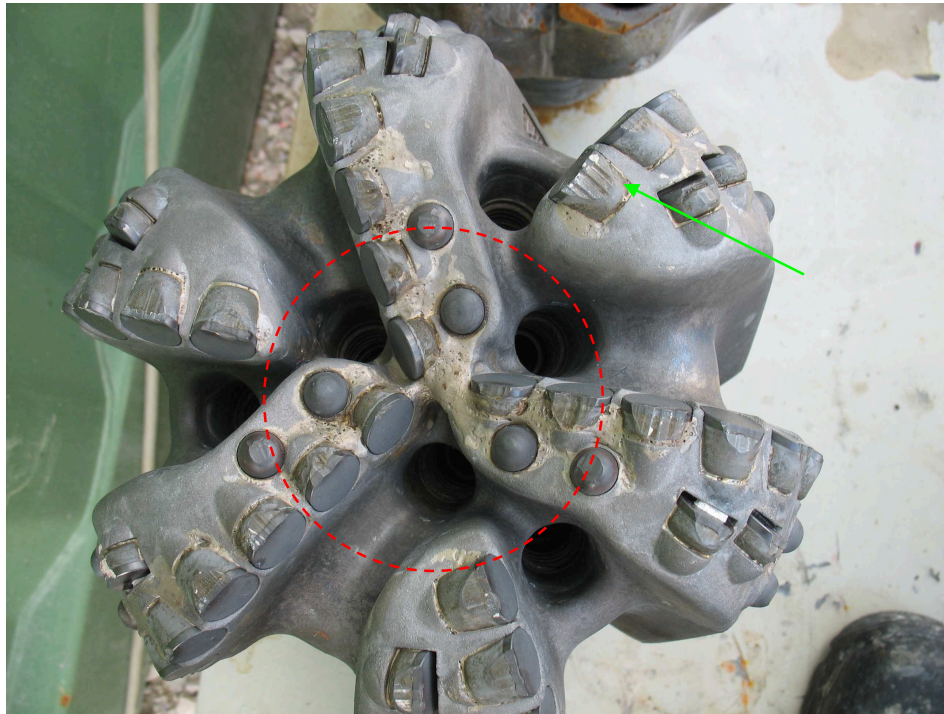
Figure 8.10 – OKSP-001 run #8: PDC with dome-topped inserts preventing a ring out, high wear though at outer cutters

After retrieving the MSF 616 M-A2B, observations of the dome-topped inserts showed the protection against a ring out. High wear on inner-row cutters were a sign of the high percentage of clasts in the layers. Nevertheless, the dome-topped inserts protected the bit's center cutters (Figure 8.10 – circled red). Still, the relatively high wear on the bit with little meters drilled was alarming (Figure 8.10 – highlighted green).

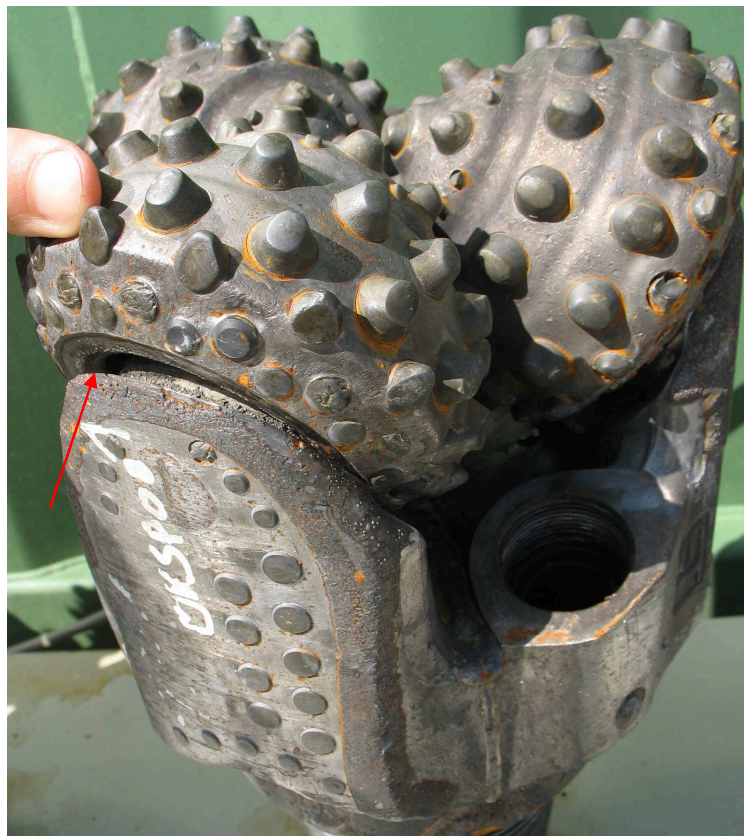
Figure 8.11 – OKSP-001 run #9: loose cone at TCI after 46.5 hours

Being the bit with the most hours on bottom, bit wear was severe. Parallel to previous runs, the roller cone's TCIs were normally worn and the factor limiting the TCI's lifetime is detected as the bit's bearing. In a highly altered position (Figure 8.11), beginning cone interference was at hand. This being observed, drilling hours of the next 8 ½ inch TCIs were kept at 40.

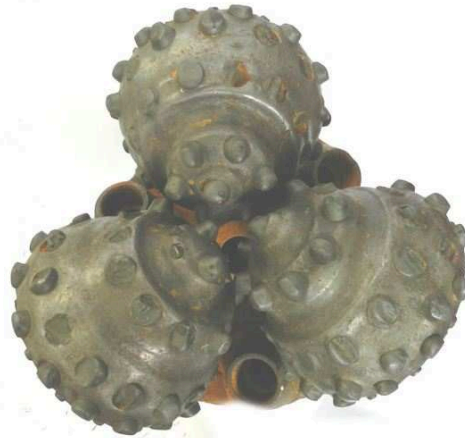
As Received

PR7554 Top View

- The PR7554 was a tight hole run. For this reason, some of the data on the above table is missing.
- PR7554 was run from a depth of 5688.9 feet to 6515.7 feet, a total of 826.8 feet in 55 hours. The bit was POOH due to hours. When retrieving the bit the bearings from cone #1 and #2 were still effective but when the cones were rotated no springback was observed. Based on this it can be concluded that they were in process of failure. The #3 assembly had failed. The bit was sent back to the Reliability lab in order to perform a full analysis regarding grease water content, bearing conditions, boots, seals.

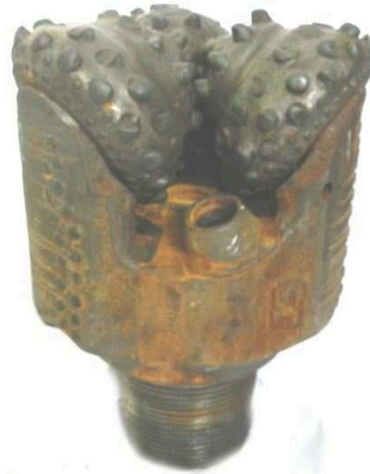
PR7554 Side View

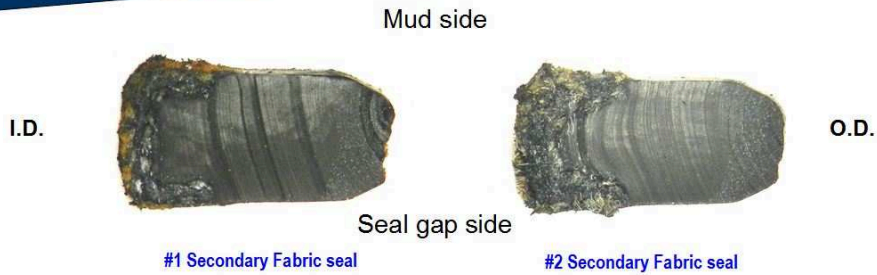
Secondary Seals Investigation

SEAL DIMENSIONS	#1 Secondary seal	#2 Secondary seal	#3 Secondary seal
Current seal cross section			
Original seal cross section	0.360"	0.360"	0.360"
% loss of seal squeeze	100 %	100 %	100 %
Seal gap grease water %

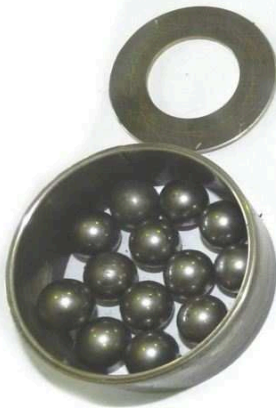
#1 internal components

Thrust Washers Investigation

- #1 and #2 cone internal components showed no signs of wear.
- #3 bearing sleeve was not found in the bearing because it was destroyed after the seal failure due to mud intrusion and cone misalignment.

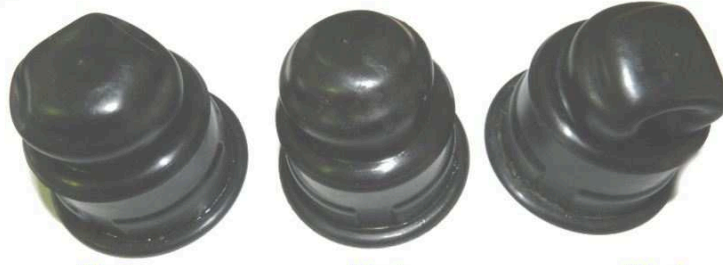
Reservoirs and Grease Water Analysis

valvola n°	Data	BarCode	PS	P0	P1	P0 - P1	EsitoTest
1	08/04/11	PR7554	165	151	152	-1	Test PASS
2	08/04/11	PR7554	179	168	168	0	Test PASS
3	08/04/11	PR7554	178	163	163	0	Test PASS

PR7554Cone #	#1 CONE	#2 CONE	#3 CONE
Bearing Grease water analysis	14.01 %	20.90 %	
Reservoir Grease water analysis	0.71 %	5.28 %	
Reservoir fill condition	Almost empty	Almost empty	Contaminated

- #1 boot was found in semi-extended position and almost empty. The partial depletion was caused by the primary seal leaking.
- #2 boot was found in relaxed position and almost empty. Even in this case, the depletion was caused by primary seal leaking.
- #3 boot was found in relaxed condition but contaminated with mud. No damage was observed on all three of them. Internal BRDB revealed that all three boots passed the nitrogen test within Smith Specification.

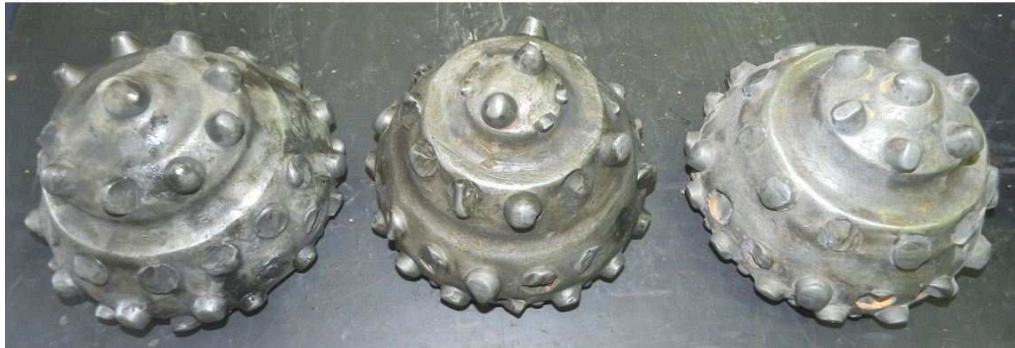
Cutting Structure Investigation

#1 cone

#2 cone

- Inner row cutting structure was severely broken.
- Severe breakage was most likely caused by vibration and bouncing due to drilling in conglomerate formation.

- Based on the results of this investigation and on the past experience, one can conclude that the #3 assembly failure was caused by primary seal wear.
- The #3 seal bearing failure was accelerated by gage rounding, inner cutting structure breakage and low HSI.
- The #1 and #2 assemblies still have grease in the bearings, but since high water % was found during the grease water analysis, they were in process of failure.
- Based on the results of this investigation, no material or manufacturing non conformances were found to be related to the #3 seal/bearing failure.
- All three legs have deep grooves worn between the p-feature inserts. This was most likely caused by the bit lying on its side in the 31 degree deviation, abrasive formation.
