Master Thesis

Optimization of Progressive Cavity Pumps in Mature Oil Fields with special focus on OMV Austria

Abstract

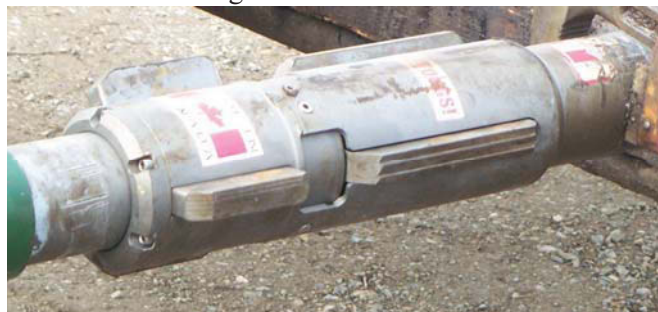
Figure 5 torque anchor STU139

This tool is installed below the stator. It prevents rotation of the tubing. Since the rod string is rotating the rotor in the stator, the stator would be forced to rotate as well if it would not be fixed somewhere. The torque anchor prevents rotation in one direction by gripping the inner wall of the casing.

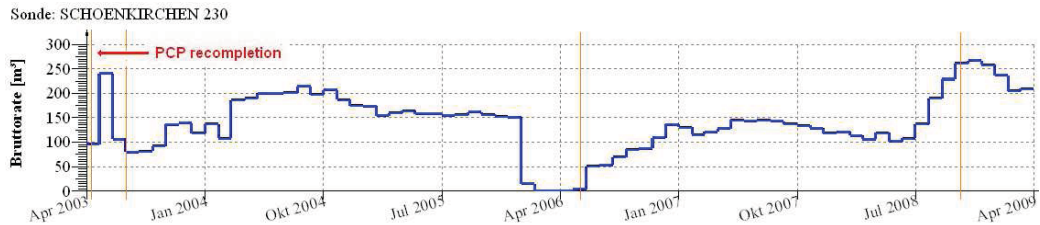
the tubing string. The completion was running fine for 2 and a half years when production stopped. Again the tubing string was leaking and the PCP was changed (after 3 years running time). In October 2008 it was decided that the rod string has to be lifted 10 cm. In June 2009 the well stopped producing. Tubing leak is assumed, the well is waiting for workover.

Relined tubing is planned for the next installation to prevent the tubing leaks.

Figure 21 production history S 230

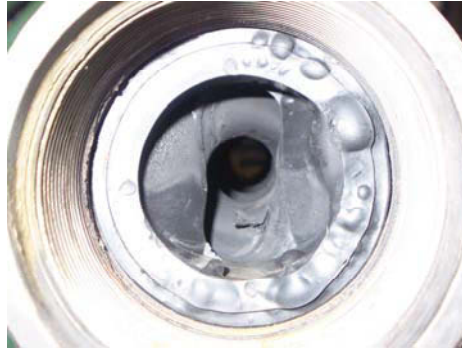
Figure 24 damaged stator elastomer, Pir 96a ,June 2008

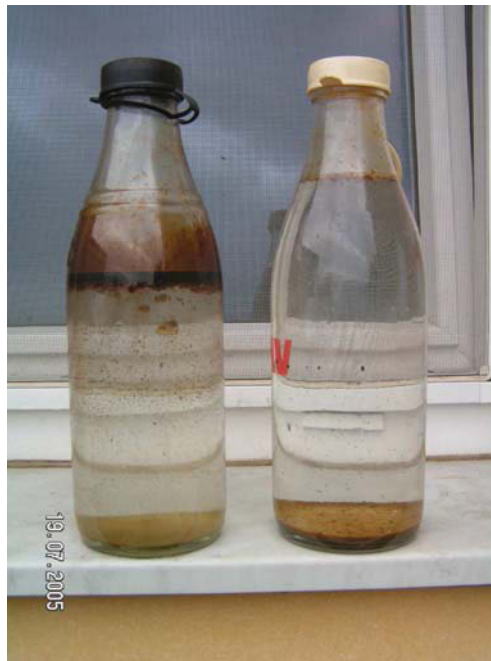
Figure 27 sample of Pir 79 from 19.07.2005

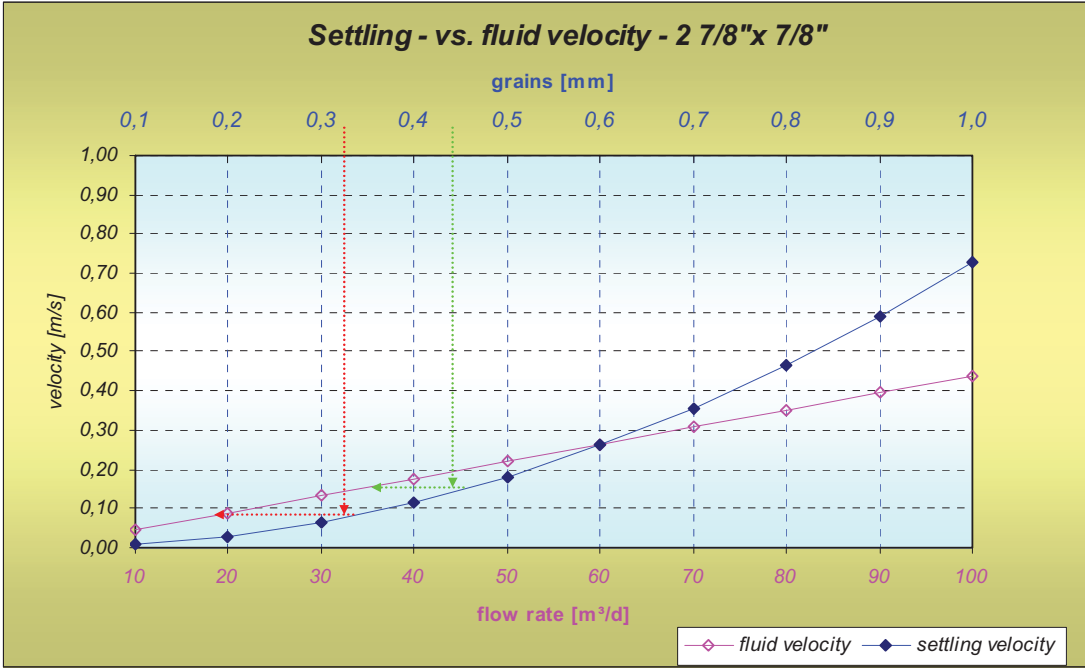
Figure 28 solid settling velocity for 2 7/8" (and 3 1/2" relined) tubing with 7/8" sucker rods

for 3 1/2" relined tubing since it has the same inner diameter like 2 7/8" tubing. The information one can get from this plot is the minimum required flow rate for transporting a defined grain size up to the surface. A grain size with a diameter of 0.5 mm needs a flow rate higher than 36 m³/d to be produced up to the surface in a 2 7/8" tubing. At 36 m³/d the settling velocity would be the same like the fluid velocity resulting in a floating of the particles. The problem hereby is not in the producing mode, but as soon as the pump is stopped the solids will settle down and plug the pump.

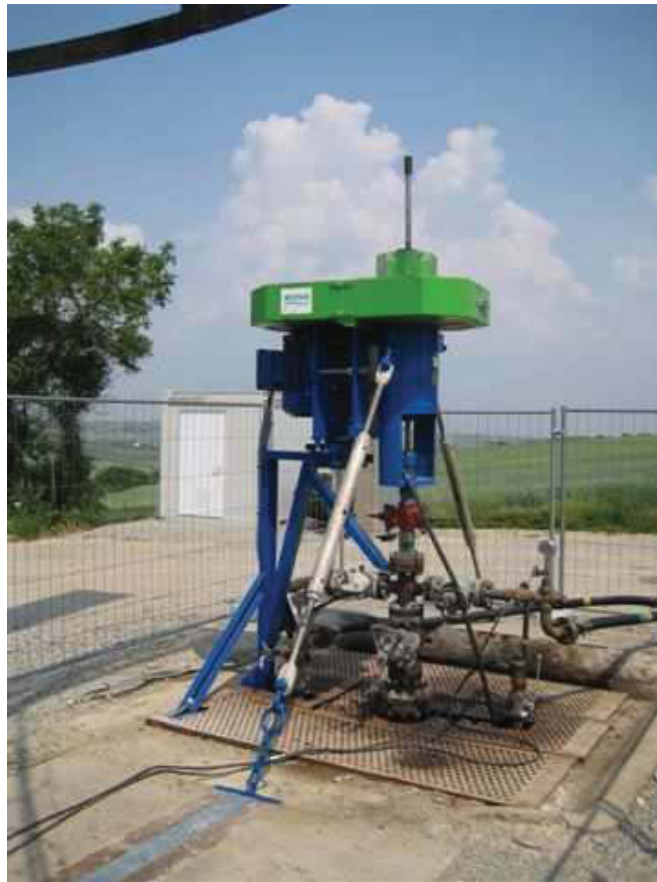
Figure 30 protection against vibrations for Drive Heads

The situation is getting dangerous if the pump is running at high rpm because at some point the drive head at the surface starts vibrating. The maximum rpm that can be achieved with today's PCPs is 500 rpm. OMV found their individual optimum rpm range without any vibrations at 170 rpm. The variable speed drive (VSD) is operating from 100 to 300 rpm. Though all OMV PCP Driveheads should be saved against vibrations, see fig.6.

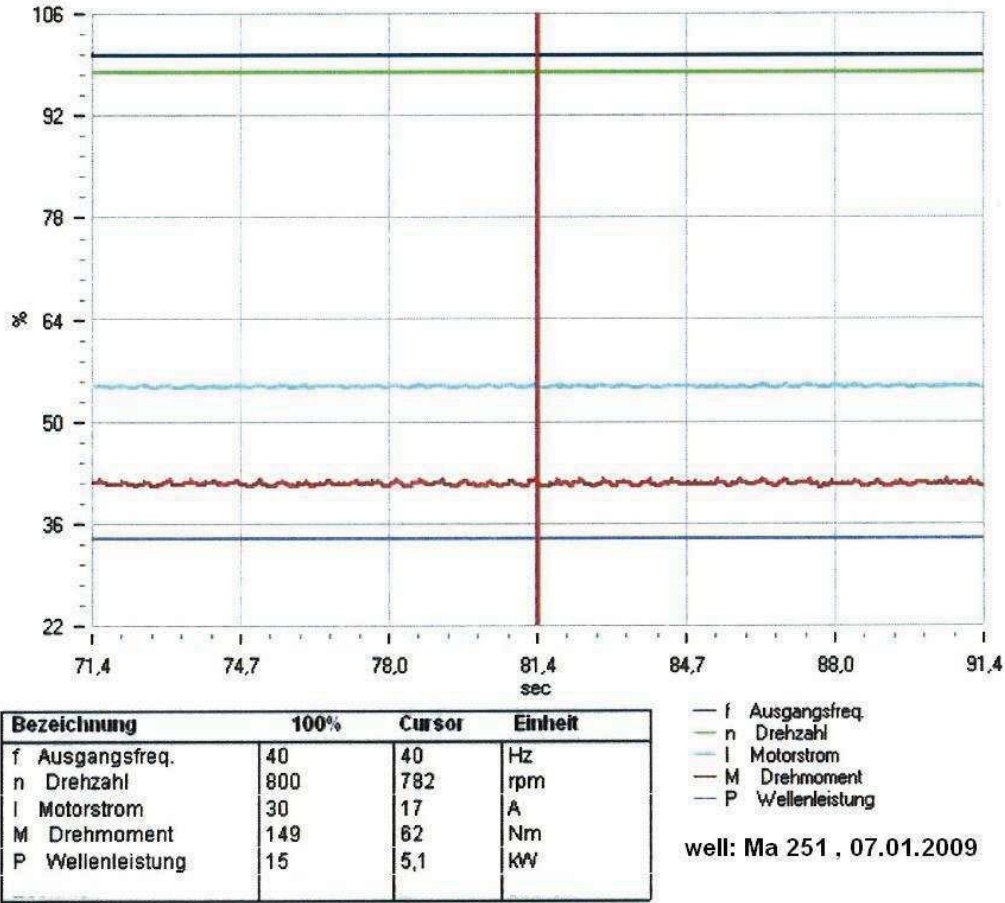
Figure 32 monitored PCP operation (Ma 251)

A helpful tool to do failure analysis for PCPs is to look at the operating parameters from the frequency inverter. These parameters can be torque, frequency, current, power and/or rpm. For good analysis it is important to compare the set value with the actual value. In the oilfield OMV uses frequency inverters from pDRIVE, they provide a software called MatriX to monitor and archive these parameters 200 seconds are the maximum monitoring time.

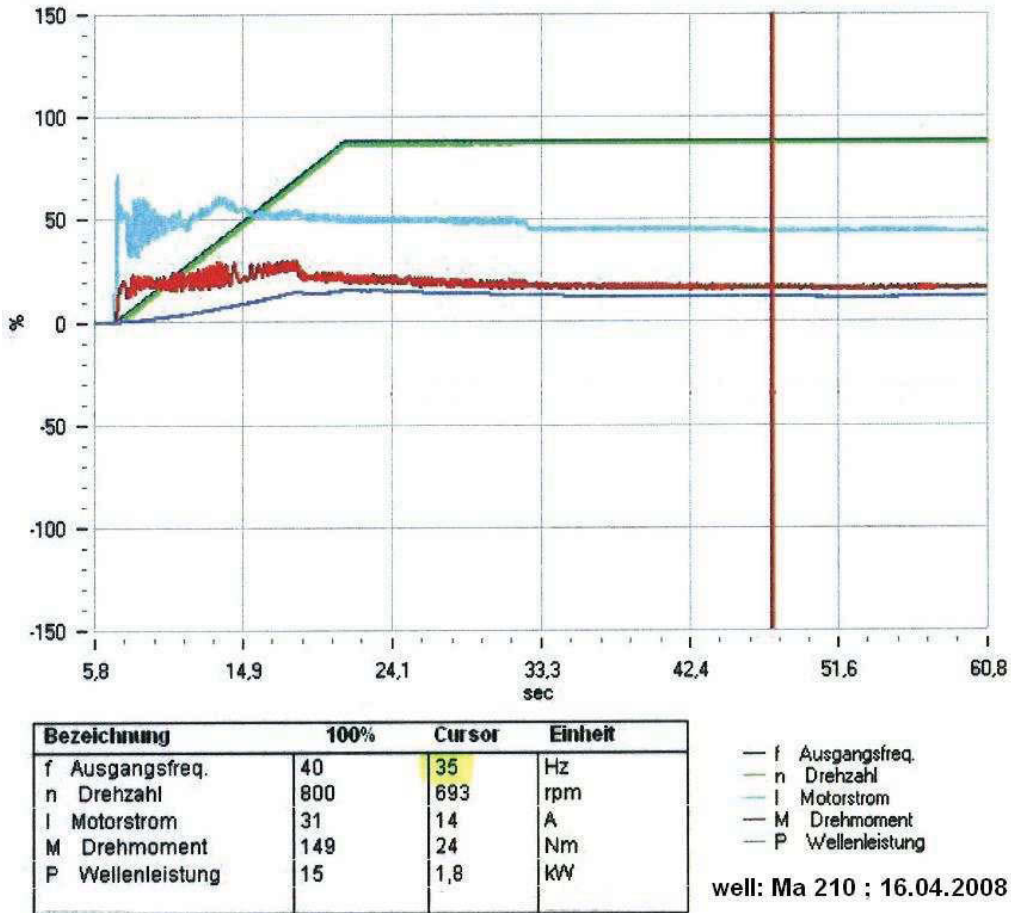
Figure 33 monitored start up of a PCP (Ma 210)

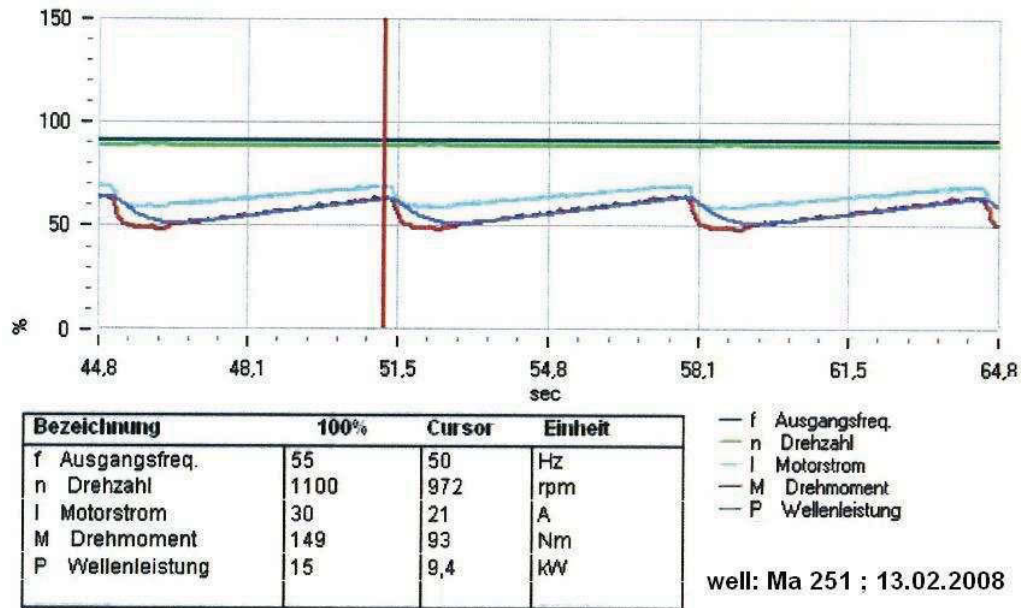
Figure 34 monitored PCP operation (Ma 251)

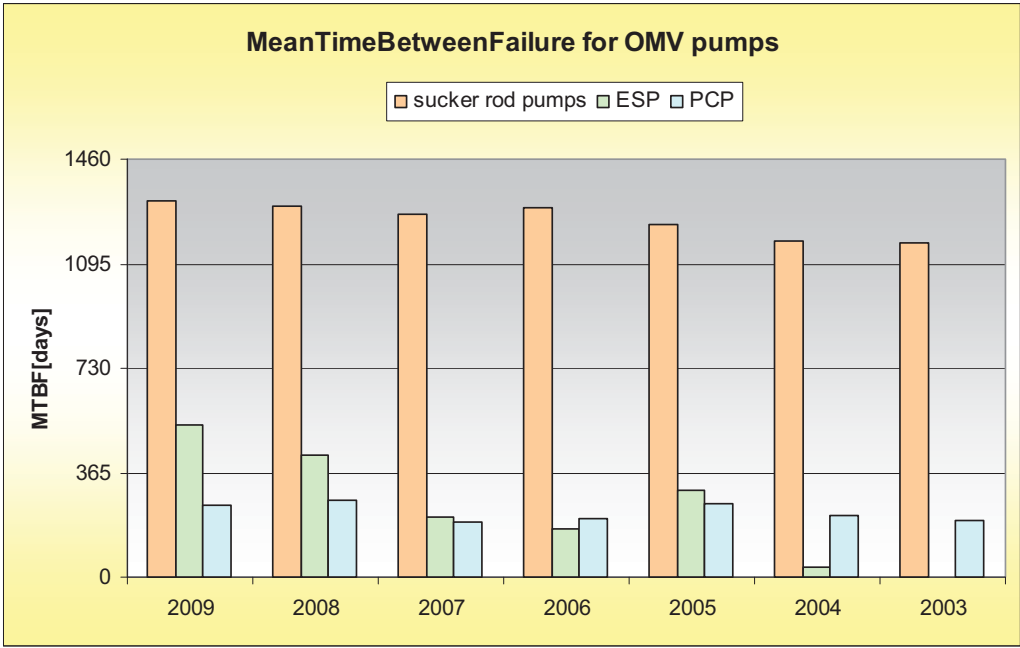
Figure 35 MTBF for OMV pump assisted artificial lift wells

documentation for PCPs can be improved significantly. In one of the later chapters the documentation will be discussed in more detail. If we compare the Mean Time Between Failure (MTBF) OMV has 271 days and Petrom has 163. MTBF is the average time between break down of a system, in this case the PCP wells. A MTBF of 271 days means that a PCP well is operating in average 271 days before a break down occurs. To compare this with a sucker rod pumping unit in OMV, the MTBF equals 1298 days for the year 2008. While a sucker rod pump is running 3.5 years on average a PCP is only running 9 months. The next figure shows the different MTBF for sucker rod pumps, PCP and ESP from 2003 to 2009. For 2009 the actual values are used, variations are expected until the end of the year. It has to be mentioned that OMV is installing ESP since 2004; therefore the MTBF is increasing each year.

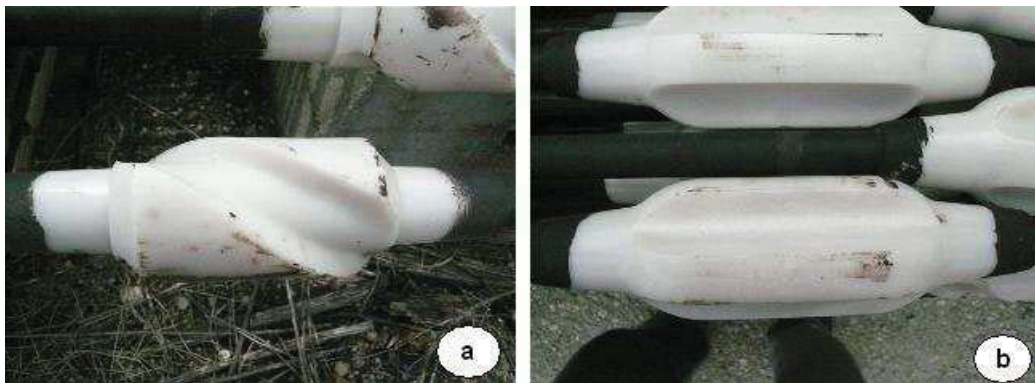
Figure 37 rotating centralizers

Two types of RC have been used by OMV; the difference is defined by the shape of the wings. The wings are either parallel to the rod string (see fig.37a) or spiral grooved (see fig.37b). The intention behind the spiral grooved wings is the continuous contact area with the tubing wall. The parallel wings are better for axial rod movement and the spiral grooved wings are better for radial rod string movement.

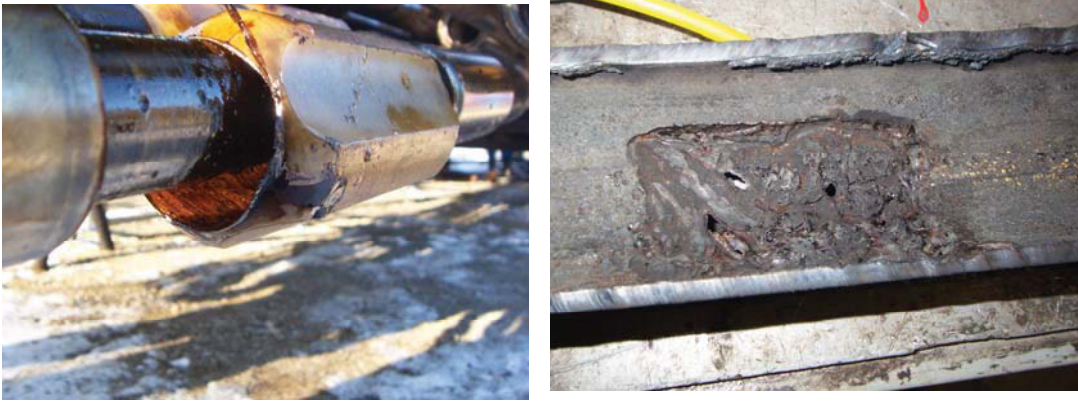
Figure 39 non-rotating centralizer and the impact on the tubing wall

tubing wall which results in a reduction in wall thickness and finally in a leaking tubing string leading to a workover. Sand is influencing the working principle of the NRC and the RC. If the sand manages to find its way between the centralizer and the tubing wall the centralizer will shear the sand into the tubing resulting in erosion.

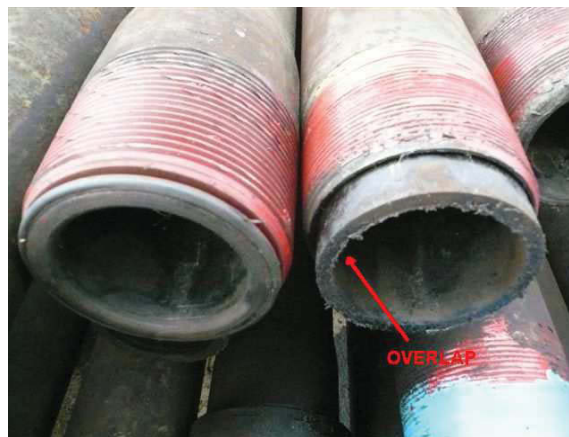
Figure 41 relined tubing after cutting the liner (right) and after creating a shoulder (left)

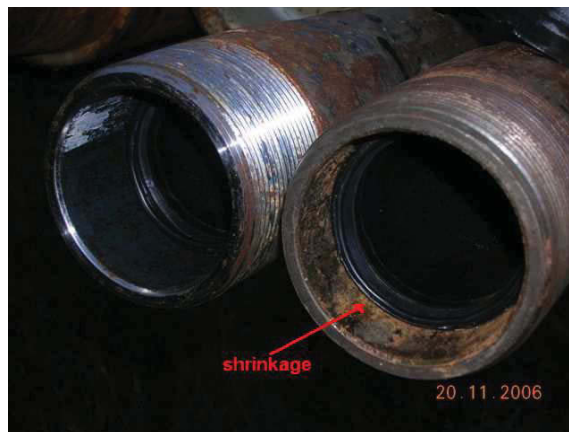
Figure 42 relined tubing with shrunk liner

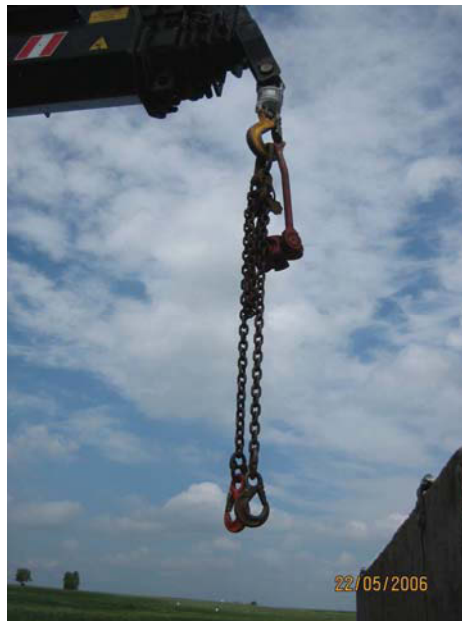
The goal of the operation was to change the drive head (DH) of the well Ma 430. First of all the engine was shut down which resulted in a (controlled) backspin of the rod string in order to release the torque. In the DH a hydraulic break is responsible to keep this backspin controlled, which means the rotational frequency stays in a defined range. The master valve was closed then. The rod string was attached to a rotatable crane hook to be lifted (fig.46).

During this lifting process the rod string lost the contact to the drive and break “claws” and the rotor was lifted in the stator downhole. This axial movement of the rotor in the stator destroyed the sealing capacity of the pump and the liquid column in the tubing was forced to flow down. As a consequence the rotor and the rod string started to rotate. The crane driver/operator quickly lowered the rod string back into the braking claws (no weight on the crane hook anymore) which reduced the rotational speed of the string immediately but the crane hook was still rotating with the same speed. The high centrifugal force of the crane hook forced the attached chain to deform the safety joint until the chain was shot away 15 to 20 meters. Afterwards the string was free of tension and the DH could be changed.

Figure 51 crane which lifted the rod sting of a PCP (near miss 2006)

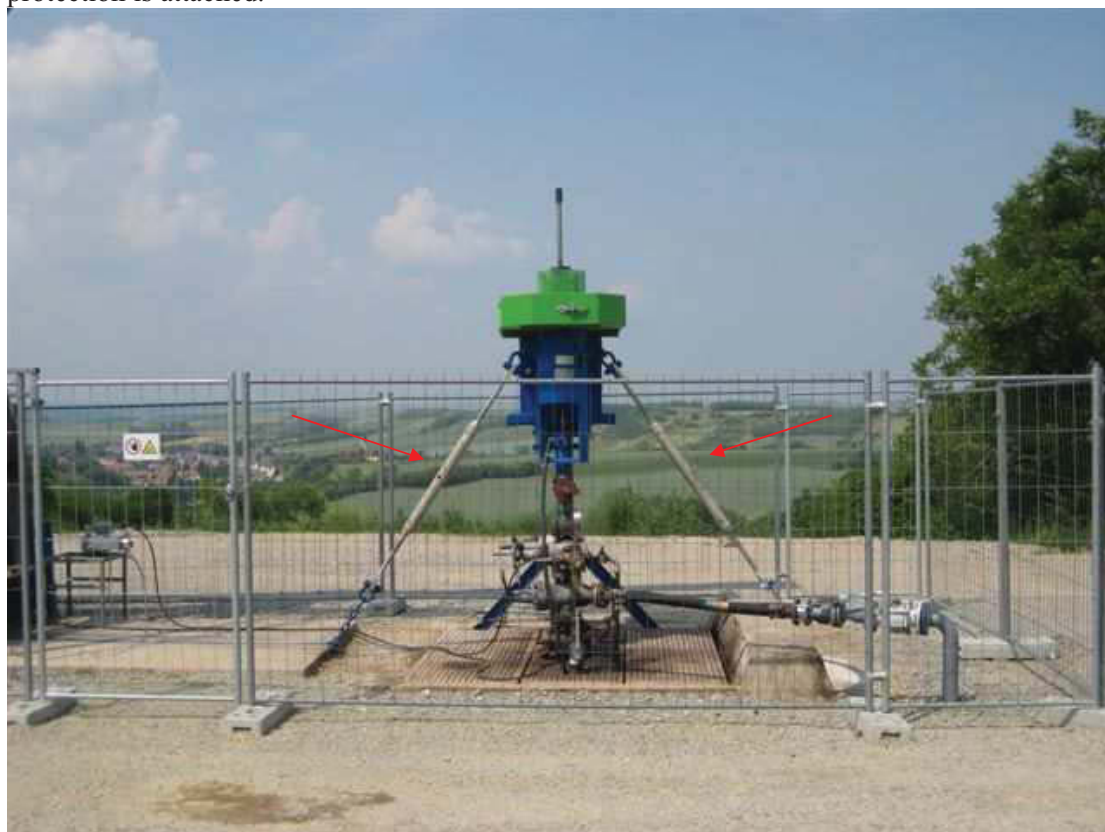
Figure 53 protection against vibrations of DH.
