LANDSLIDES CAUSED BY THE MW7.8 KAIKŌURA EARTHQUAKE AND THE IMMEDIATE RESPONSE

ABSTRACT

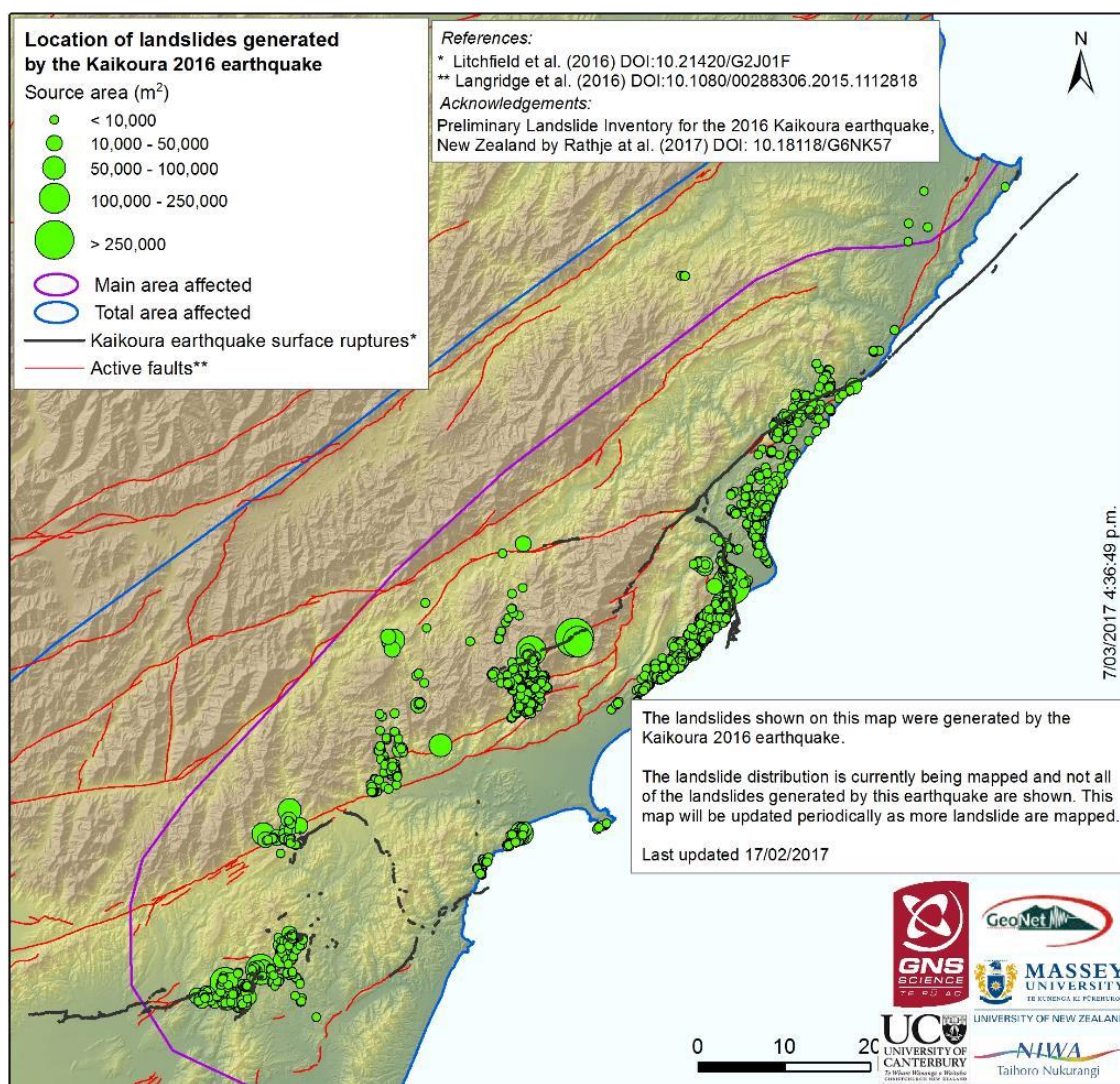
Figure 9: The landslide inventory for the 14 November 2016 M_w 7.8 Kaikōura earthquake as at 17 February 2017 (estimate 30% complete). The active fault ruptures cause by the earthquake are shown as black lines on the map. The landslides, and particularly the largest landslides cluster around the fault ruptures.
